Real or Fake?

Examination and Analysis of a Clock Presenting Itself as a "Horizontal Table Clock from the 16th Century" with Astronomical Display

from Jürgen Ehrt

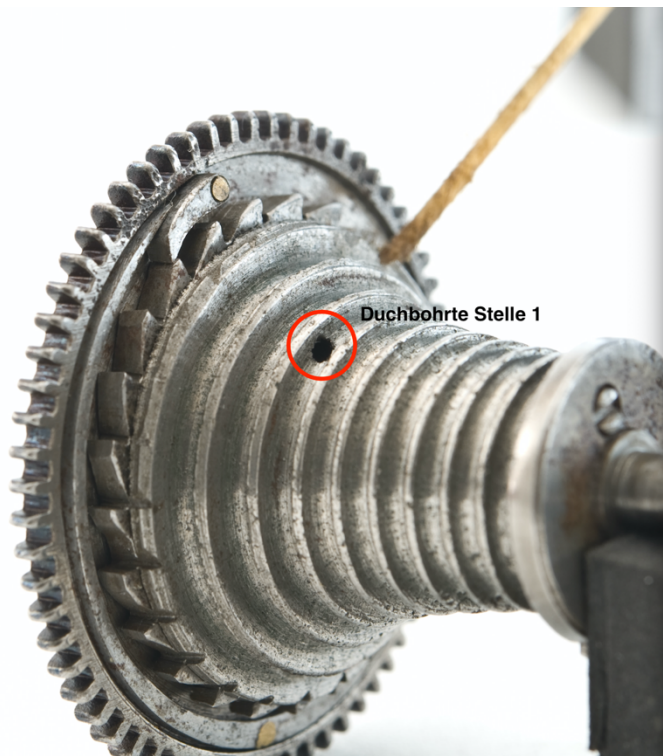
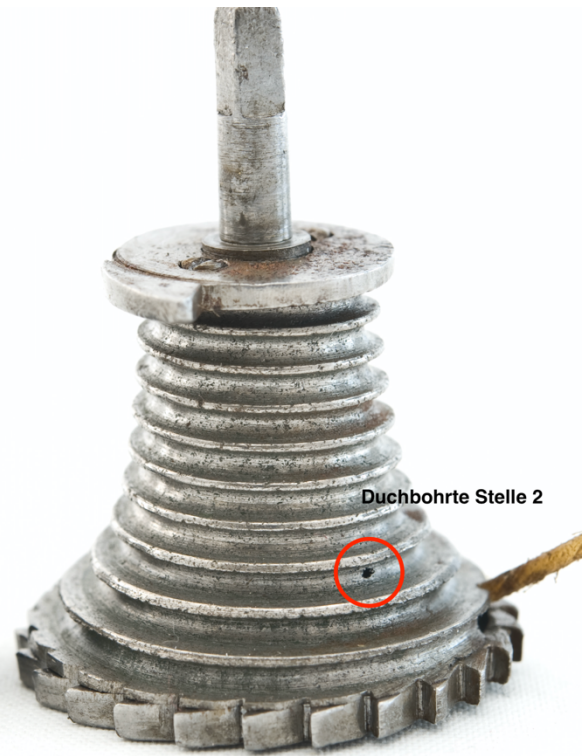
Perforated outer wall of the fusee.

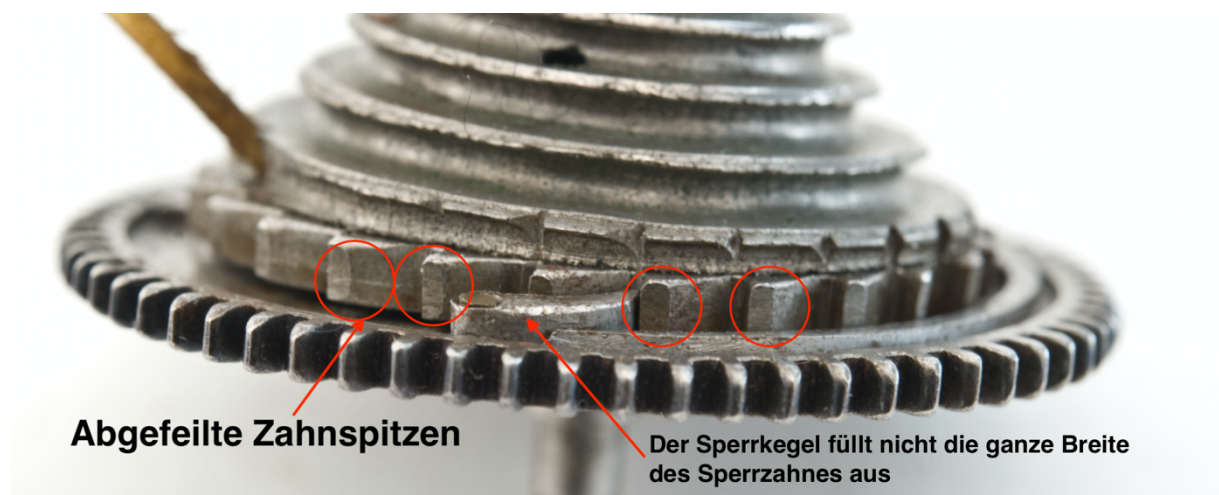
The detent on the ratchet wheel, due to its narrow dimensions, only reaches about three-quarters of the width of the tooth flank. The teeth of the ratchet wheel have been filed with scratch marks across the entire width. This inhomogeneous, feigned wear pattern of the detent on the teeth already suggests at this point that the crafting was done with the intent to counterfeit.

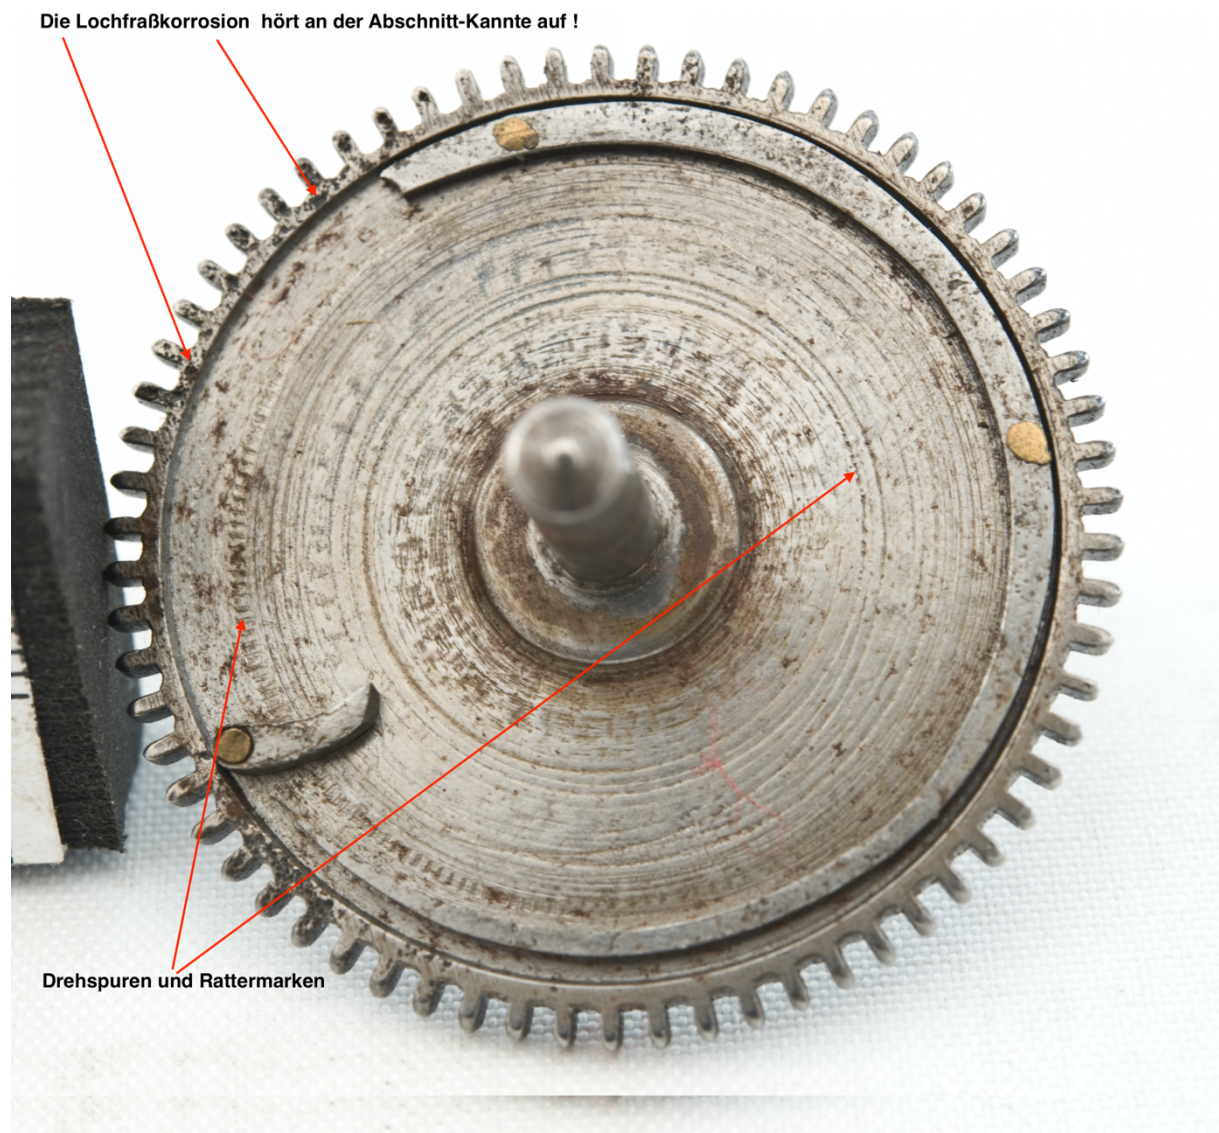
As can be proven for all other gears in the movement, the fusee wheel mounted on the detent is made from old iron material. The flanks of the wheel show significant old corrosion, some of which also has traces of pitting. However, this corrosion pattern is notably absent on the tooth cycloids, the tooth flanks, and the tooth roots.

The corrosion pattern, which extends to the cutting edges, would not have stopped at the edges in the case of homogeneous corrosion. It would naturally have continued into the tooth roots, tooth flanks, and cycloids as well.

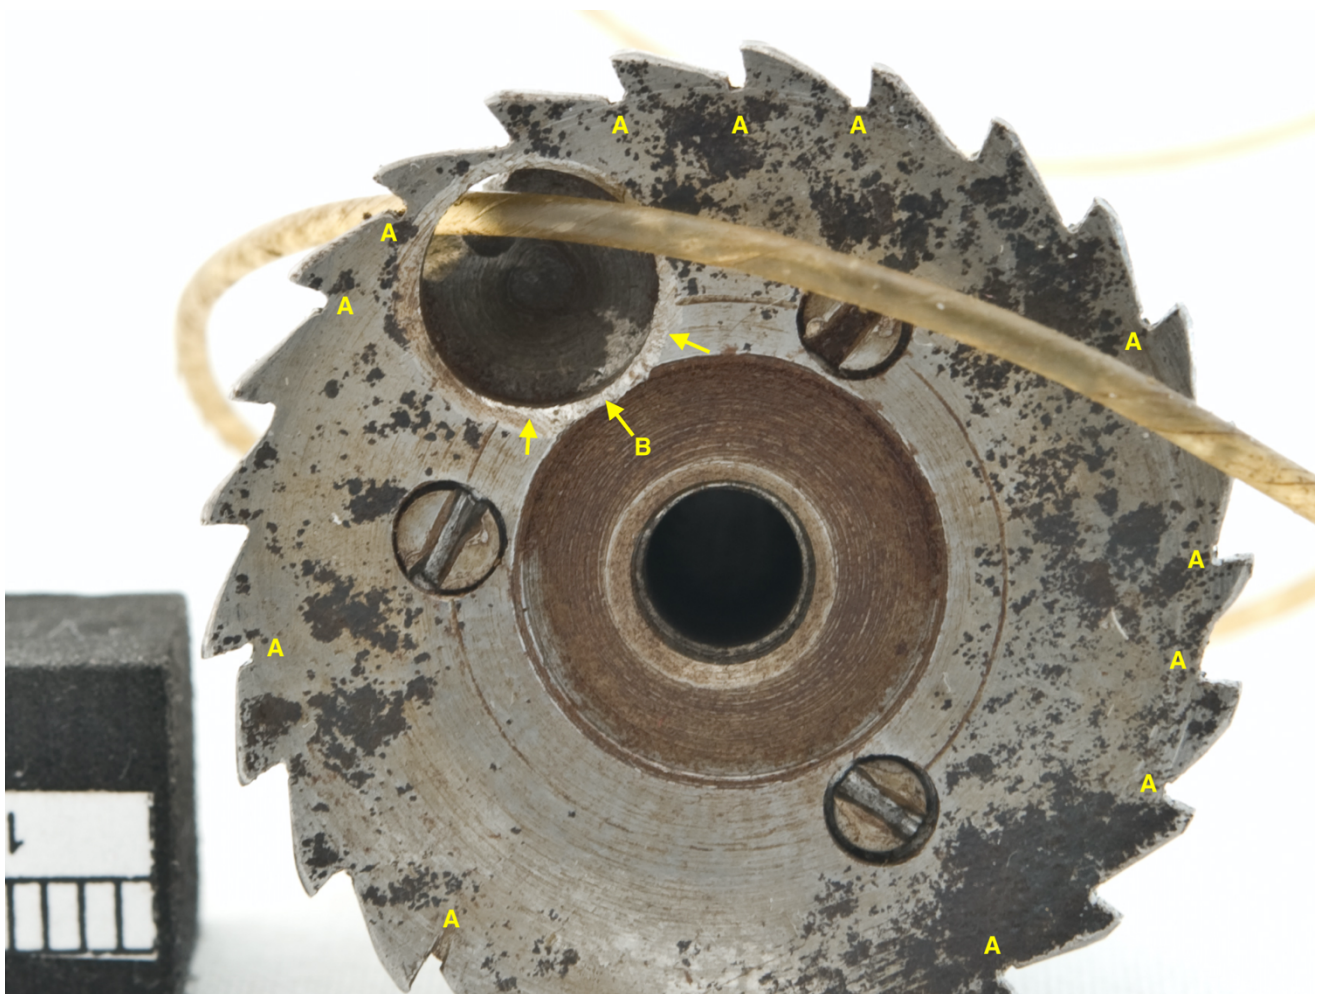
The tooth flanks appear to have been heavily polished at their cycloids and also exhibit an entirely inhomogeneous wear pattern in relation to the corresponding drive engagement with the fusee wheel. (See microscopy)

The detent wheel of the fusee, also made from old iron, shows sloppy workmanship at the points marked A, where the detent teeth have been poorly crafted. Points B indicate the subsequent fresh deepening of the borehole at the entrance for the gut string knot.

The extreme flat filing of the tooth tips may also have been carried out to avoid any rubbing or jamming of the detent teeth against the pressure spring of the detent cone.

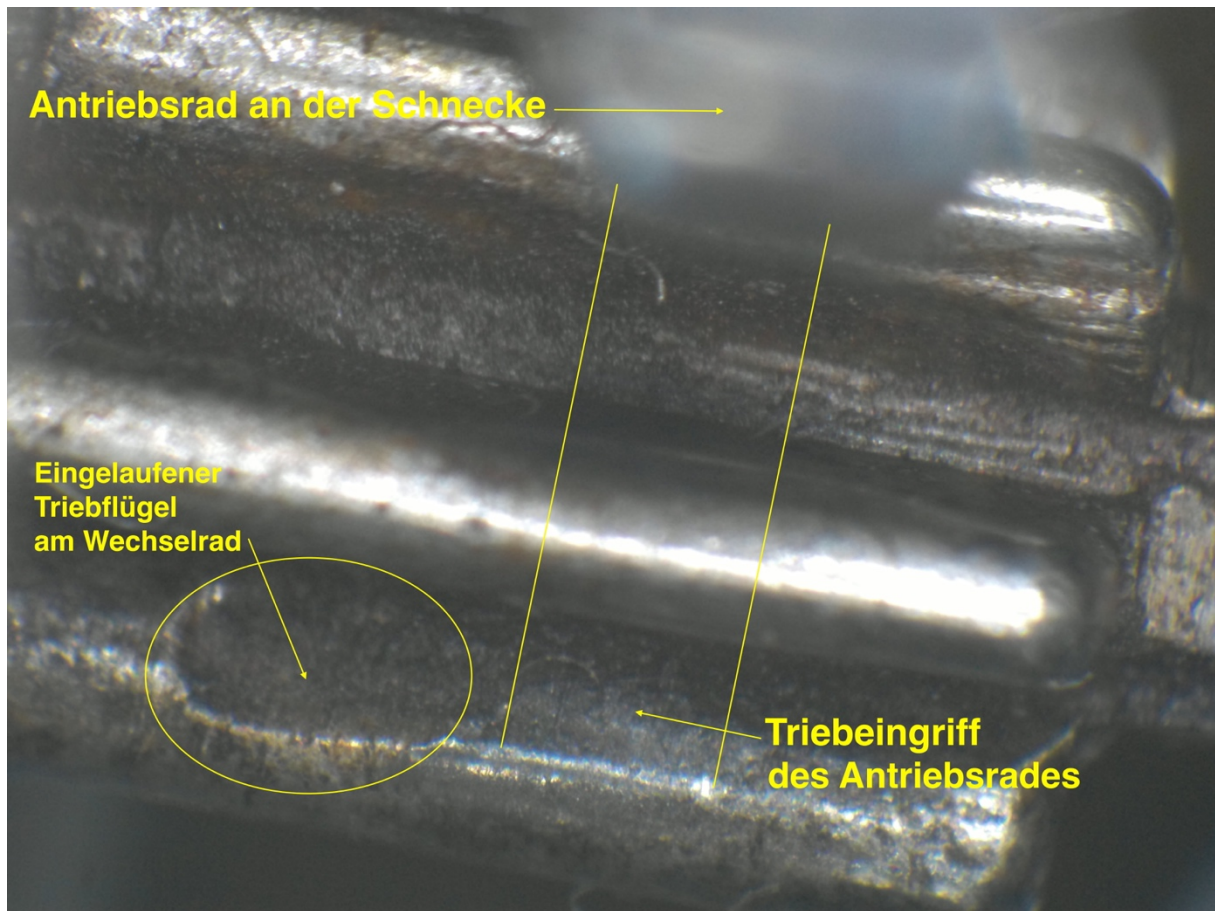
Mikroskopie

In the microscopic image, the incompatibility between the fusee wheel and the reversing wheel drive is clearly visible. The wear marks on the drive wings of the reversing wheel should align with the position of the gear engagement from the drive wheel of the fusee, but in reality, the wheel drive engagement is offset.

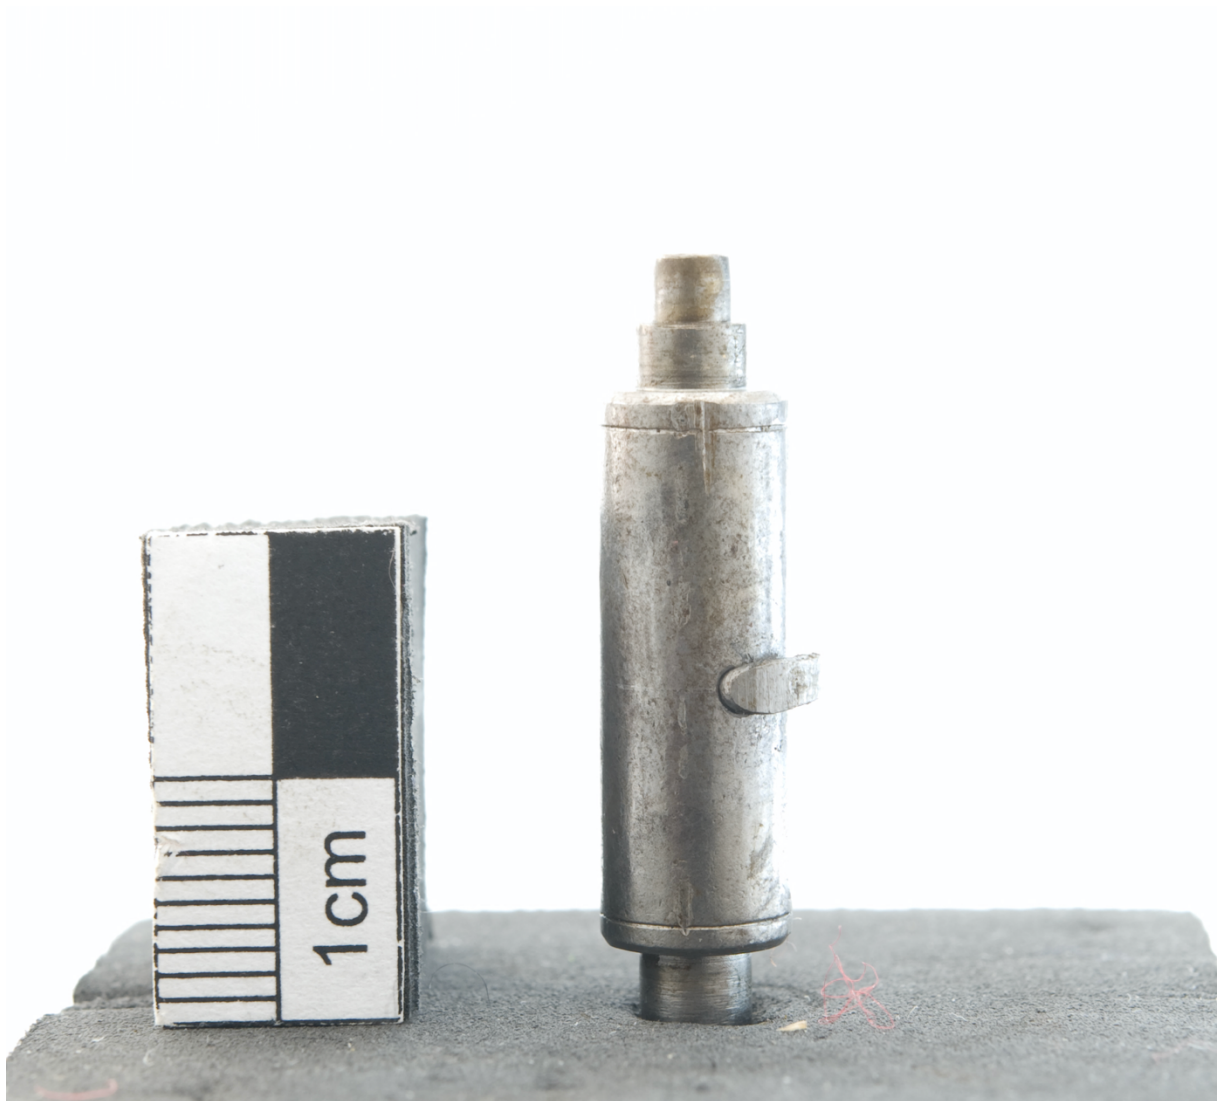
It can be assumed that in order to fit the newly manufactured mainspring arbor (spring core), the mainspring barrel had to be modified at its cover openings. For this, the mainspring barrel was clamped into a four-jaw chuck (green), and after re-clamping, it was done a second time (yellow). The turning marks on the brass bearing are clearly visible on the outer edge and in the bore.

The mainspring barrel shaft is of more recent manufacture and does not match the design of a mainspring barrel shaft from the second half of the 16th century. The stereoscopic examination proves that the mainspring barrel shaft is a new creation.

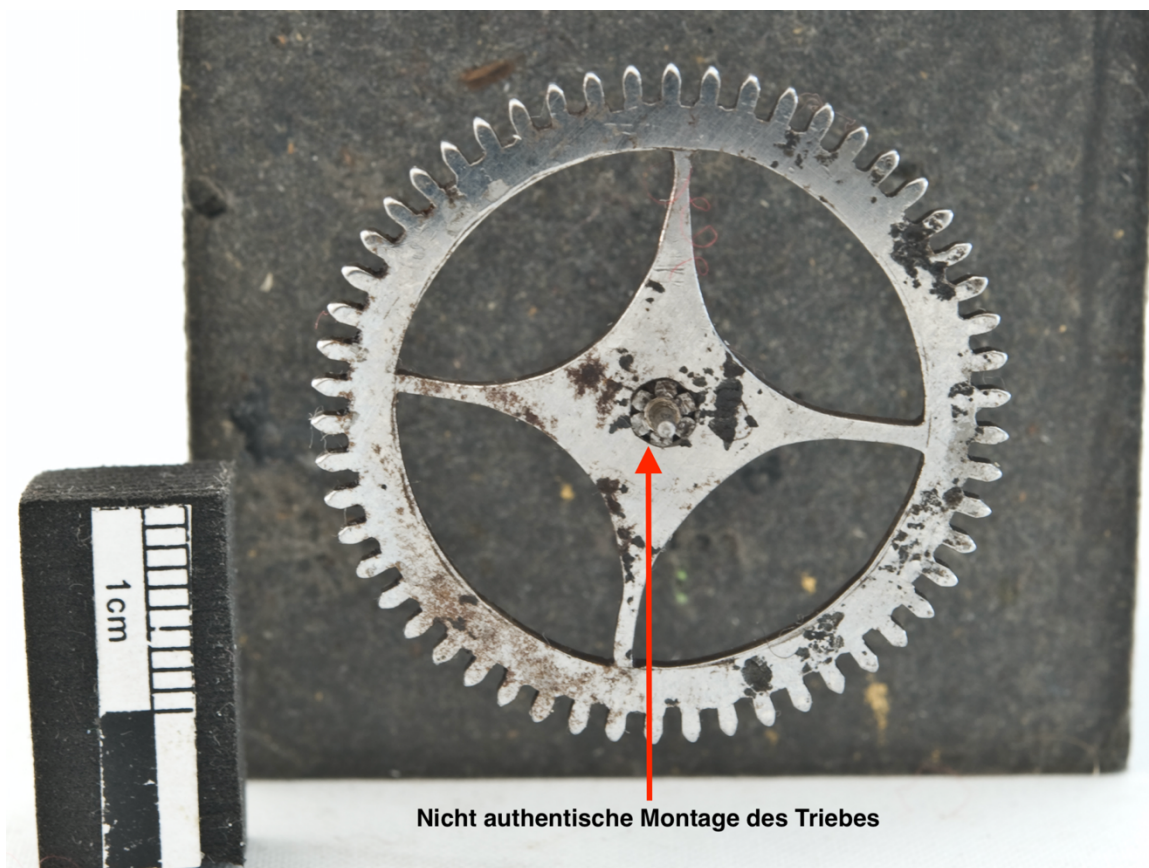
The wheel was cut from old, heavily corroded iron, some of which shows signs of pitting, and was rudimentarily machined to simulate an old, worn condition. As described with the fusee wheel, the same procedure was followed here. Notably, there are also no uniform corrosion patterns on this gear. However, traces of use on the intermediate wheel mechanism indicate that it was previously used in a different movement, i.e., in another clock.

The shaft, too short to fit into the 29.5mm gap between the plates, was fitted with a brass bearing. The shaft, made of iron, comes from a stock of old parts, has been reworked, and modified for use in this clock. The gear does not engage correctly with the next wheel, the crown wheel. Therefore, no corresponding wear patterns can be detected.

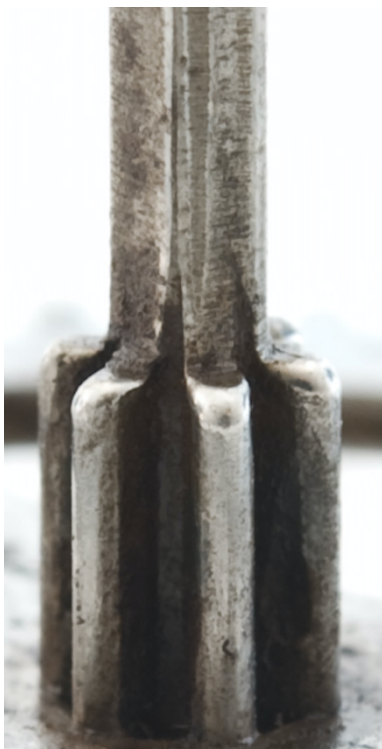
The gear shaft was subsequently reshaped from its original round form to a square shape. Evidence of this modification can be found in the filed traces left on the gear teeth.

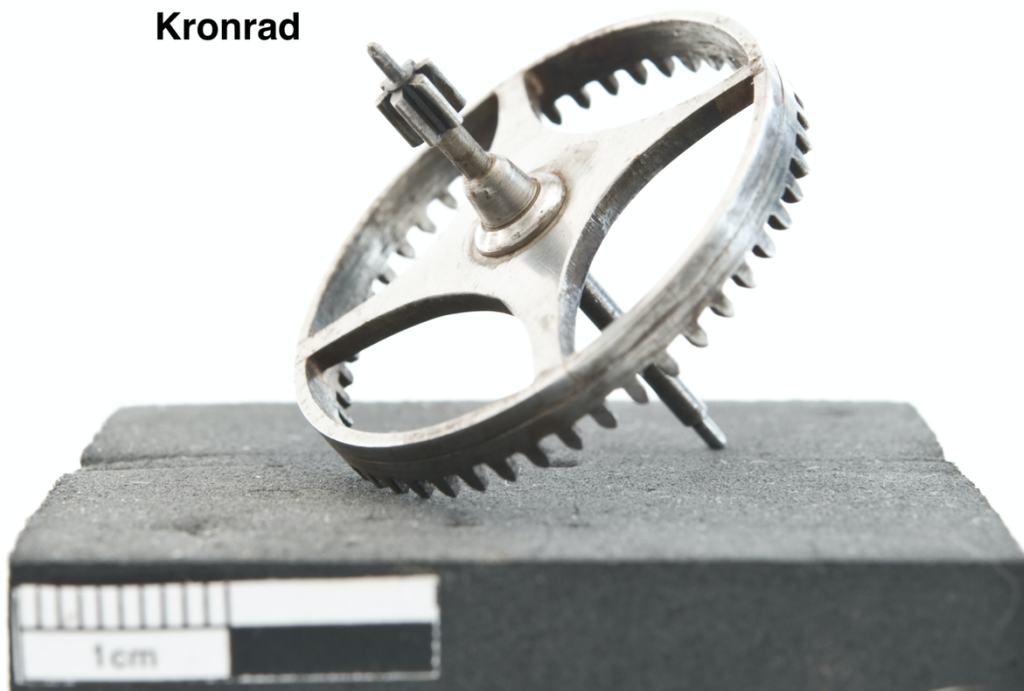
Kronrad

The crown wheel corresponding to the change wheel is also a new construction made from old iron. No coherent wear traces from the change wheel are observable on the crown wheel. However, authentic wear traces from use with a clockwork not belonging to this mechanism are present on the crown wheel drive.

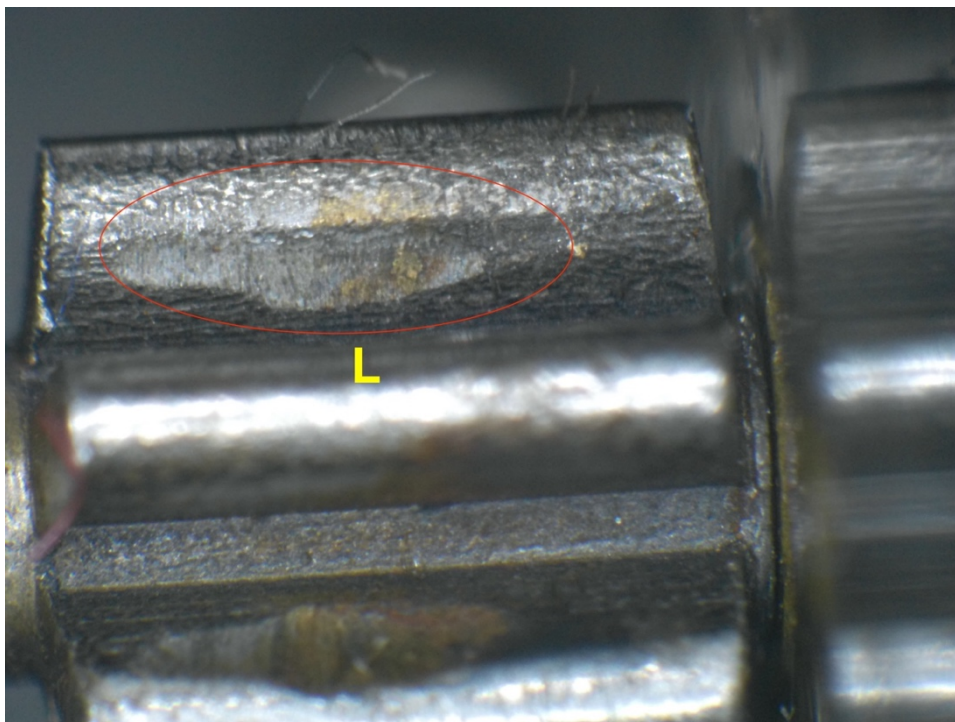
Mikroskopie 01

This drive shaft was previously operated in the opposite direction (**L**). However, for use in this clock, the reverse direction was required, so the previously unused drive flank (**R**) had to be worn in. To achieve this, material was milled off the unused flank using a milling cutter, in an attempt to simulate a worn drive flank.

The brass-colored deposits are corrosion, which was not color-accurately represented due to light reflection under the microscope.

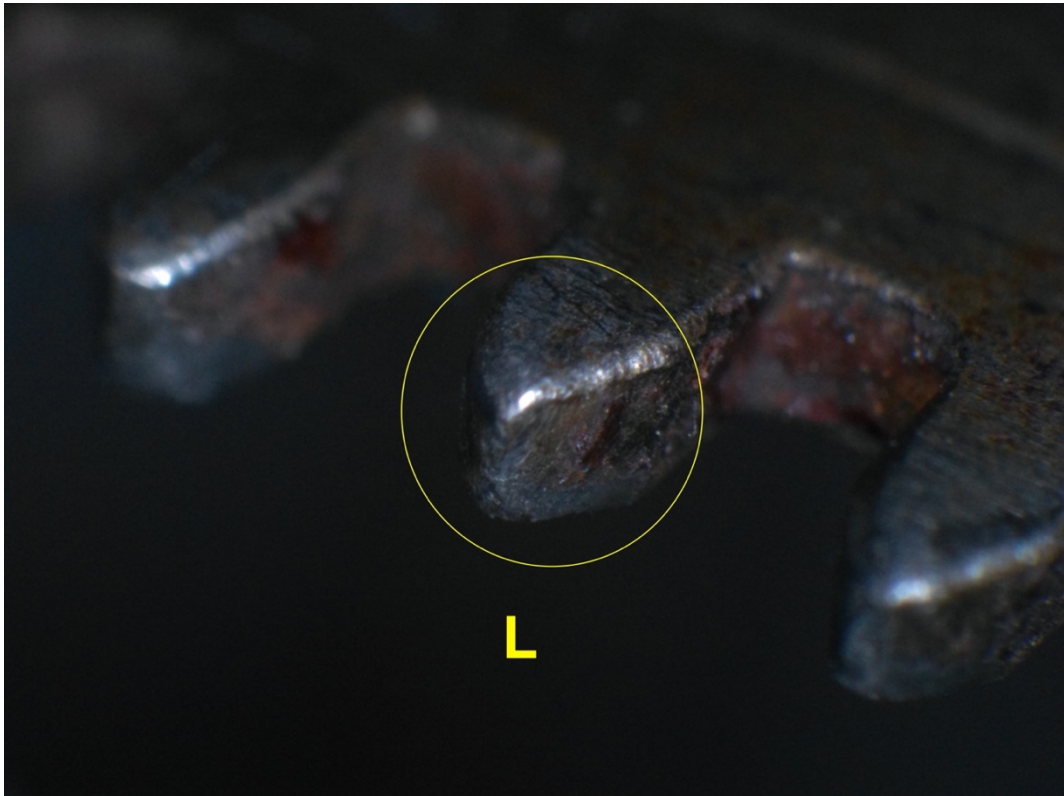
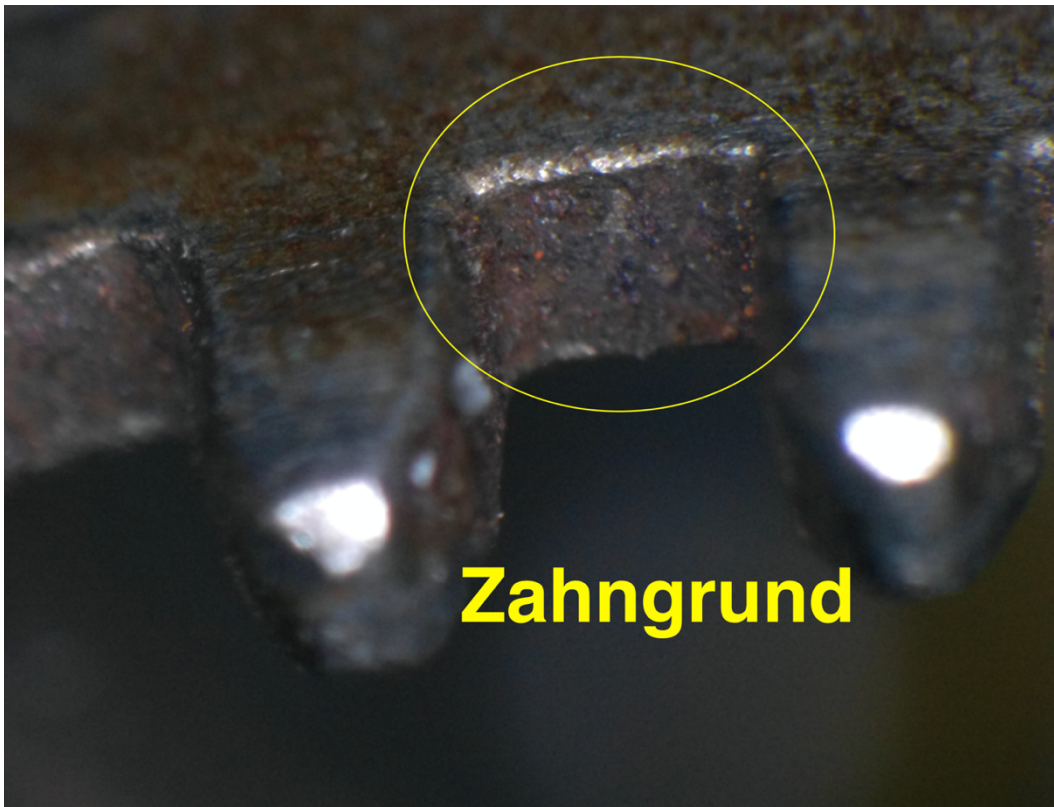
The tooth root of the crown wheel shows the typical pattern of machine-assisted milling. Here, one would expect to see filing marks, as the manufacturer attempts to suggest at other places in the movement.

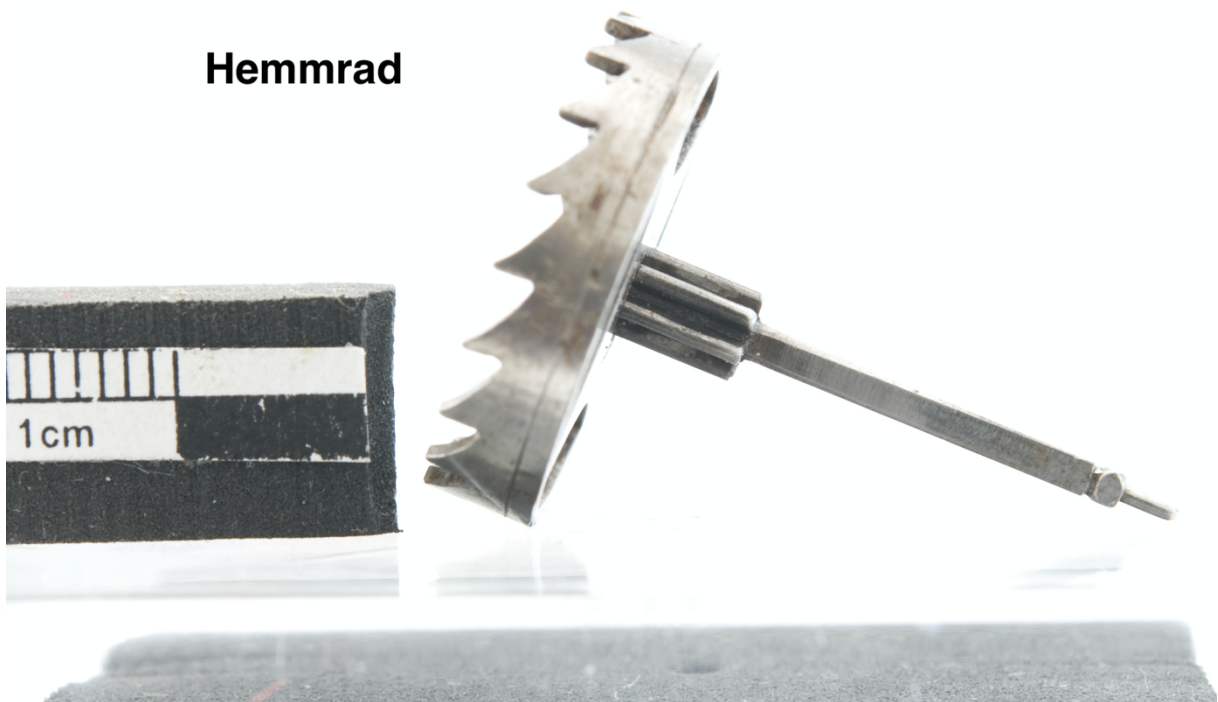
Hemmrad

The escapement wheel shows heterogeneous wear marks on both sides of its tooth flanks, but these do not correlate with the engagement with the crown wheel. Based on this observation, the escapement wheel, which is also newly made, must be considered inauthentic.

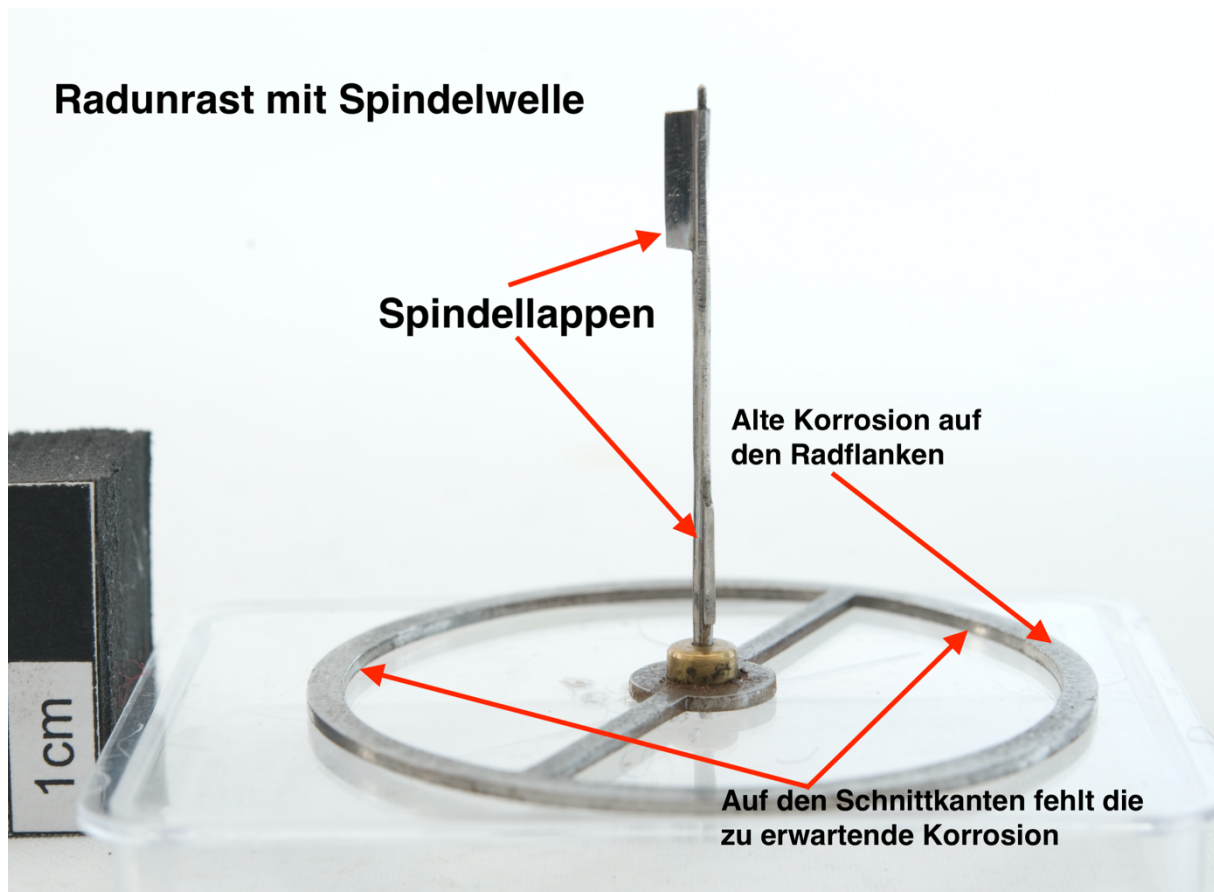
The verge with detent wheel is a complete new creation made using old iron.

The lobes of the shaft show no signs of wear on their engagement or running surfaces.

The detent wheel is coated with old corrosion on its outer flanks, which should also be present in the tooth edges of the wheel and the arms, but it abruptly stops at this point.

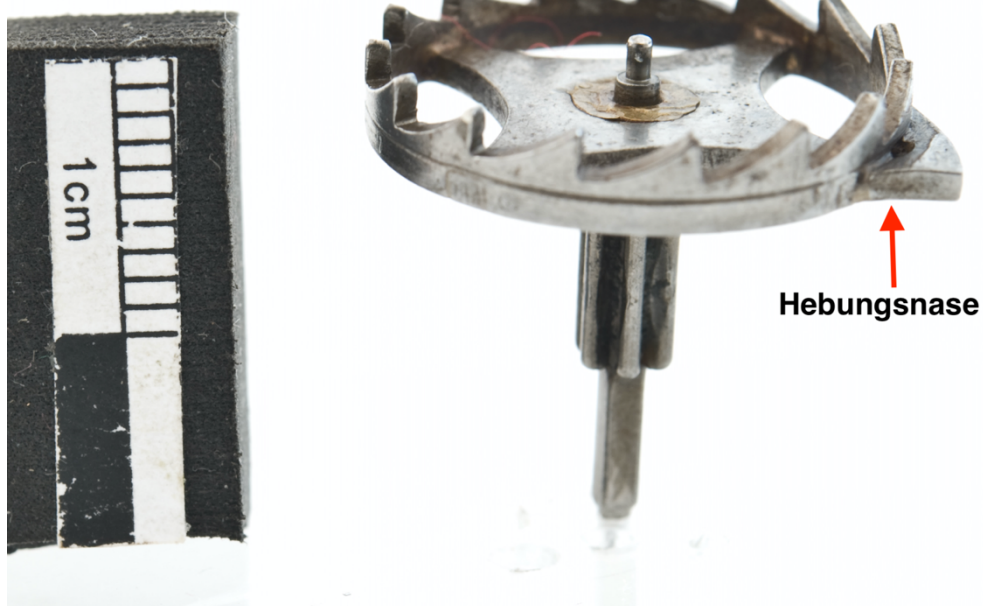
Hemmrad Schlag- und Weckwerk

A lug soldered to the escape wheel (see photo) is intended to keep the escape wheel free until the complete winding down of the alarm spring when the trigger lever is lifted to a certain height. The wear marks on the driving wheels show artificially introduced traces and, additionally, on the non-engaging side, old identical wear marks, which, however, do not correspond to any engagement in this movement. This evidence proves that the shaft is an old, reworked shaft from another clock with an inverted running direction.

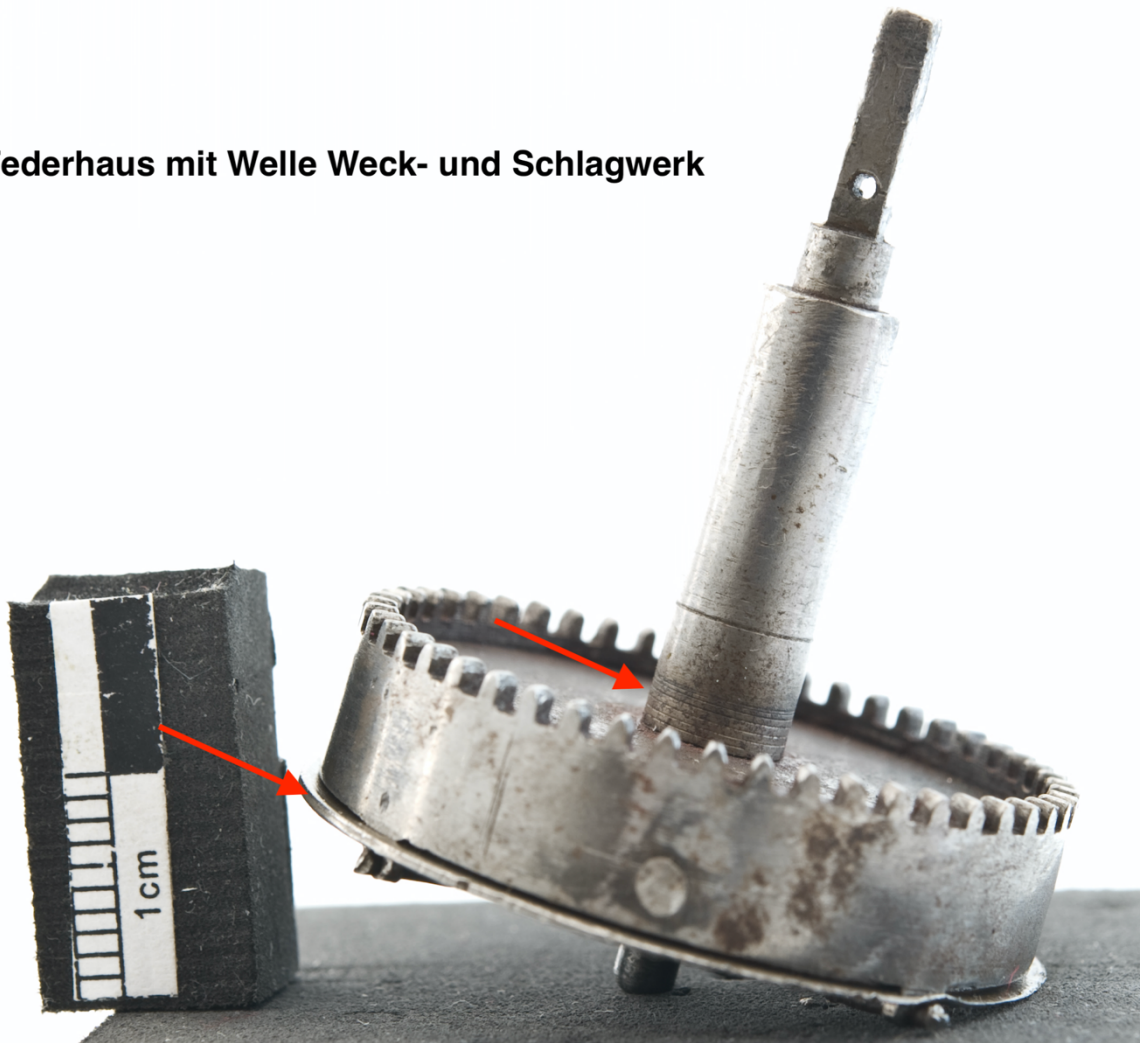
Federhaus mit Welle Weck- und Schlagwerk

The use of modern machine technology cannot be concealed in this component either. For example, ratchet marks, created by the cutting tool of a high-speed lathe, are visible on the bottom surface. As with the previously described anomalies, we also find the absence of coherent corrosion transitions in the direct adaptation of components here.

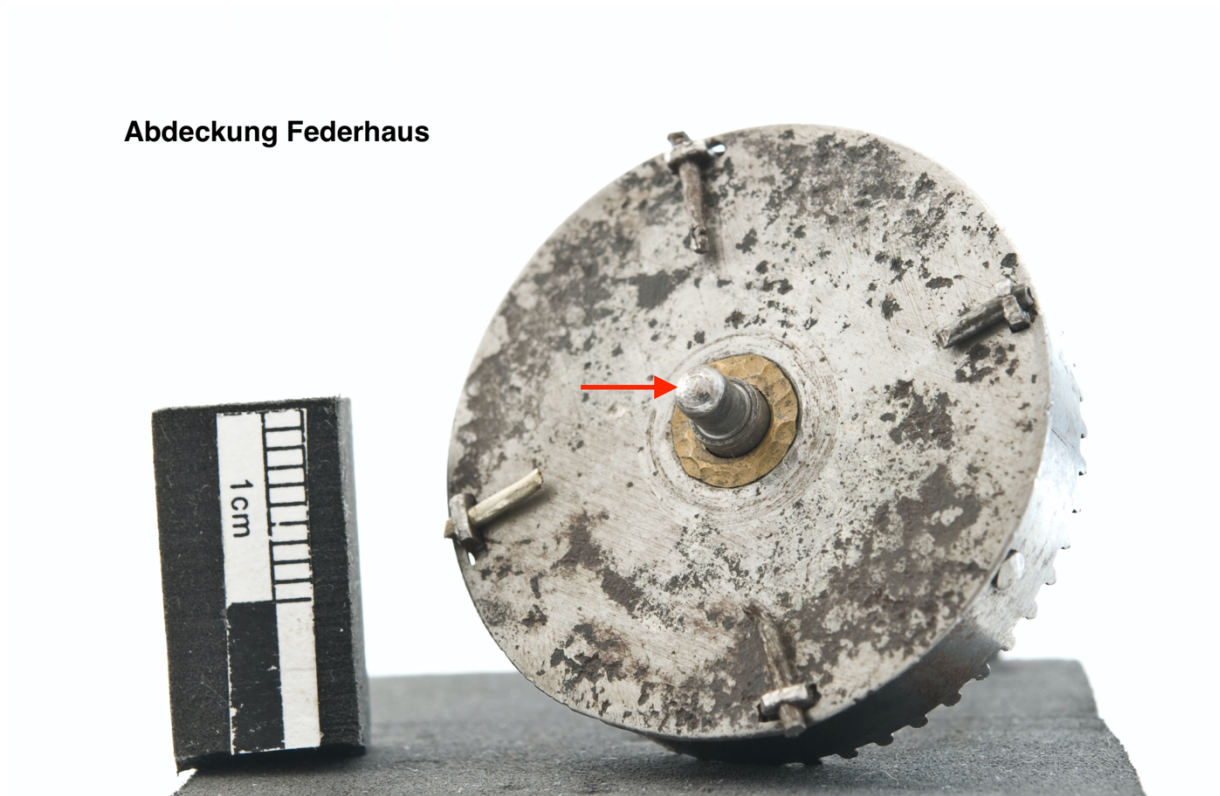
Abdeckung Federhaus

**Fehlende Korrosionsspuren
den Stirnflächen des Federhauses**

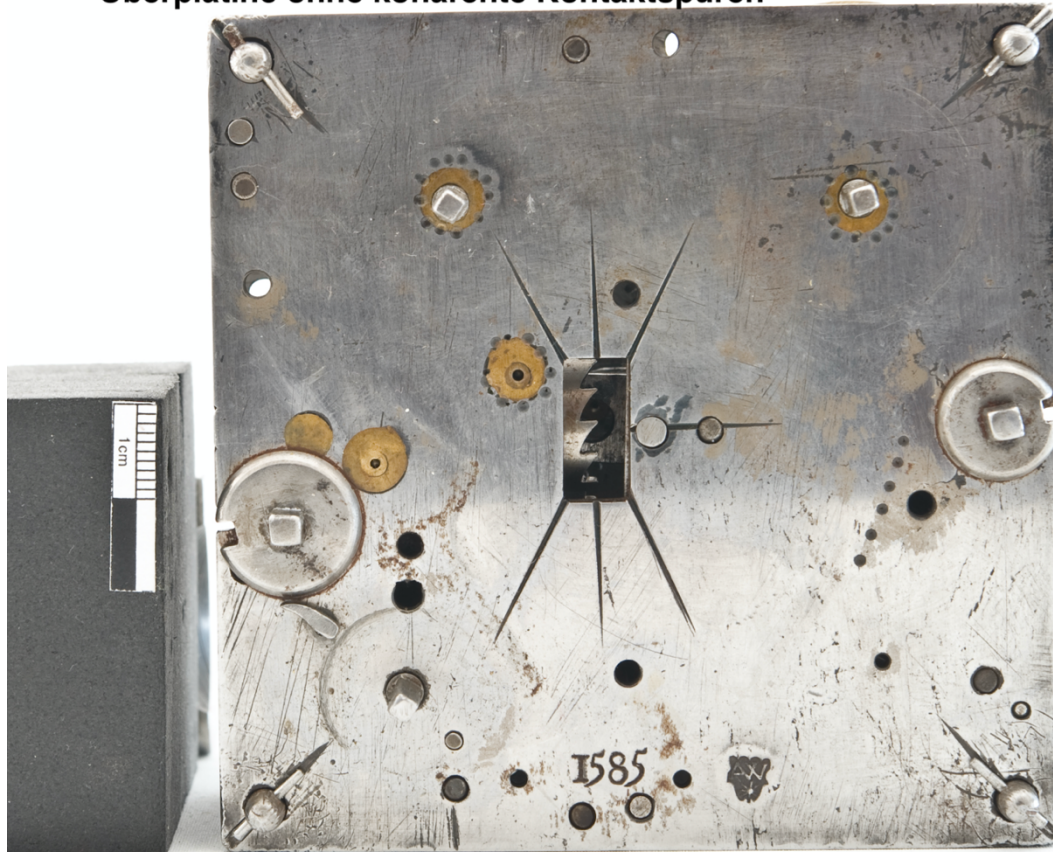
B + C: Locking spring for the locking cone and the locking wheel (**F**) of the alarm and strike mechanism's barrel. These locking springs, like the locking spring (**C**) of the barrel for the movement, are made of old iron. Both springs show heavy pitting corrosion on the back, which is in direct contrast to the corrosion-free upper surfaces of the springs. **It is also impossible** for components that lie flat with their corroded side on the upper plate—like here— to leave no marks on it. This provides another strong indication that the upper plate is not original. The absence of authentic, coherent contact marks on the upper plate is evident at all points where components are in contact with the plate.

Oberplatte ohne kohärente Kontaktspuren

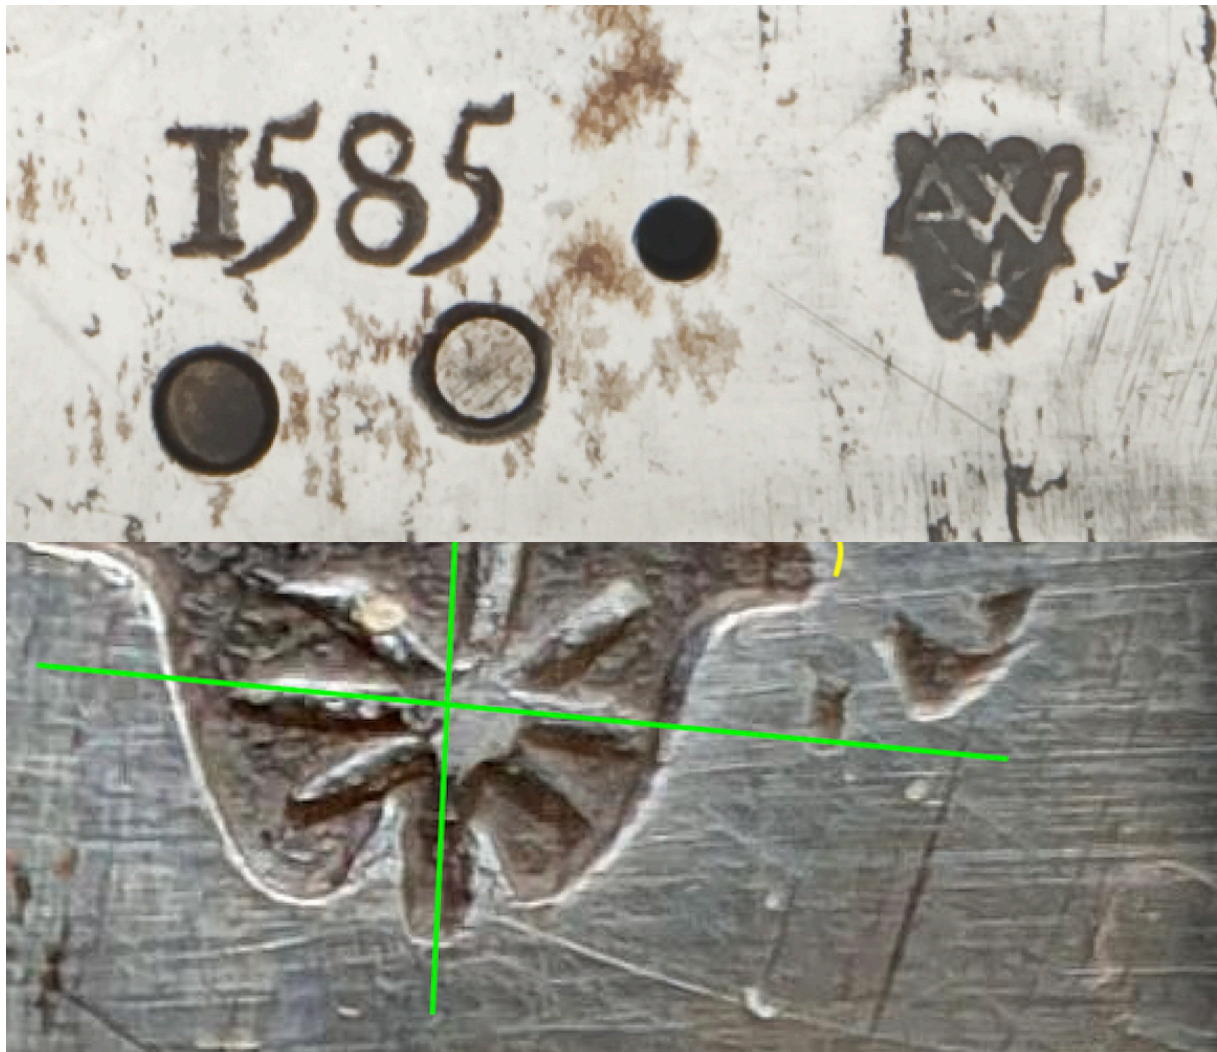
The punch with the ligature AW and star does not exhibit the typical characteristics of a mark struck into iron. There are usually slight to strong indentations and deformations with such punches, which are absent in this case. On the contrary, the stereoscopic examination reveals features that suggest it may have been produced using modern engraving techniques or "sink erosion" under high voltage, which cannot be ruled out.

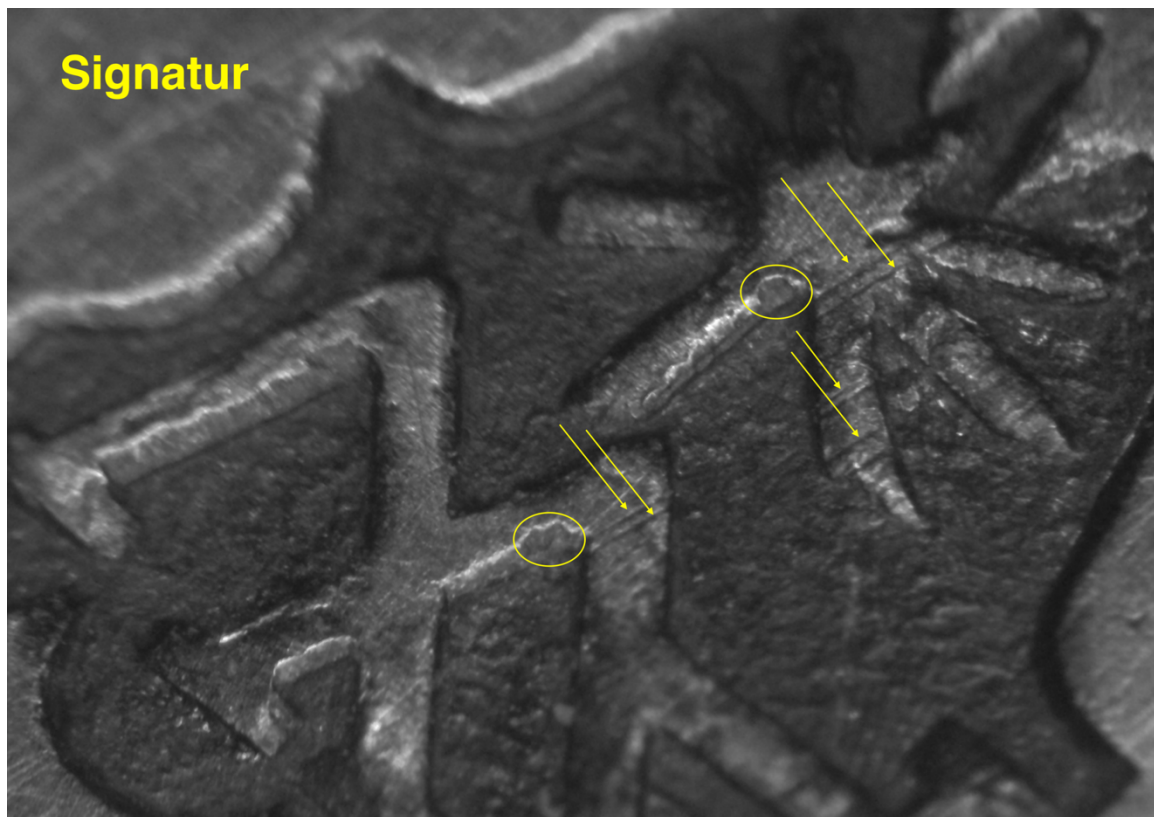
The corrosion covering the base of the signature forms a closed pattern, which would not be expected. The etched edges of the signature in the indentation are free of corrosion, as seen in the red arrows and the red edge. This is not possible, as homogeneous corrosion would not remain on the edges. Moreover, this corrosion extends over the edges of the ligature AW and the star, covering them as well as the surface. The yellow markings point to processing marks that were applied in the form of engraving strokes before the corrosion developed.

Conclusion: The corrosion was produced after the entire forged punch was stamped, by applying an etching medium. The edges of the coat of arms, the ligature, and the star were re-engraved, making a definitive identification of the punch's origin impossible. On one hand, the punch could have been made with a laser or micro-engraving computer, while on the other, a hand engraving is also a possibility. The seamless post-applied corrosion has made the work traces harder to read. However, the uniformity of the punches in the previously discovered watches suggests that they were likely produced with a computer-controlled laser or diamond cutter engraving, which was later touched up with a burin.

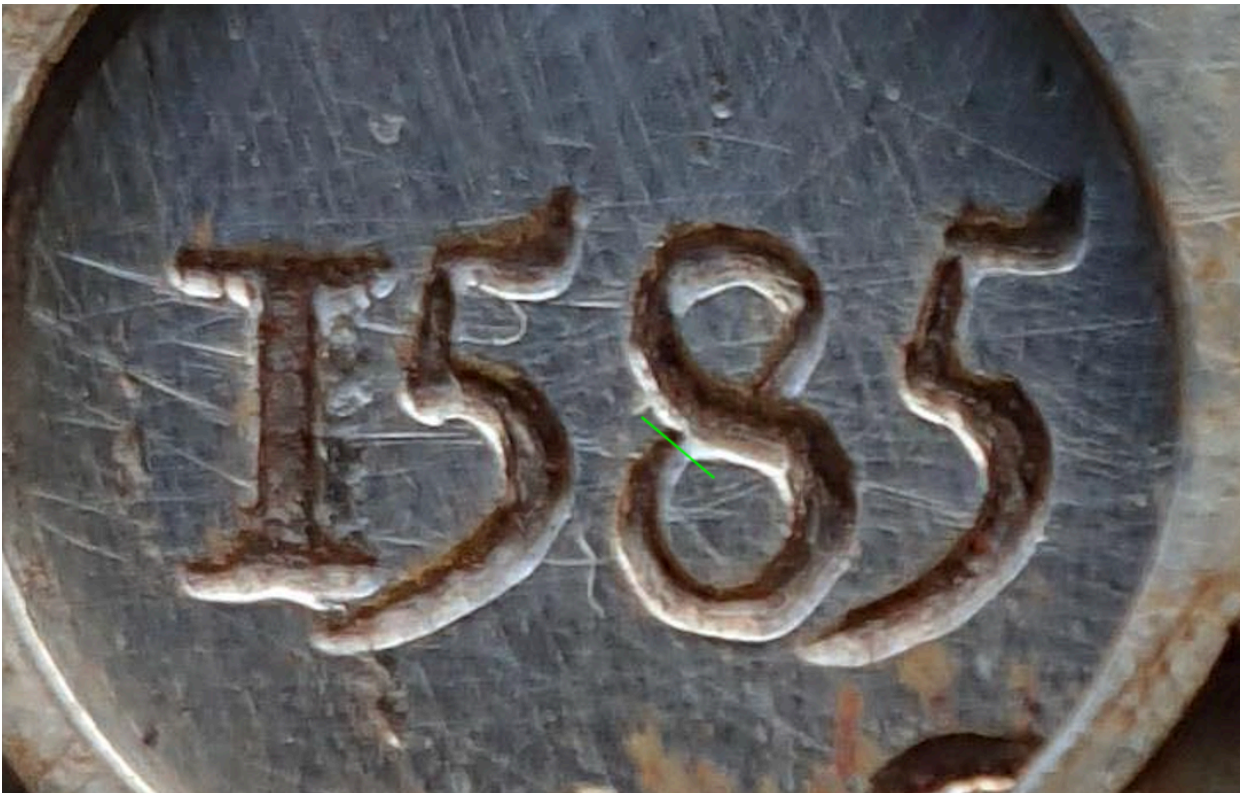
The manually engraved year "1585" on the plate has also been treated with an etching medium to simulate old corrosion.
