Real or Fake?

Examination and Analysis of a Clock Presenting Itself as a "Horizontal Table Clock from the 16th Century" with Astronomical Display

from Jürgen Ehrt

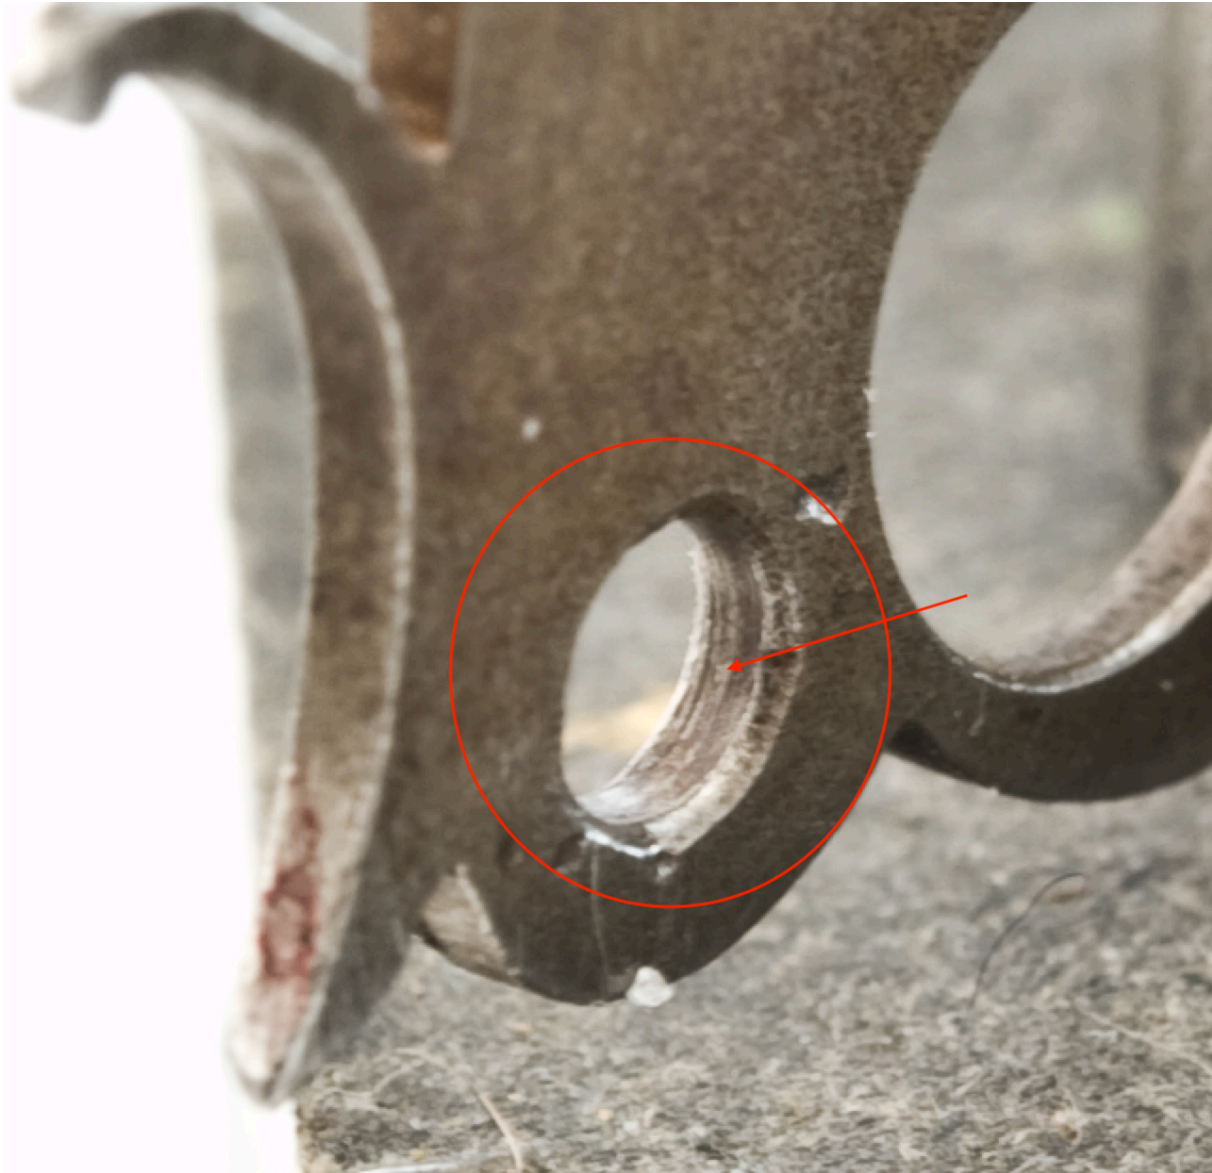
The macro image clearly shows the cutting marks of a spiral drill. The attempt to rework these telling marks has only been inadequately done.

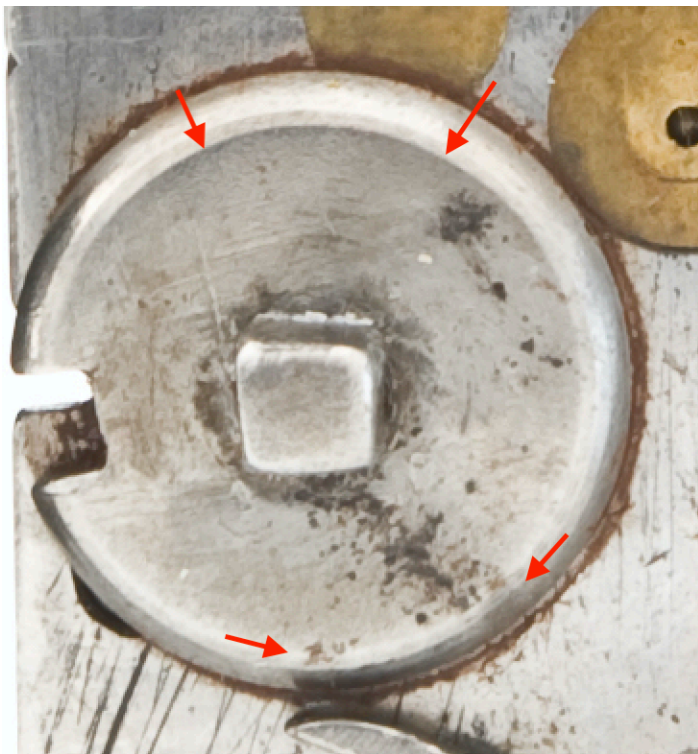
H The locking gear that secures the plate to the movement cradle in the case does not align precisely with the cut-out on the plate and has been re-riveted on the back. This riveting is also found on the second locking gear. Both gears are made from old iron and show signs of corrosion on their flat surfaces. However, the edges have been machined, and they should also show corrosion traces, which would not stop abruptly at the rounded edge.

The square for adjusting the closure shows, notably, that there are no corrosion transitions at the junctions between the closure disc and the square. The corrosion on the surface of the closure stops abruptly at the square. This square was separately worked into the closure and is used below the movement plate for riveting. The macro image clearly shows machining shavings that were forgotten to be removed.

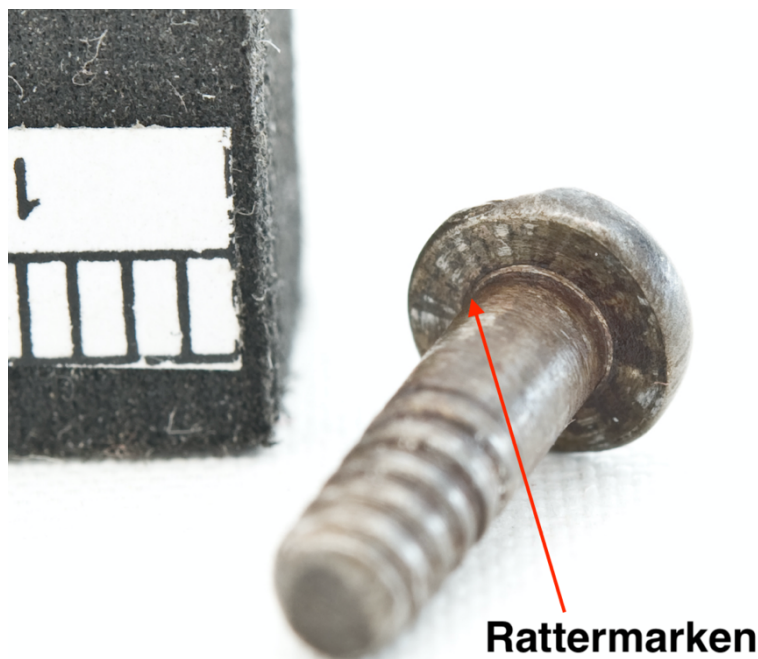
However, we miss the inaccuracies typically found in hand-made threads from that era. Variations in the accuracy of measurements meant that the screws could not always be interchanged. Watchmakers had to remember the placement of removed screws during repairs.

In the watch under investigation, the screws are uniform and interchangeable. They all have a thread size of approximately 2.8 mm and 2.25 mm and show no deviations in the pitch. The blanks for these screws were made on a modern lathe and show chatter marks under some of the screw heads. The characteristic brown coloring of the screws may result from a bluing process after manufacturing, where the screw is heated and then quenched in oil. However, there are other methods of bluing metal. This is not relevant for my investigation, as the other detected features in the watch already allow for a clear judgment at this point.

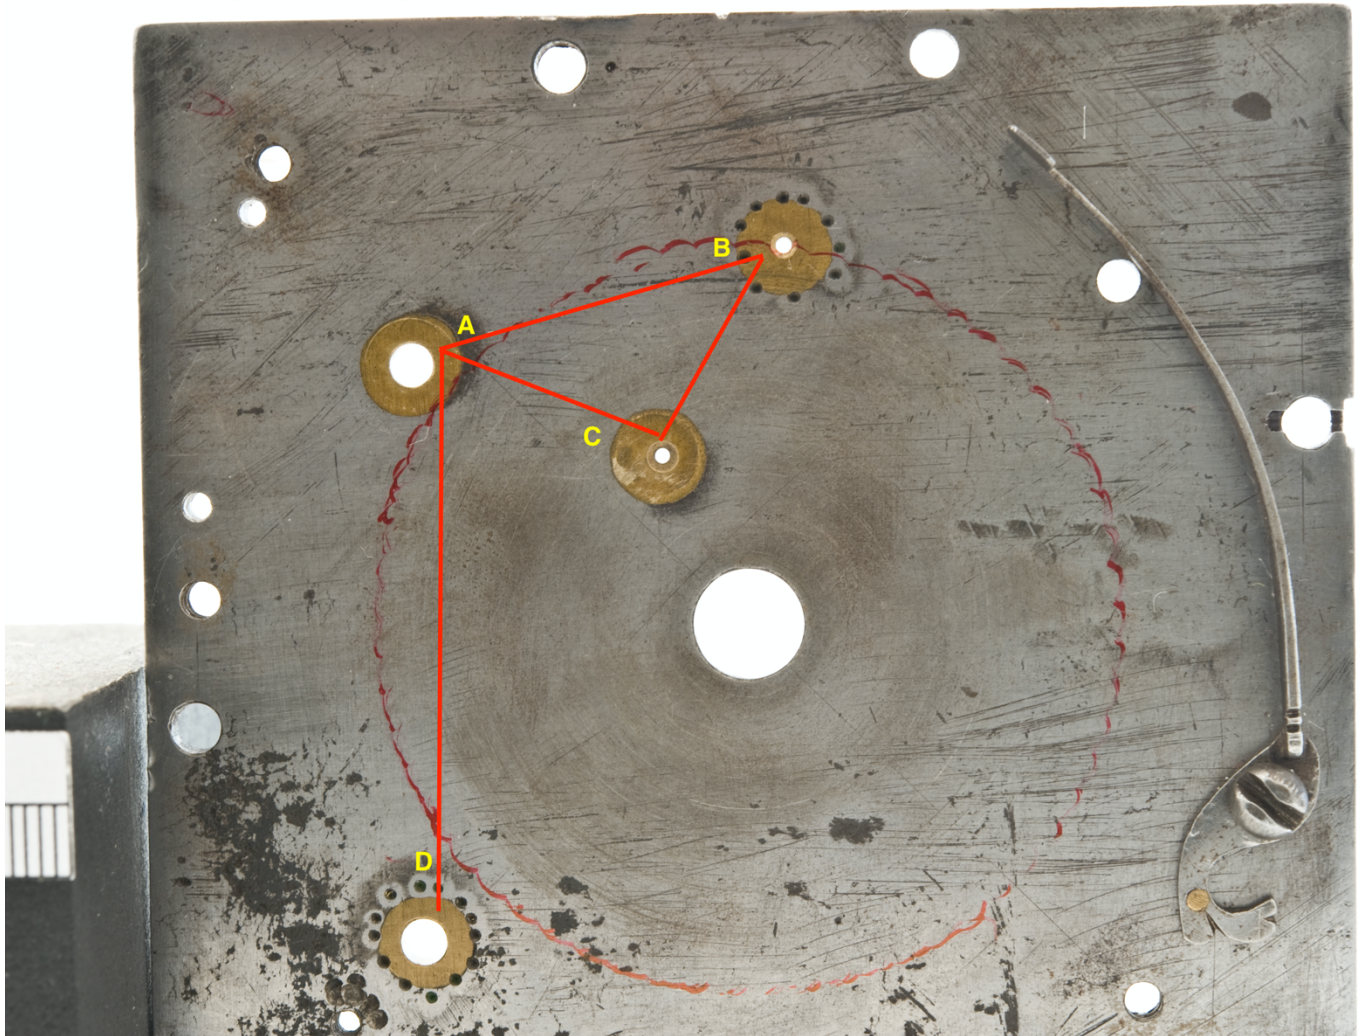
A classification of the entire movement frame into the second half of the 16th century is already ruled out due to the pillar attachment. The pillars of 16th-century table clocks were not soldered. Their common feature is found in a two-sided screw or rivet connection. Both construction methods were used in one timepiece, for example, the screws securing the pillars on the upper plate, while the pillars on the lower plate were riveted, and vice versa.

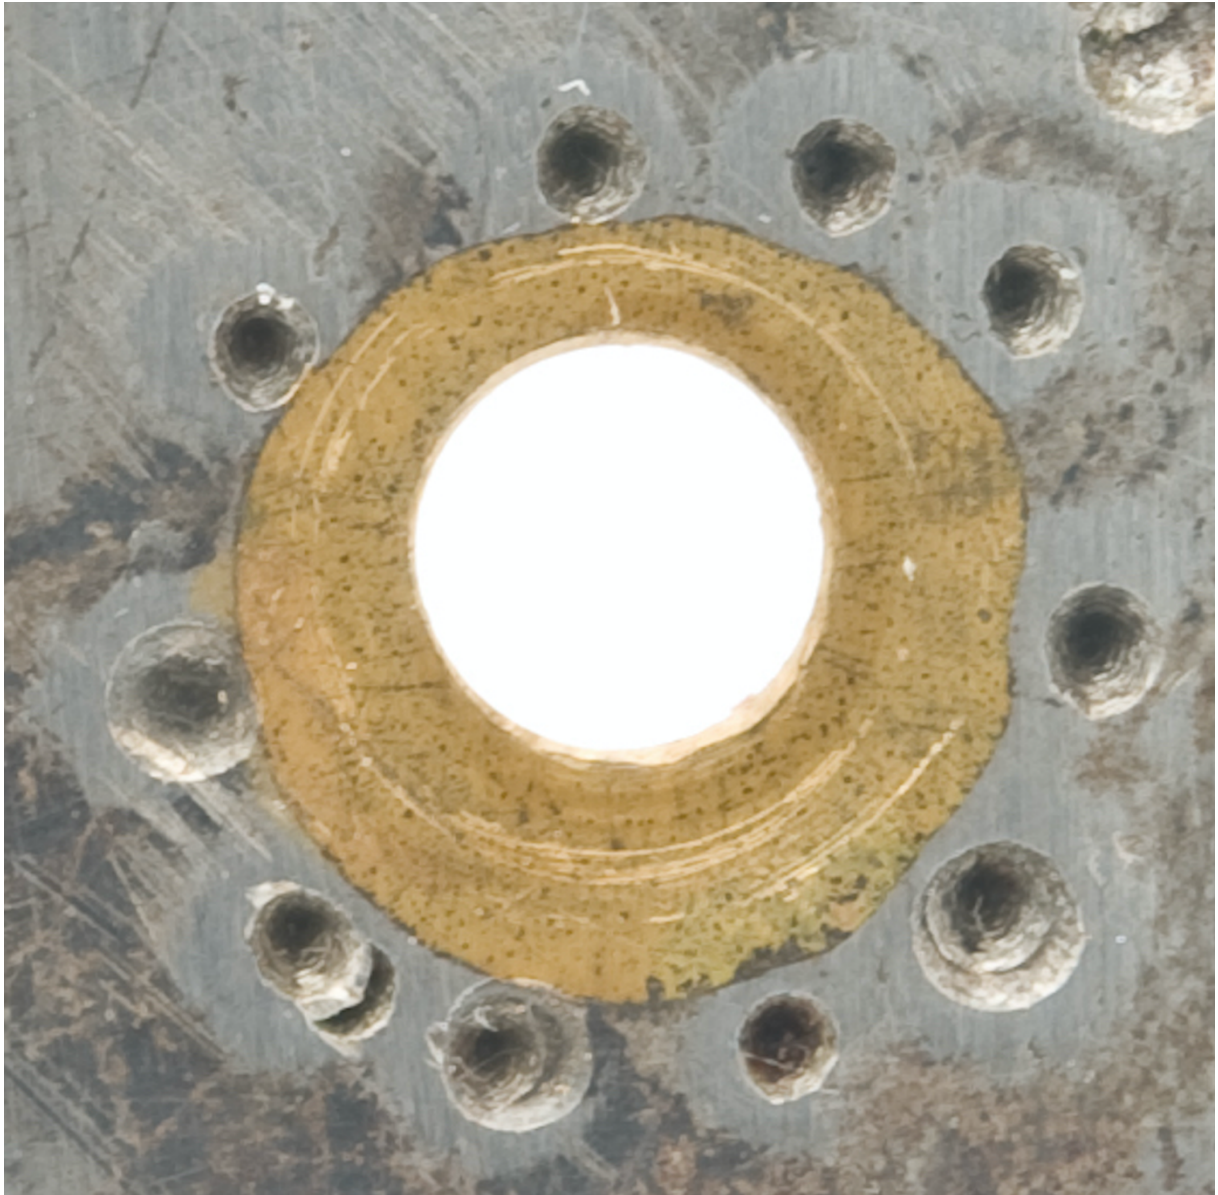
The widely drilled plate was filled with old brass. The punches marked with **B** and **D** around the Ms-bearings were not stamped with a punch as expected. In the stereoscopic examination, it became visible that the recesses were milled with a machine-operated cone cutter. Therefore, these marks only have a decorative character. This is also supported by the arbitrary placement without any functional purpose upon closer inspection.

Recesses milled with a conical cutter

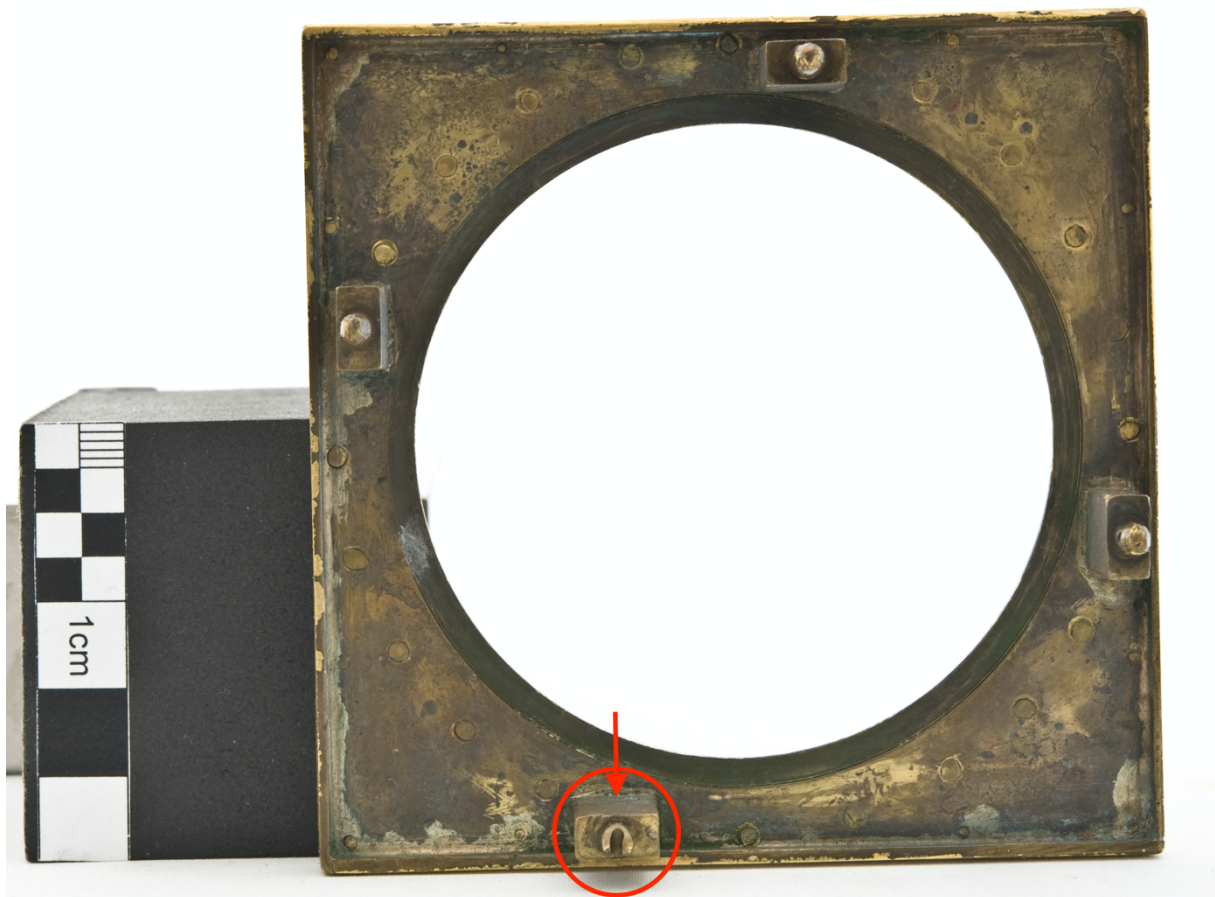
Of the four feet that anchor the dial of the clock case into the plate, one is destroyed and broken off in its upper third. As a replacement, a modern metric thread was drilled and cut into the foot. For the new anchoring, a hole was drilled horizontally through the end face of the plate via the vertical bore. This hole was drilled beyond the vertical bore as a blind hole.

During a subsequent grinding process of the plate surface, this blind hole was ground back.

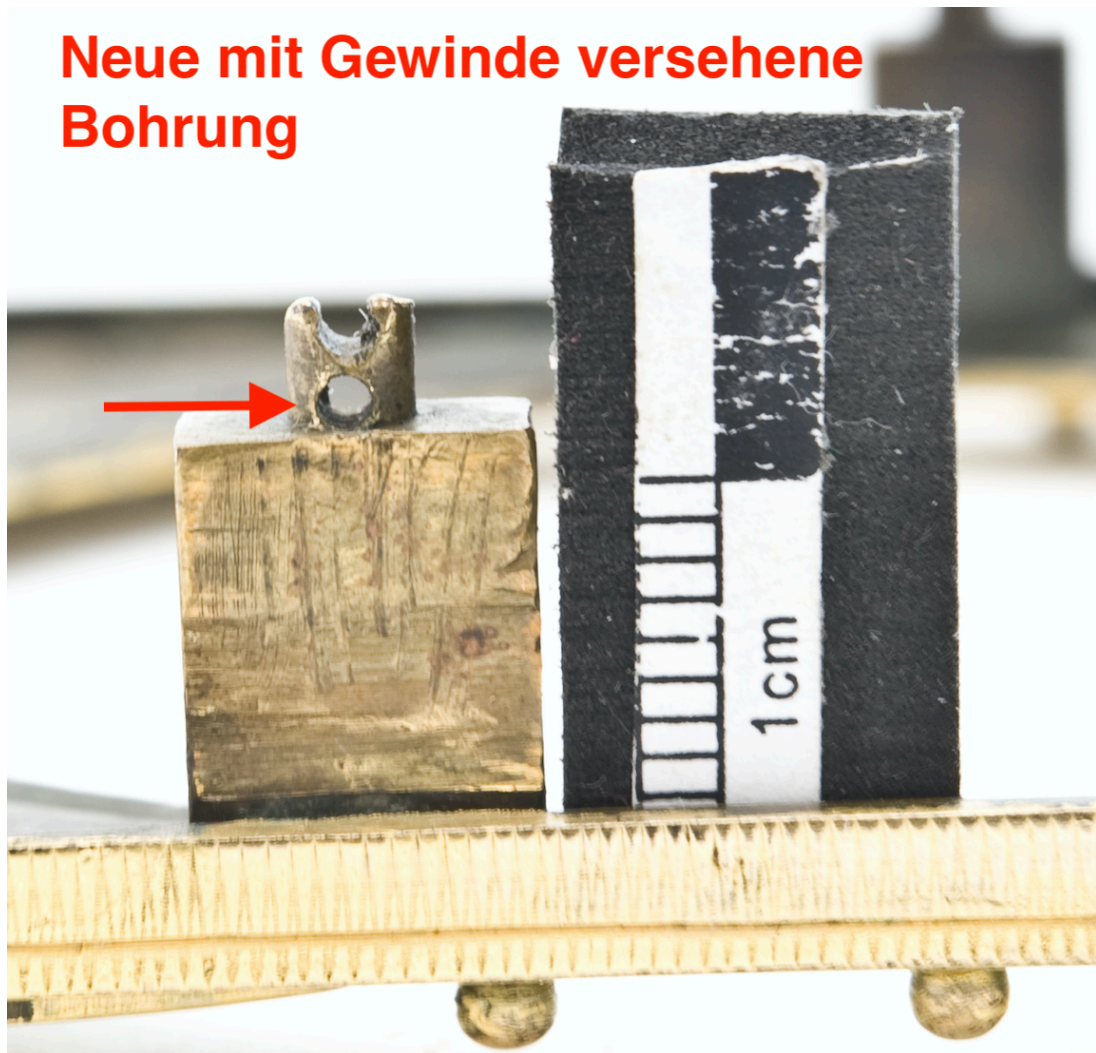
Neue mit Gewinde versehene Bohrung

As revealed by the stereoscopy, the pillar with the replacement drilling was already produced with the breakage. The microscopic examination confirmed the initial suspicion that not only the dial but also the soldered dial attachments are cast replicas of dial feet from another clock.

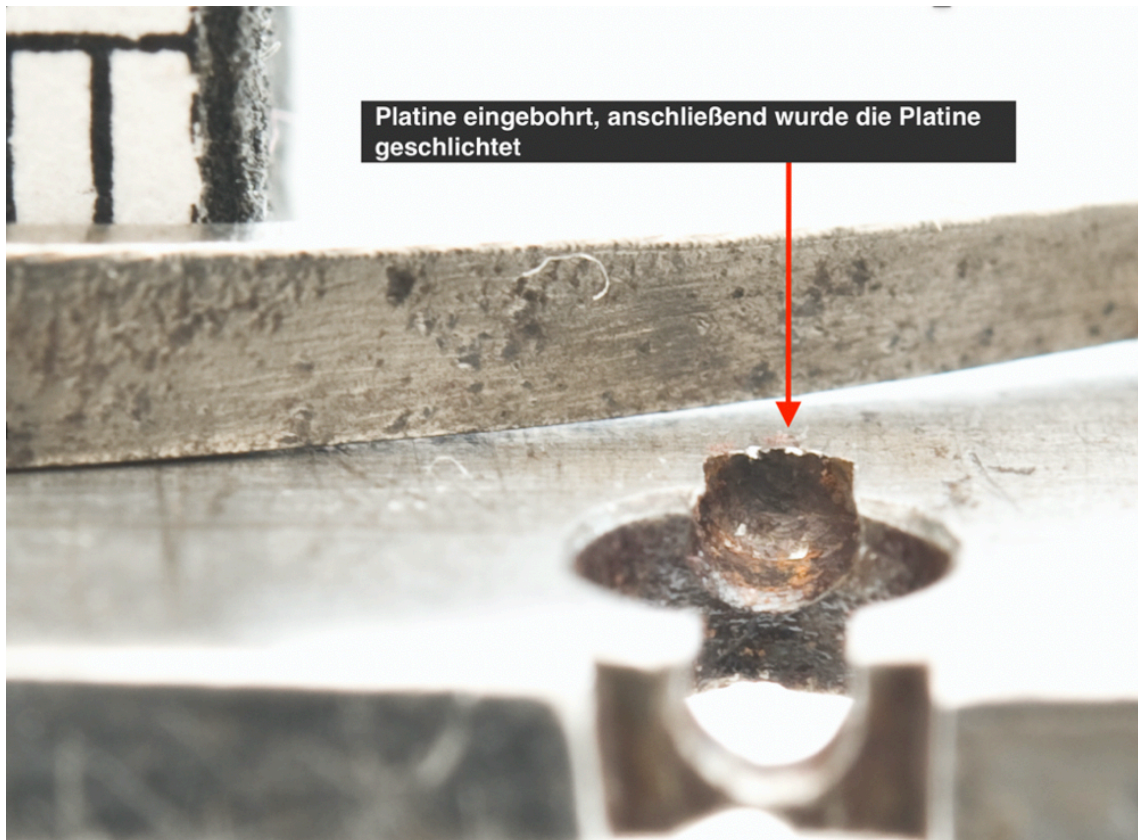
During the drilling, the craftsman made a significant error, causing the material of the plate to break. As a result, he was forced to reduce the thickness of the plate and smooth the surface.

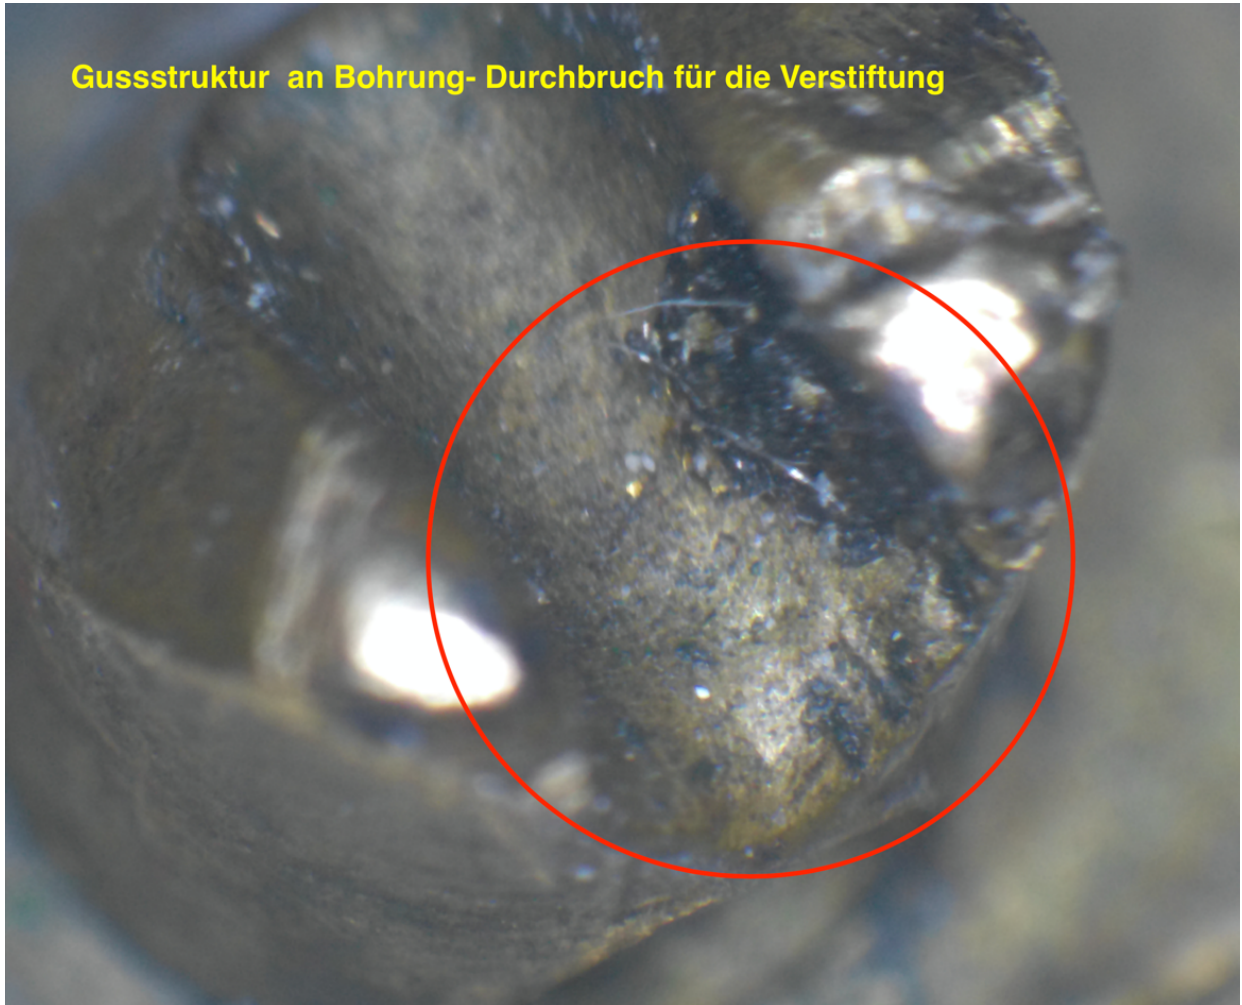
Gussstruktur an Bohrung- Durchbruch für die Verstiftung

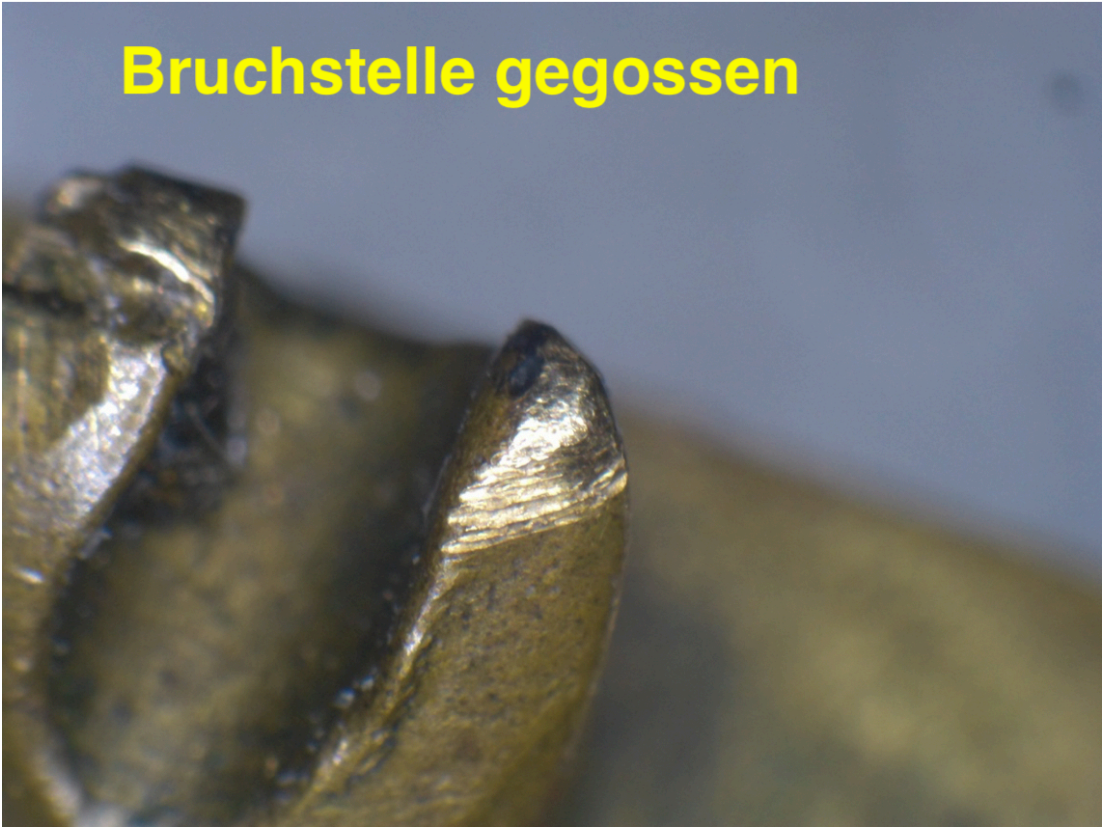
Bruchstelle gegossen

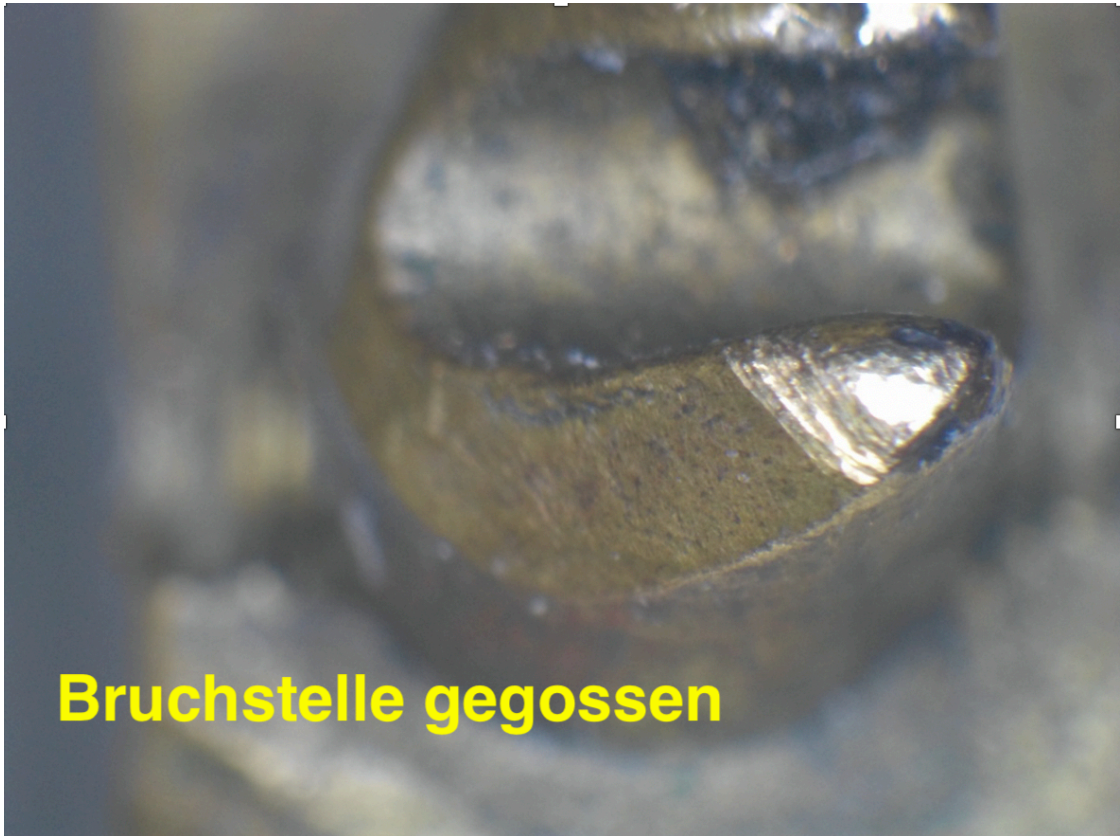
Bruchstelle gegossen

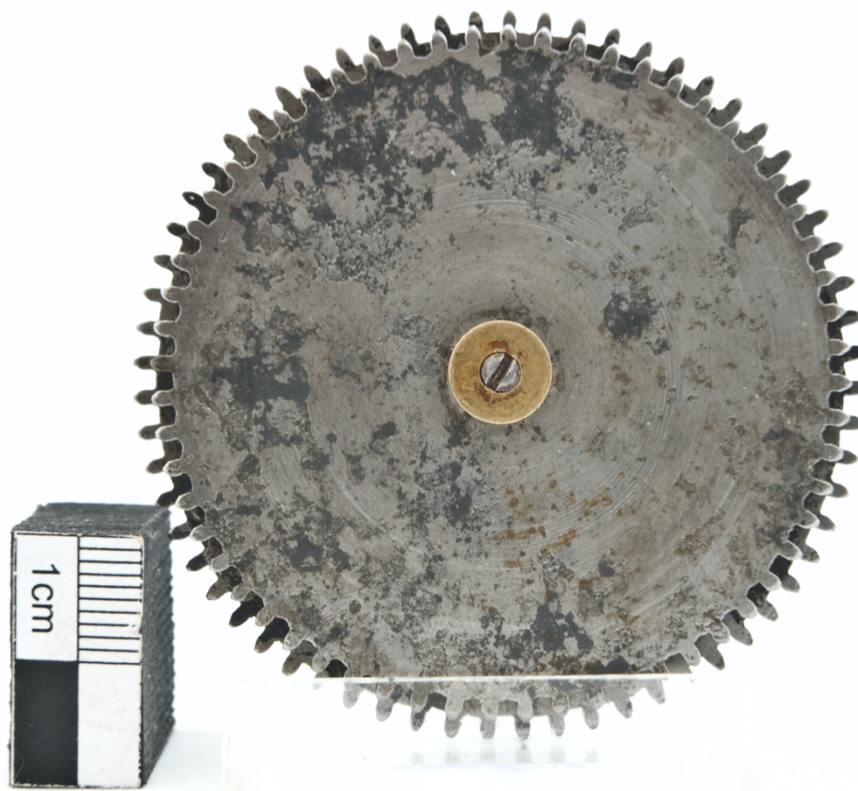
The gears and the 24-tooth release star adapted to the hour wheel for the hourly strike were made of old iron, heavily corroded with pitting corrosion. Notably, we also find no corrosion in the cut tooth flanks or the interior areas of the tooth cycloids on these gears. Stereoscopic examination revealed machine processing traces on these creations. The manufacturer tried, with rudimentary touch-ups, coarsely applied filing marks, and varying depths of tooth cutting, to obscure the machine-made traces. These are unmistakable evidence of the modern manufacturing of these wheels. See below microscopy 01 and 02 when examining the engagement of the tooth cycloids on the hour wheel and the change wheel.

Both gears are merely screwed together with a brass sleeve pressed into place. This allows for the possibility of shifting under friction between the two gears. This is intended to provide friction for adjusting the time on the dial. However, in practical testing, this construction proved to be useless. After frequent adjustments, the pressure of the screw connection loosened, and the pressed gear discs lost their mechanical adhesion. Furthermore, it was observed that the engagement between the hour wheel and the change and transport wheel for the moon disk exhibited uneven surfaces, which also precluded a coherent operation between these wheels.

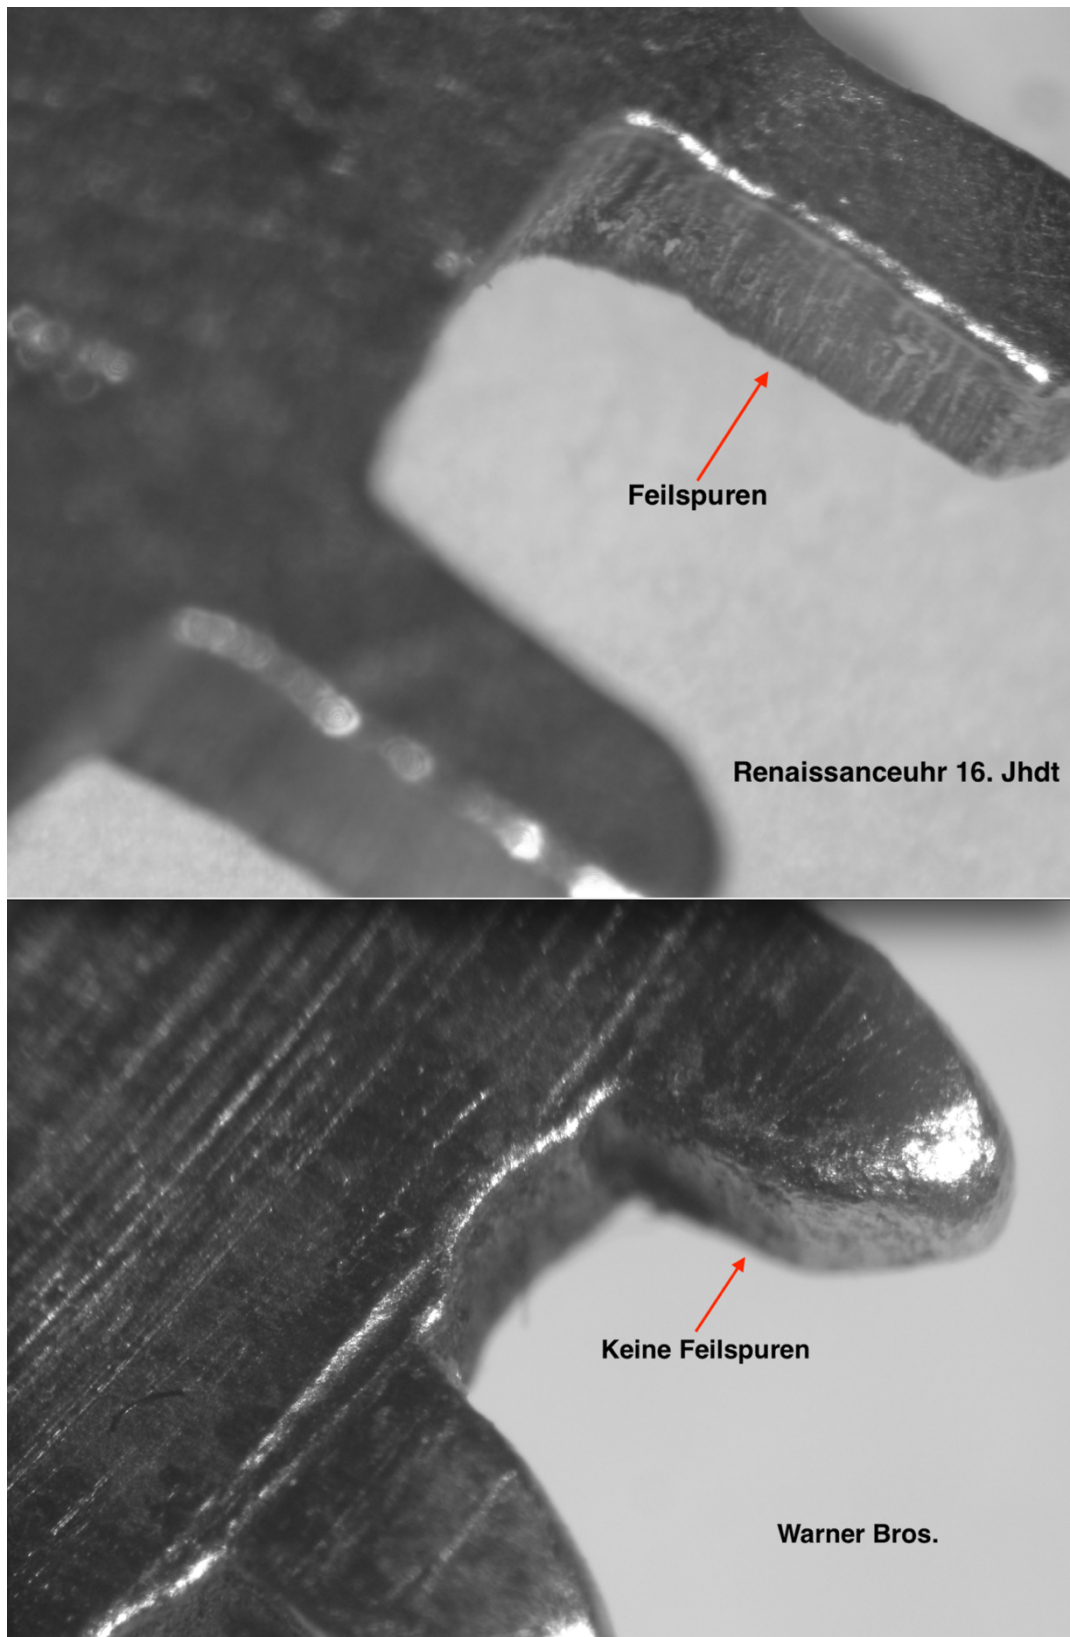
Mikroskopy 01

The hour wheel with its screwed-on 24-tooth release wheel for the hourly strike was also subject to a detailed examination. Like the previously described hour wheel, the star wheel was also made from old iron. The drilling and thread cuts also show authentic signs of a modern fabrication. Clearly visible on the screwed inner side are traces of a machine lathe. After disassembling the star wheel, previously trapped brass shavings were found on the inner surface of the hour wheel. It would be plausible to assume that these came from a corrosion surface cleaning of the heavily corroded iron of the hour wheel and were then screwed in together.

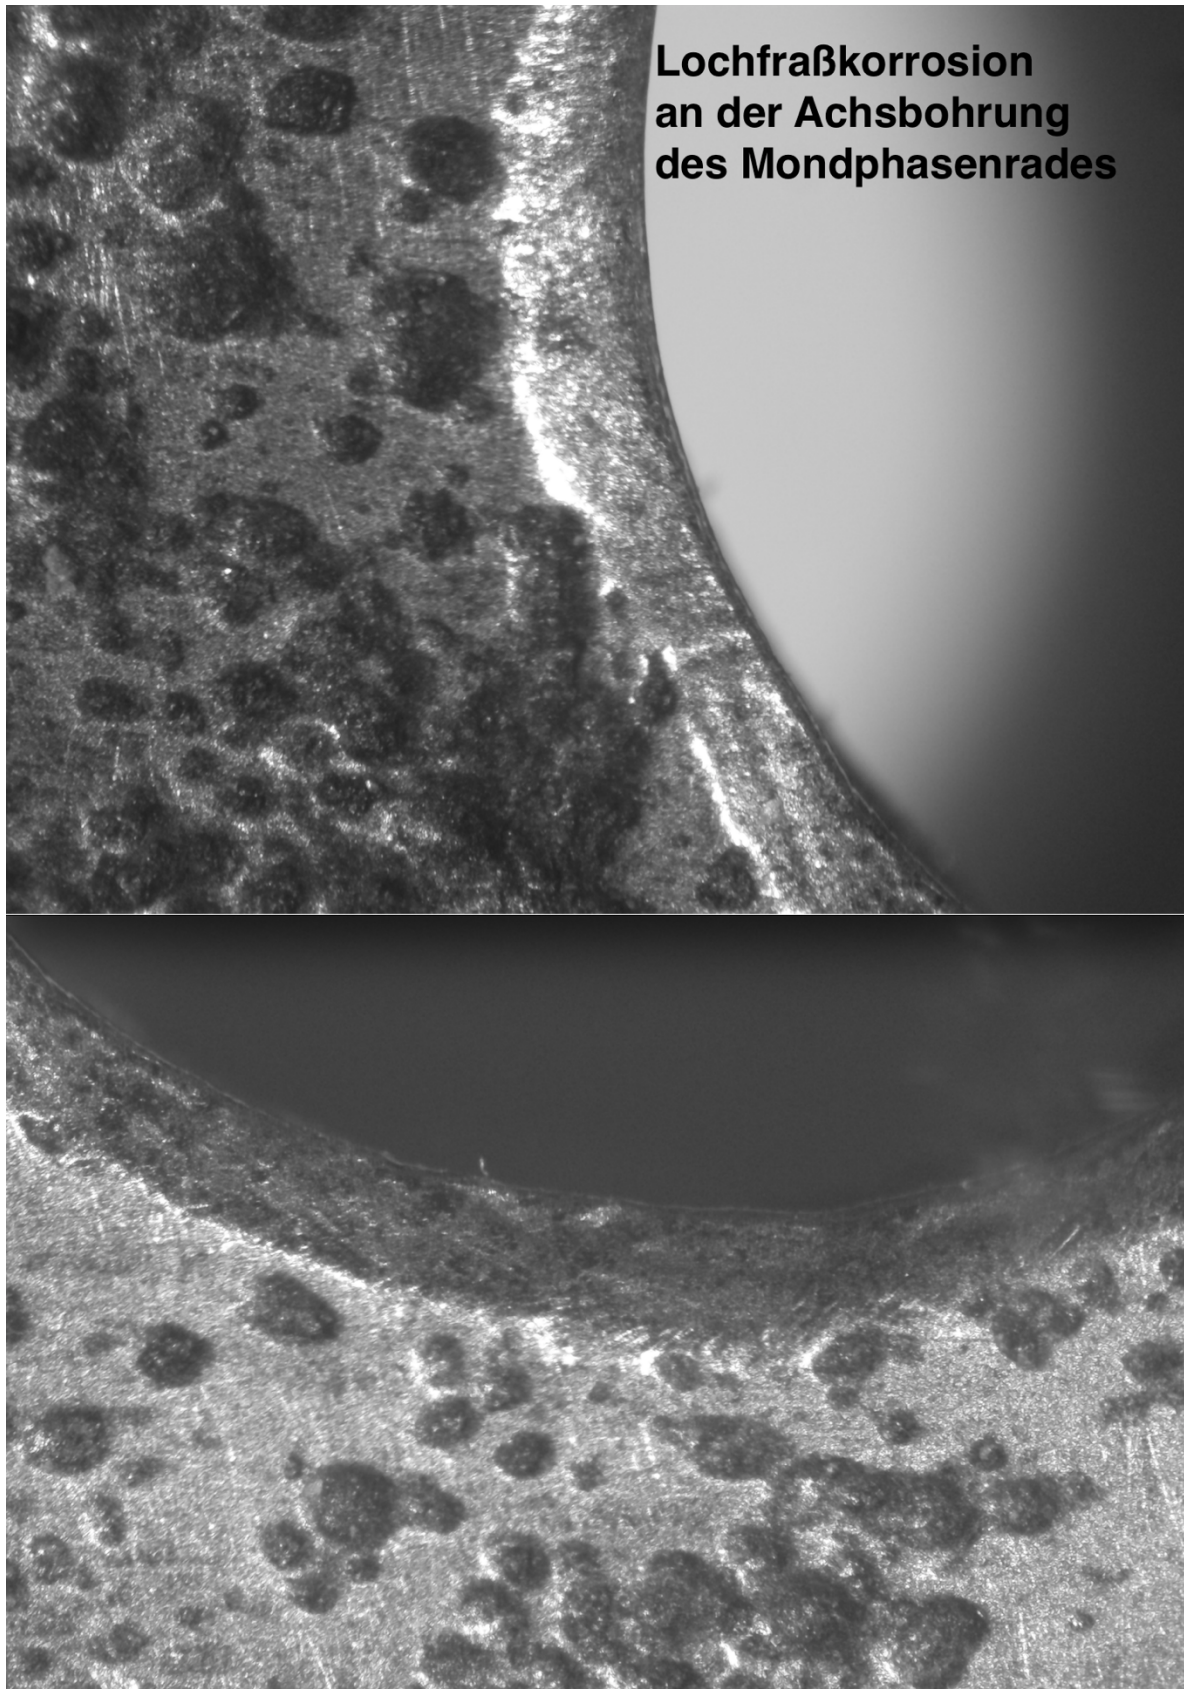
Mikroskopy 04

In the stereoscopic examination, the cut axle passage on the moon phase wheel was shown. The reaming passes through the pitting corrosion and reveals the edge beading, visible with a cone or roll countersink.

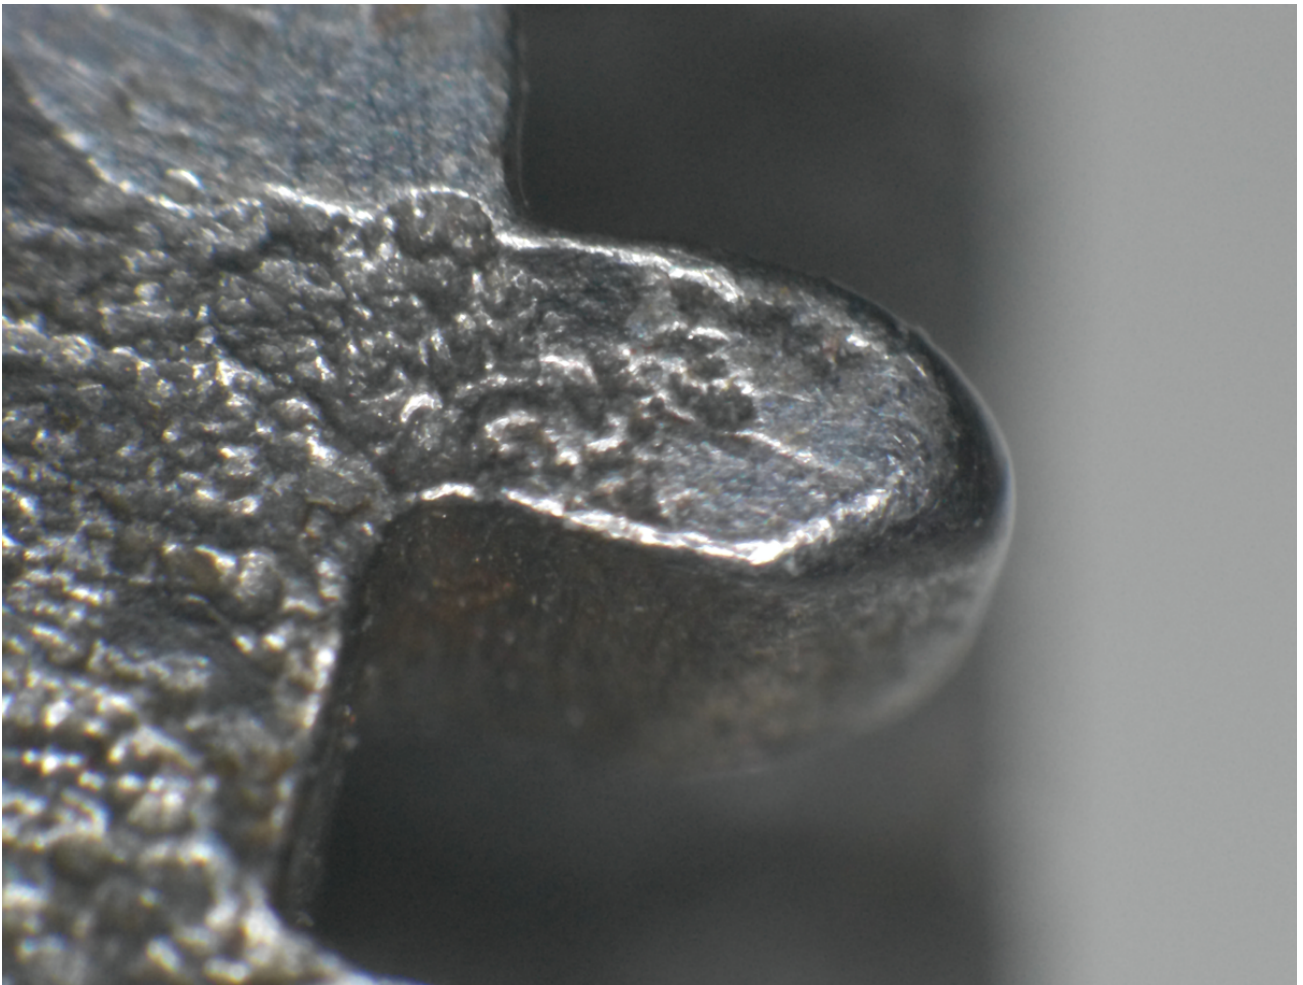
The transport wheel of the moon phase also shows an inhomogeneous pattern. Such severe pitting corrosion would have also significantly affected the tooth flanks, tooth cycloids, and the machine-milled tooth base.

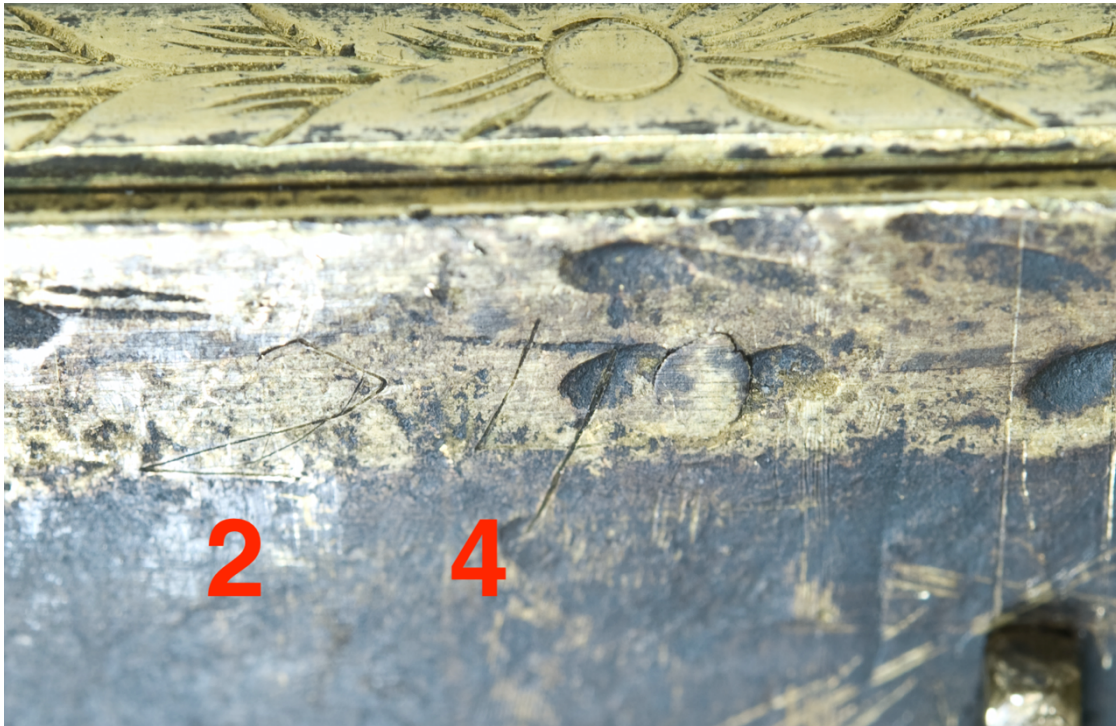
If the protective layer applied on the solder joint is removed using a cleaning medium based on gentle, residue-free surfactants, such as SurTec 104 in this case, the surface dirt is dissolved.

The surface dirt mentioned here is applied as a replacement for patina on the copper solder joint. After removing the surface dirt, even the finest file marks, which were created during the smoothing of the solder joint, become visible. Comparing the resolution of the microscope image at 0.5 mm with the spacing of the file marks makes it clear that this cannot be the work of a tool from the 16th century.

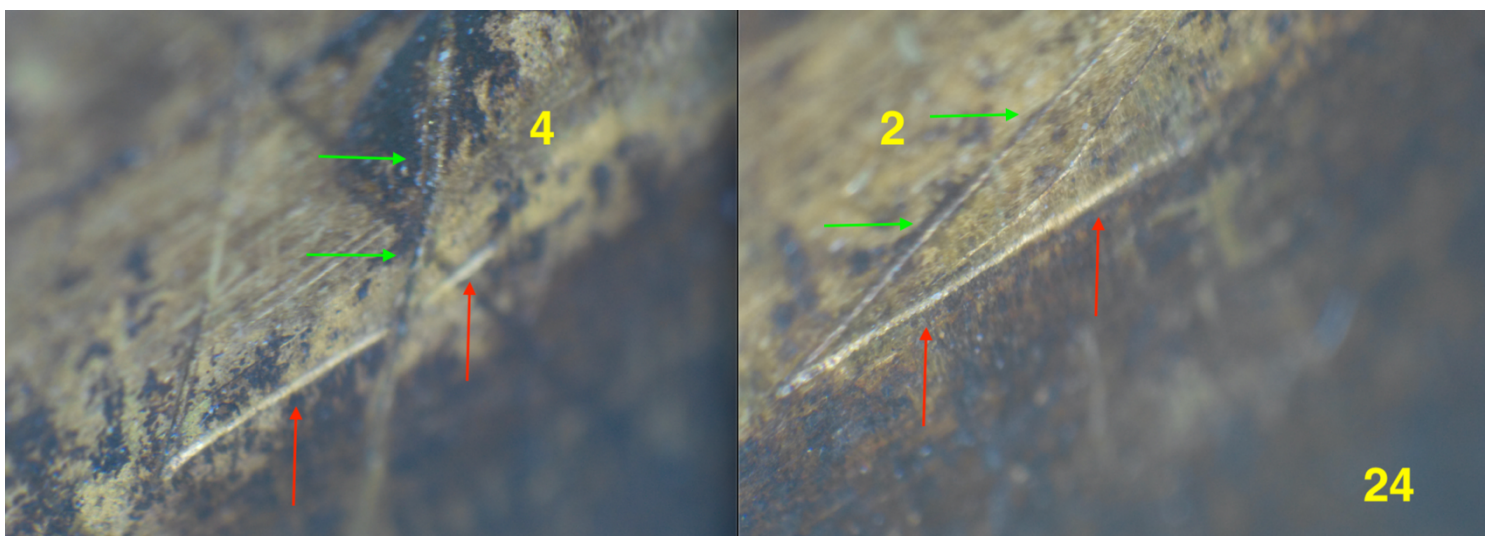
Upon microscopic examination, it is noticeable that parts of the inscription show barely or not oxidized brass, while other areas exhibit significant corrosive aging traces, as indicated by the red and green arrows. This once again raises the question of whether the interior of the case has been artificially patinated.
