# **A Myth under Scrutiny**

**Investigations on the so-called Peter Henlein Clock  
at the Germanisches Nationalmuseum Nuremberg**

**Jürgen Ehrt**

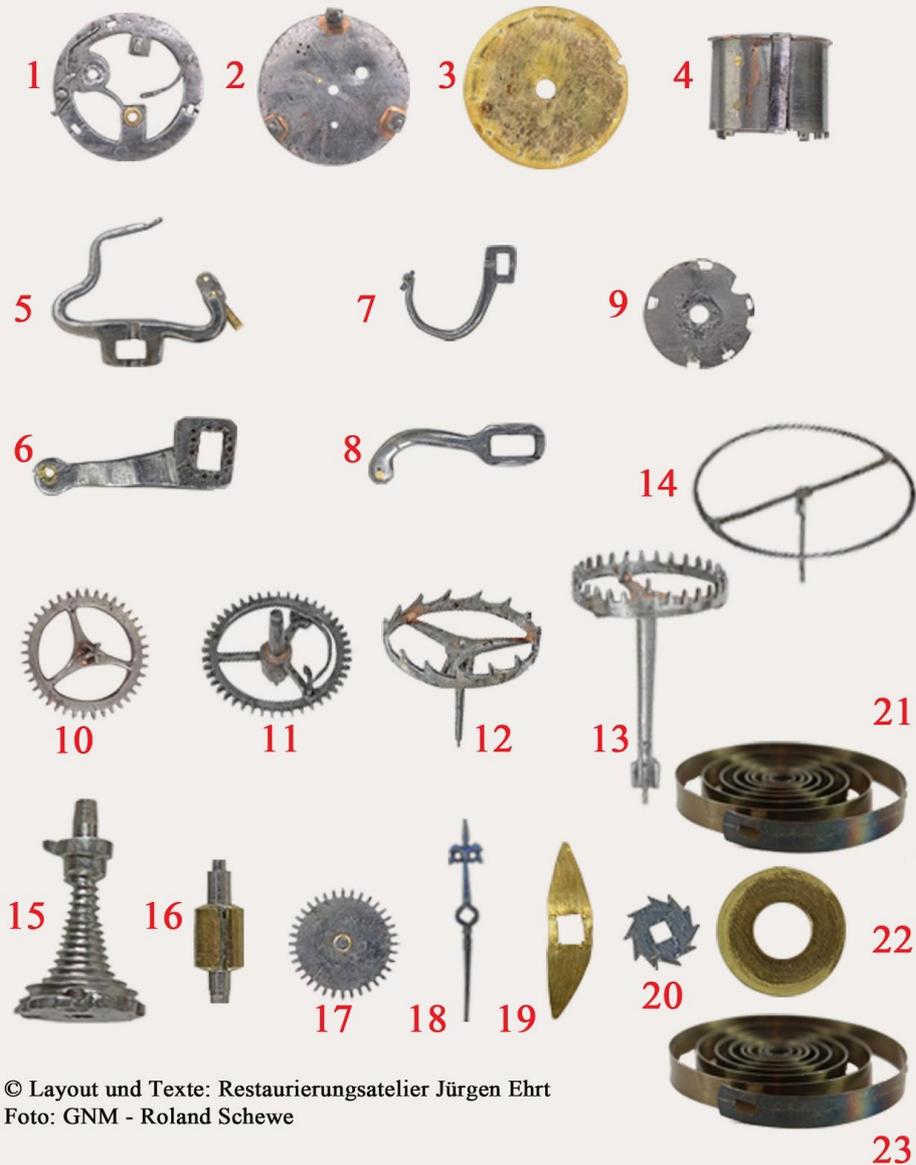
## Bauteile der sogenannten Henlein - Uhr

The following listed components are the essential parts of the so-called Henlein clock. We will not go into further detail on components that connect, stabilize, and guide parts."

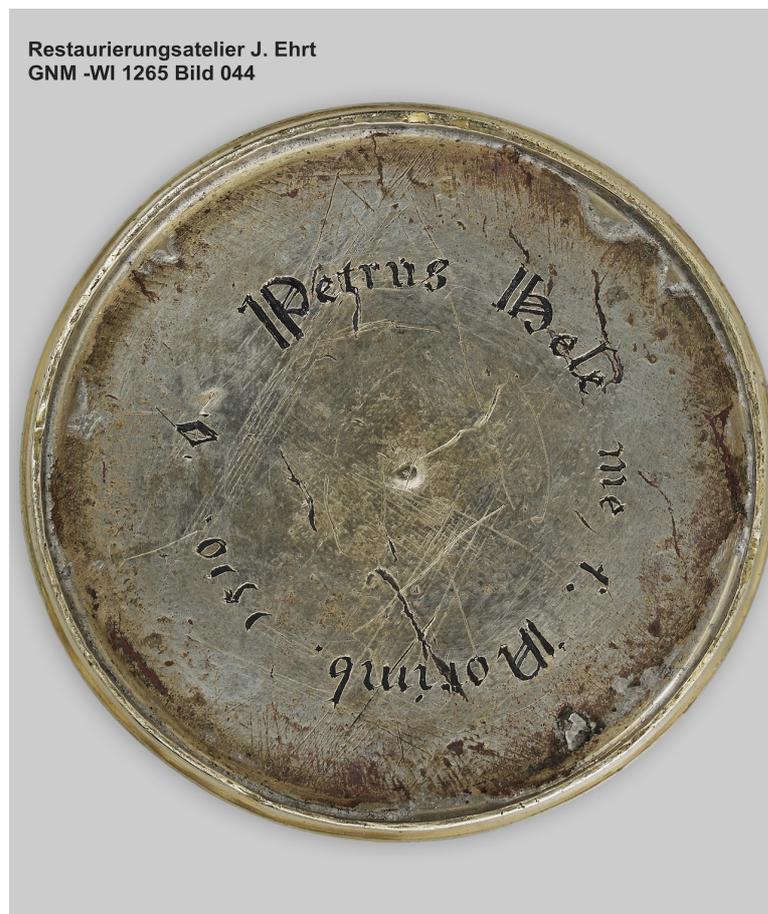
The engraved inscription on the lid, "**Petrus Hele me f(ecit) Norimb. 1510,**" implies the intention to attribute this construct to the legendary 16th-century clockmaker Peter Henlein from Nuremberg. Given this, along with the purchase in 1897 by the museum for a significant sum, the term **forgery** is indeed applicable to the so-called Henlein-Uhr.

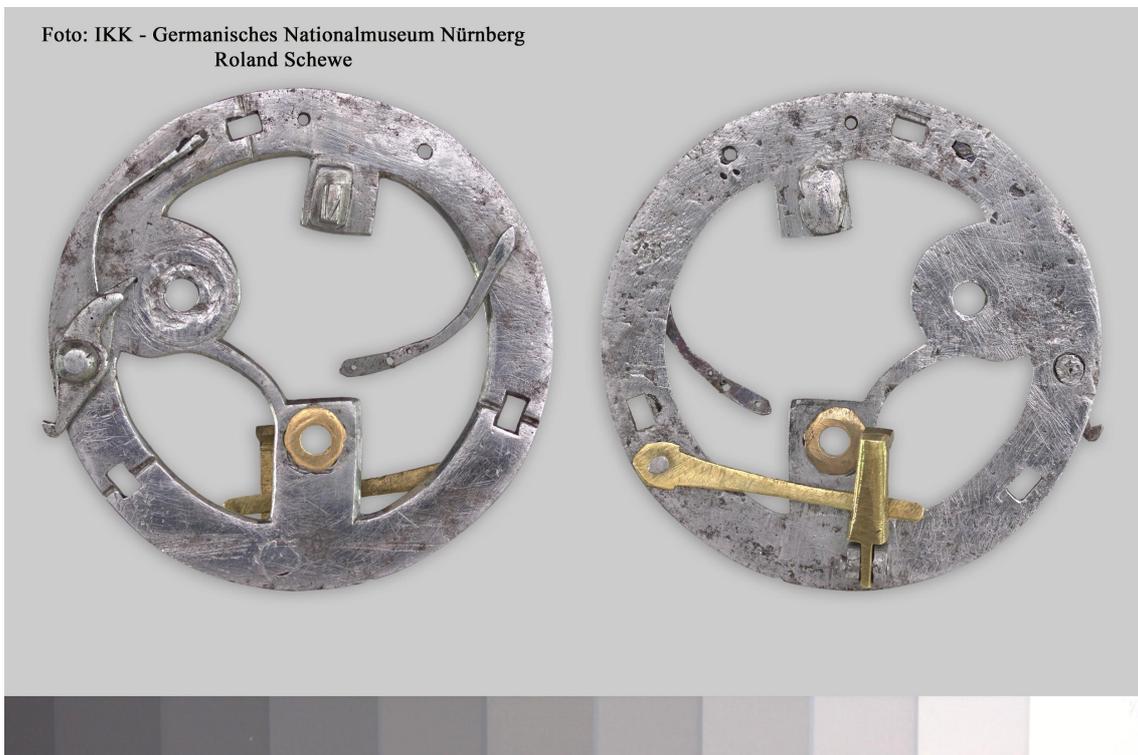
*Image: Lower Plate*

The examination results will demonstrate that we are dealing with a movement frame used as the base for the reconstruction of the so-called Henlein clock.

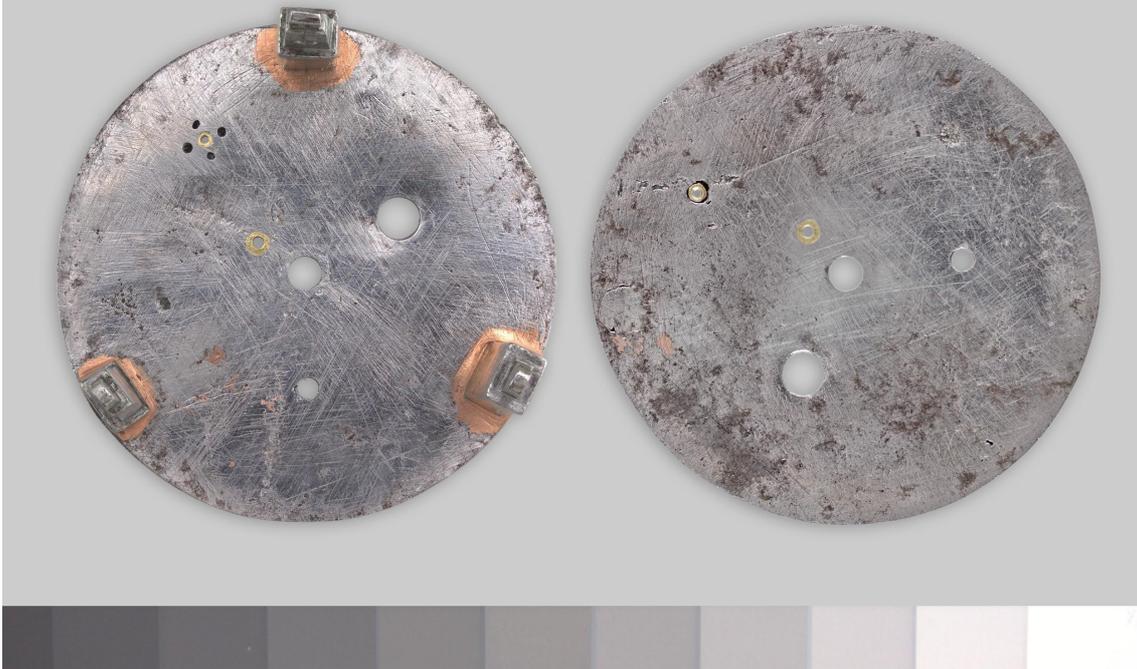
*Image: The upper plate inclined toward the dial*

The chamfered edges - see yellow markings - as opposed to the sawn edges on the lower spindle bearing bracket support the finding that the movement cage was modified for a new construction.

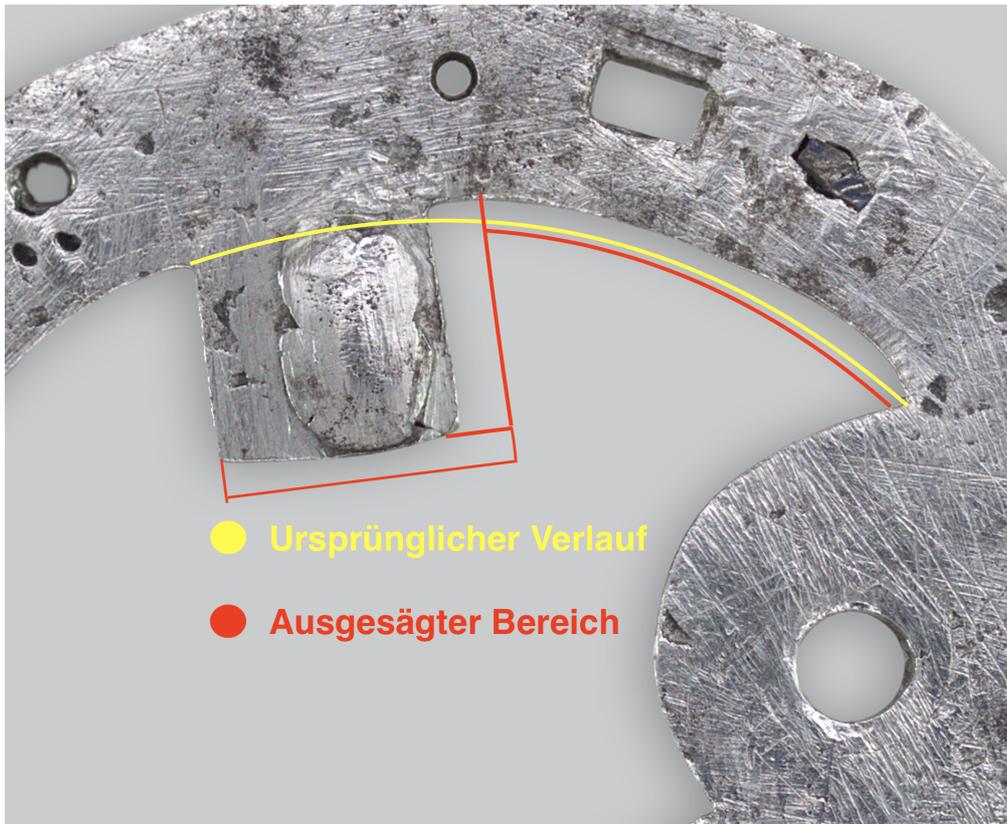
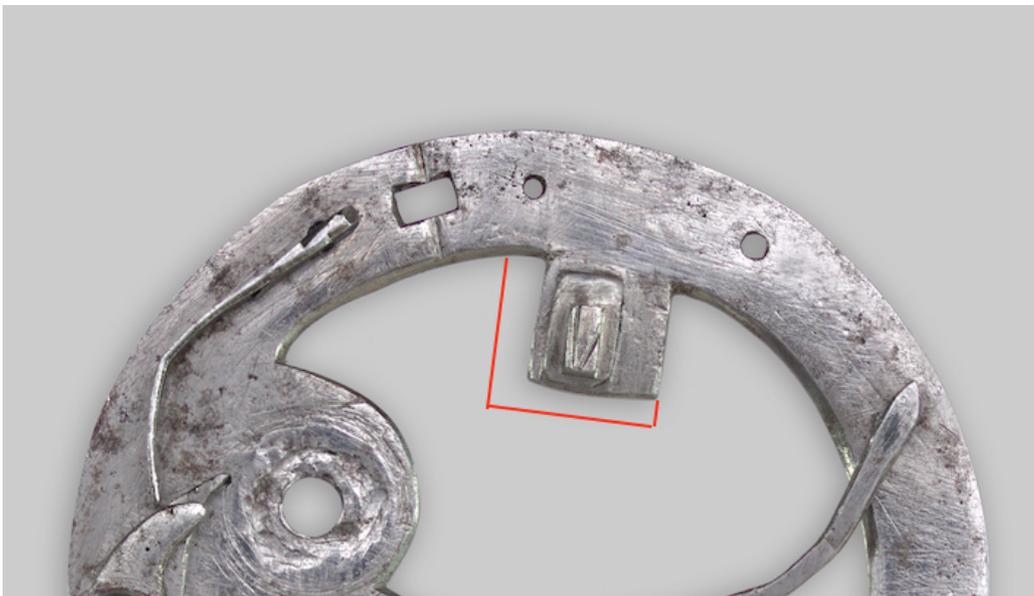
The plateau for accommodating the lower verge bearing bracket was sawn in width and length to create a clearance space for the barrel and escapement wheel. Consequently, in this movement cage, before this modification was carried out, neither the existing barrel nor the installed escapement wheel could have been present. In the tomography, an old transverse hole can be seen through the riveted plateau pin, which serves to accommodate the lower spindle bearing bracket. This unused transverse hole originally had the plateau pin riveted under a different plate, which, however, cannot be identical to the one used here. Thus, this plateau pin cannot belong to the examined exhibit.

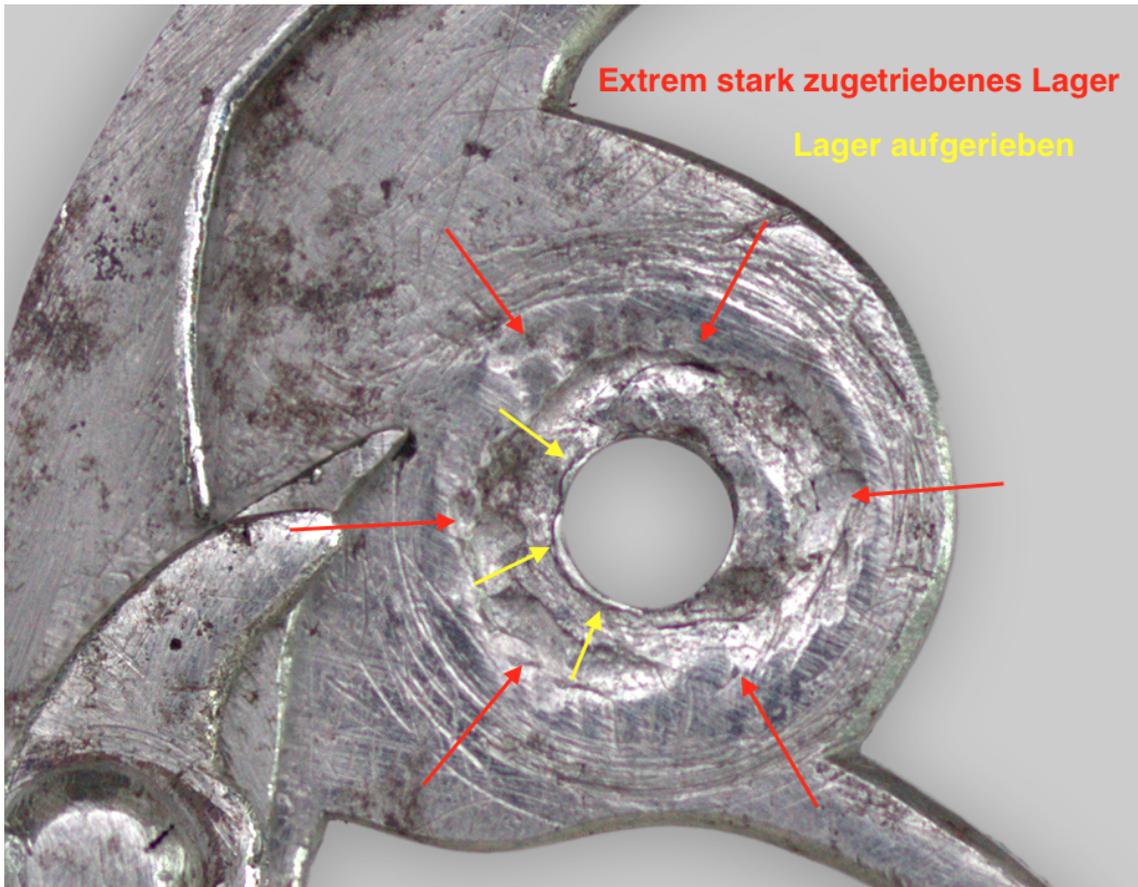
Assuming that the arbor with the barrel arbor does not rotate but, when tensioned, locks the barrel to let it run down on itself, only wear on the barrel bottom bearings can occur, not on the arbor pin of the barrel arbor or its bearing. This is another indication of a component addition. Subsequently, I will demonstrate that the barrel was originally not part of this movement cage.

Image: Bearing for the Barrel Arbor Shaft

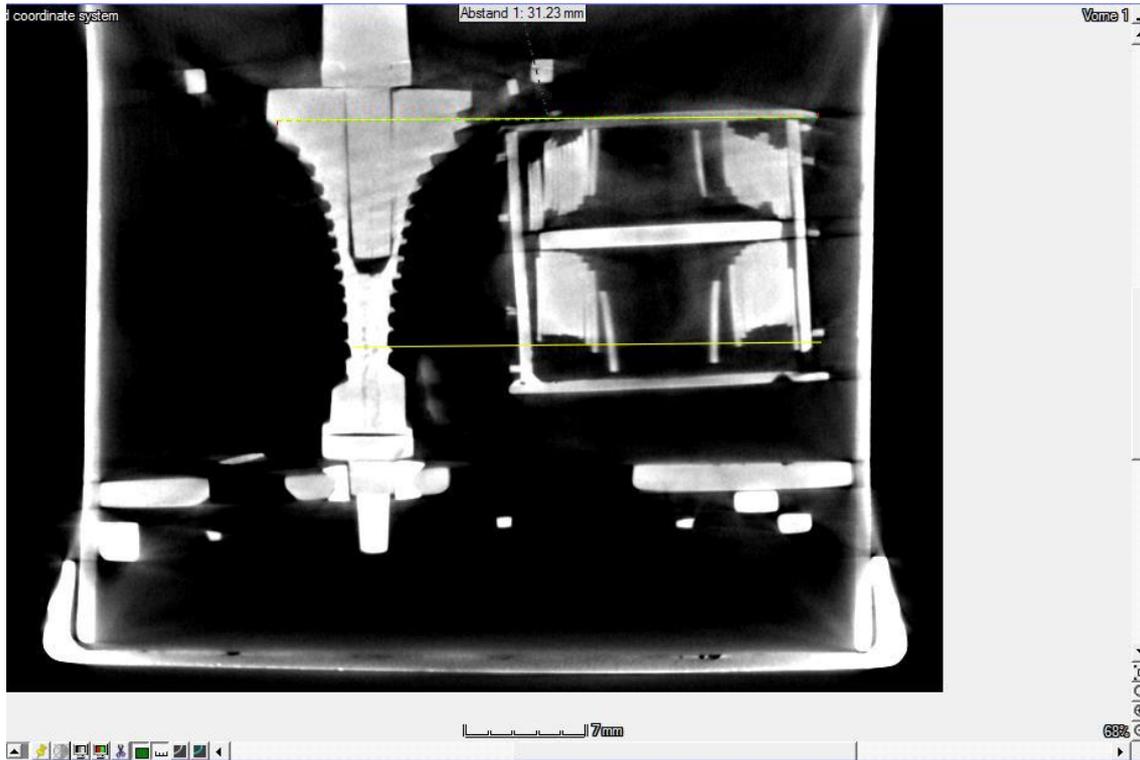
*Image: Component distances between the fusee and mainspring barrel.*

The distance, i.e., the vertical clearance between the drive wheel and mainspring barrel tab, now amounts to a maximum of 1.6 mm. Considering mechanical imponderables such as bearing play, vertical clearance in the pivot bearing, and the non-circular rotation of the drive wheel and mainspring barrel, one can reasonably assume further reduction of this measured 1.6 mm at rest. There would have been no space left for proper functioning.

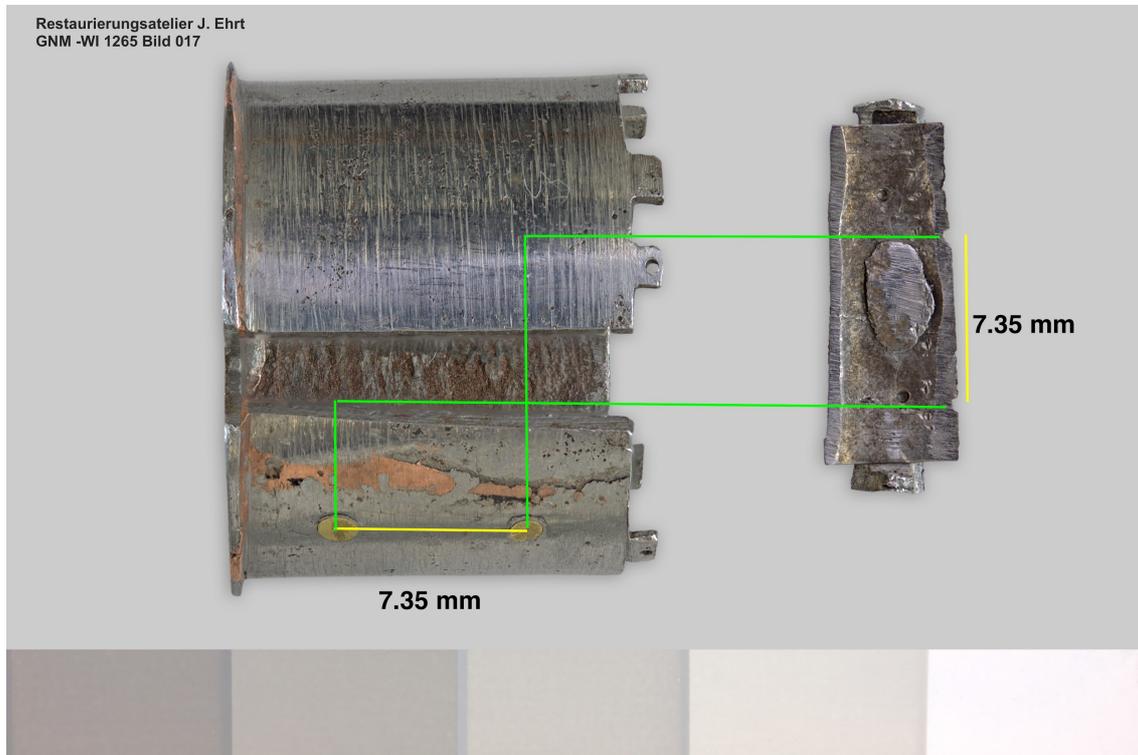
The holes located within the yellow circular markings go through the mainspring plate into the closure wedge of the mainspring barrel. This may have been an attempt to shorten the old mainspring in height, thus adapting it to the shortened mainspring barrel. After this was unsuccessful, a remaining piece of the mainspring was riveted onto the wedge as a closure lock.

*Image: Remnant of the old mainspring riveted onto the closure wedge of the mainspring barrel.*

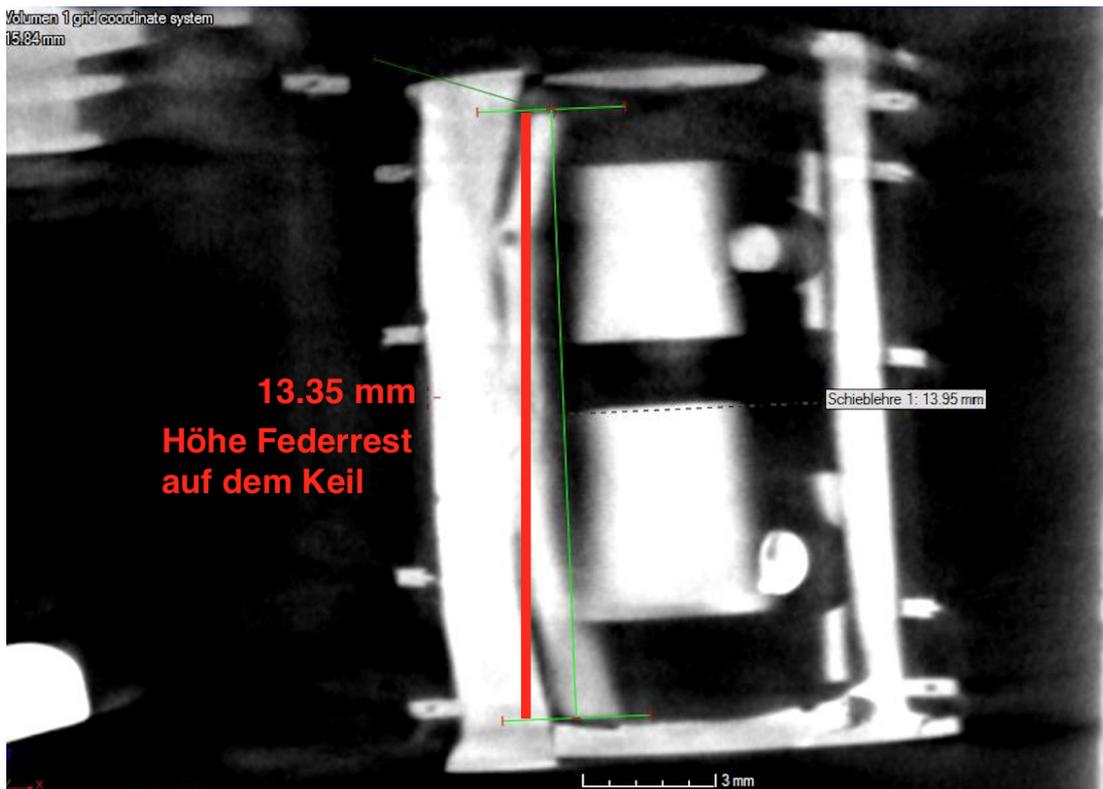
After the shortening of the mainspring barrel, a friction-free operation of the mainspring was no longer guaranteed with the modified mainspring shaft in the remaining clearance of about 1.4 mm.

*Image CT: Dimensioning of the component remnant on the mainspring barrel*

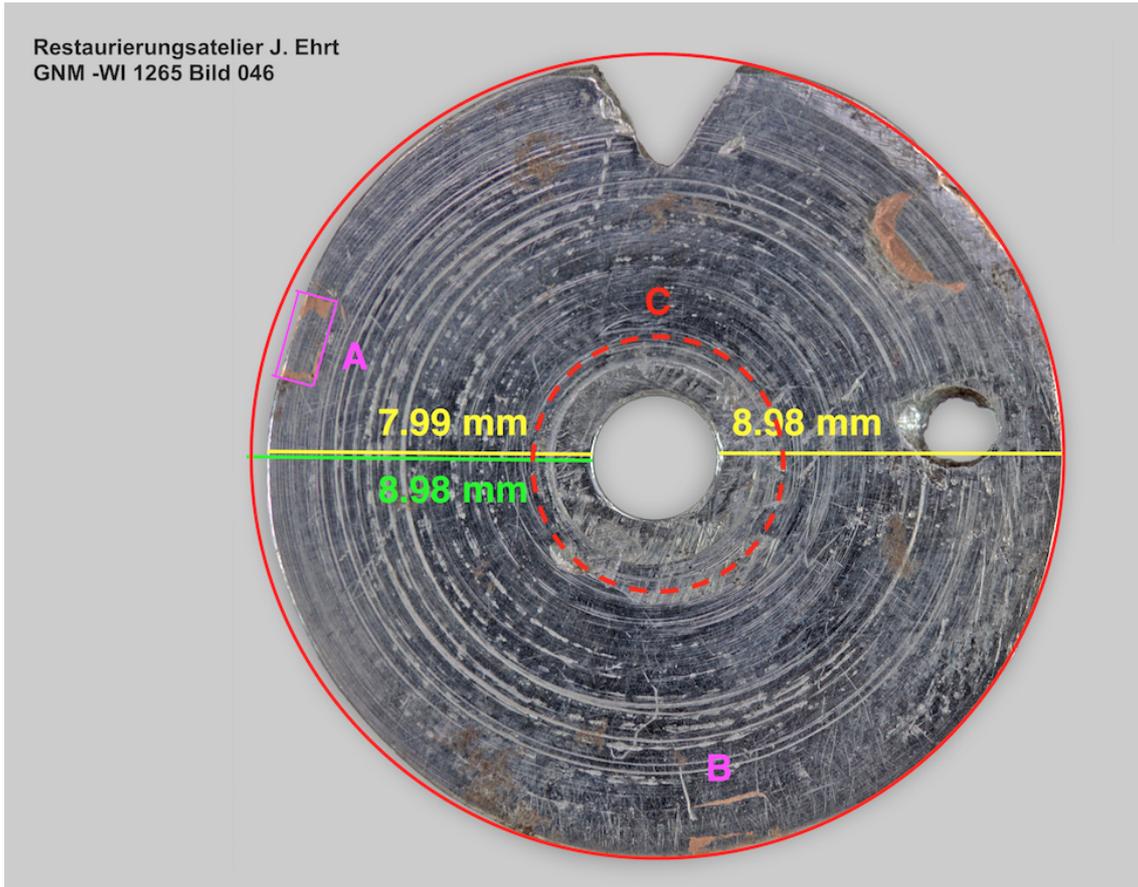
The semi-open solder joint of the soldered tab (A) suggests an approach where the bottom was first soldered to the mainspring wall and then filed to the desired circumference, leaving a raised edge."

*Illustration: Machining marks on the mainspring barrel bottom*

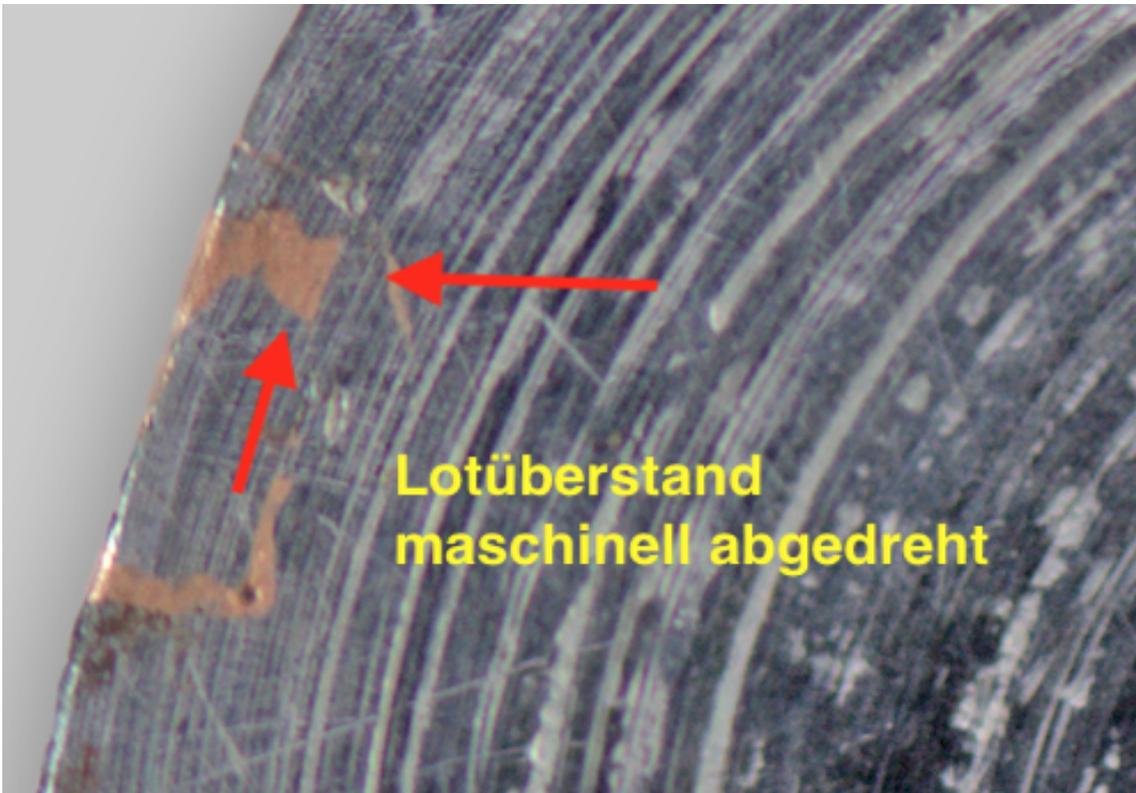
**The red arrows mark the cutting traces going through the brass solder, indicating the mechanical machining process.**

At the position marked with (A), milling traces, as left by a rapidly rotating drill or mill, can be found. This intervention, the interruption of the brass solder seam by the file and milling traces, is also evidence that the soldering of the mainspring barrel cover to the outer wall must have occurred before this intervention.

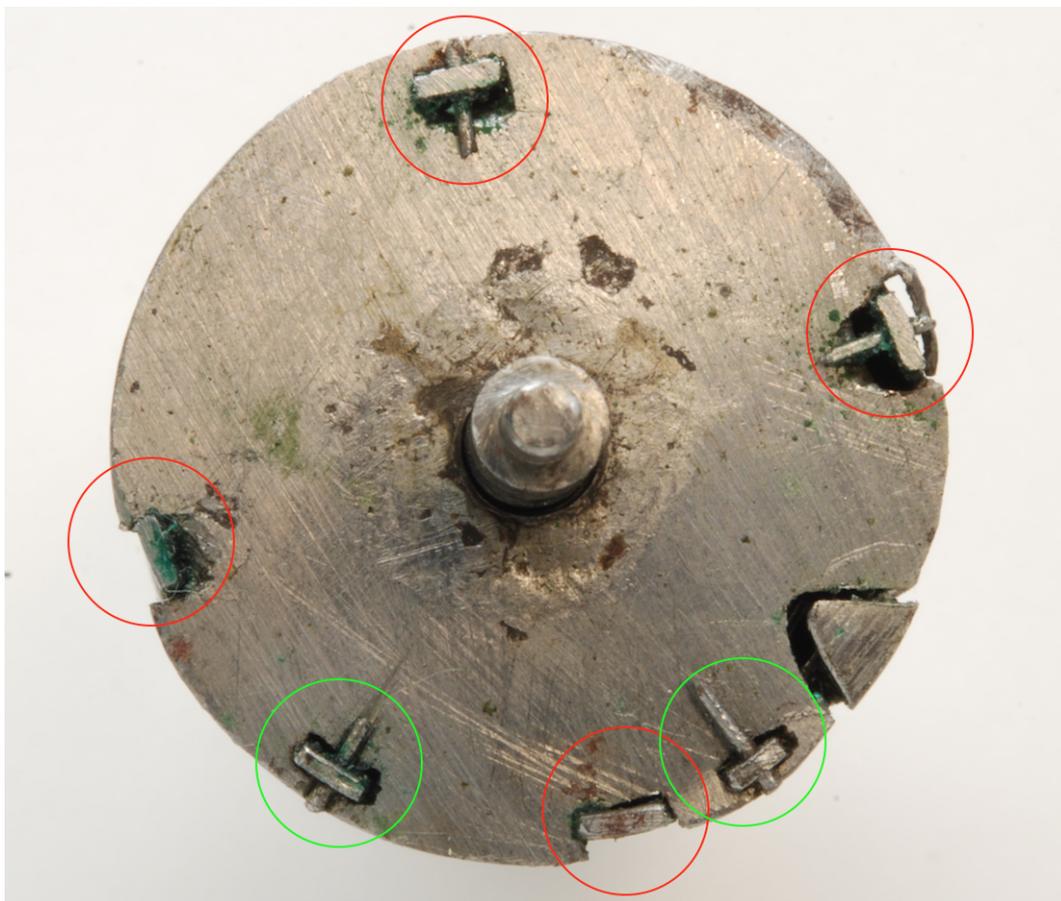
*"The modifications to the mainspring barrel affect all its components. The entire mainspring barrel has been reduced in height by at least the amount of a length corresponding to the vertical tabs that hold the cover and are pierced for the front pins. Two of the four tabs had to be worked out of the mainspring barrel wall at another location due to defective areas at the openings in the cover. In the cover, two new openings were inserted accordingly. Two now unused rectangular openings in the cover indicate the old position of the removed tabs."*

**The locking mechanisms marked with a red circle in the image are the original tabs. These were shortened to the dimension of the newly worked-out tabs from the mainspring barrel wall, marked with a green circle.**

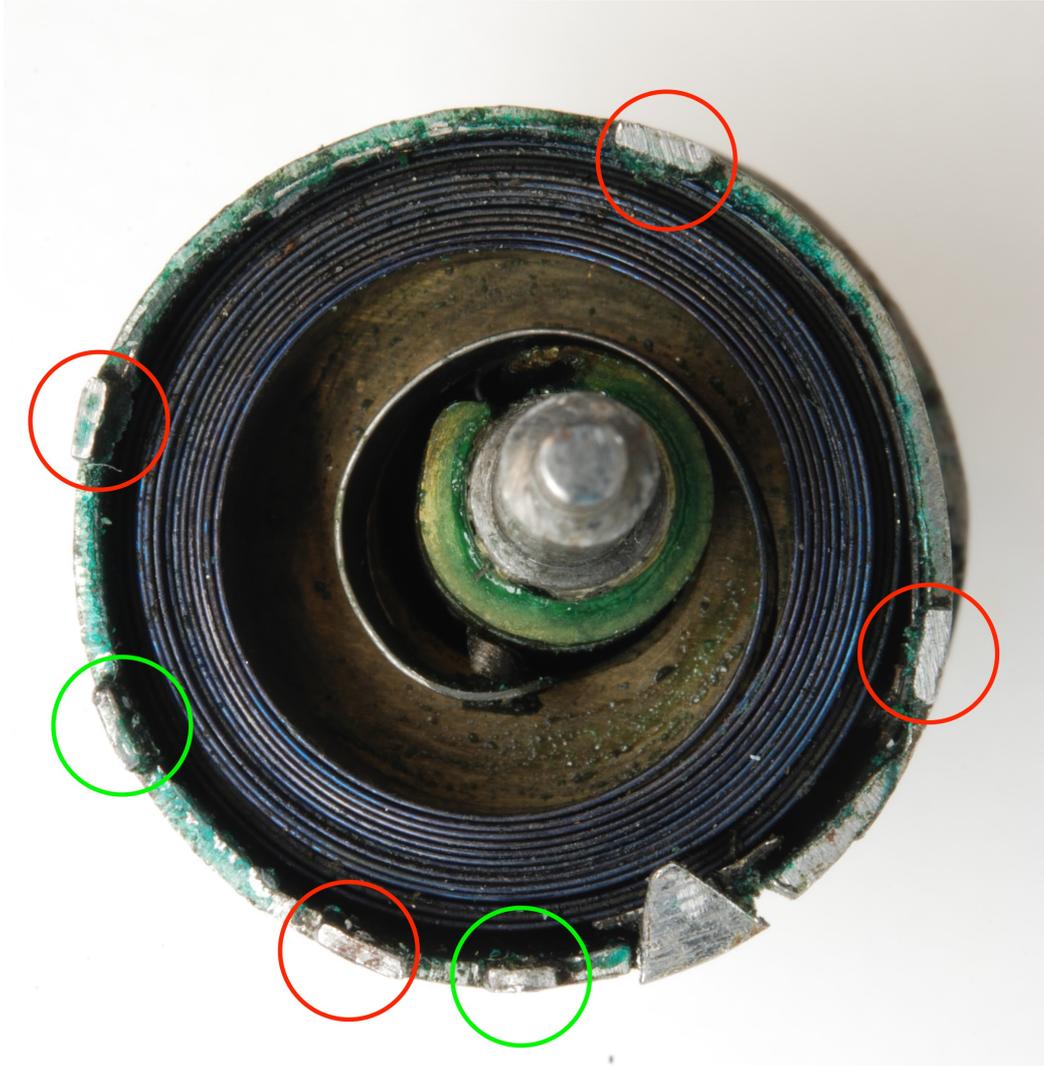
**The locking mechanisms marked with a red circle in the image are the original tabs. These were shortened to the dimension of the newly worked-out tabs from the main-spring barrel wall, marked with a green circle.**

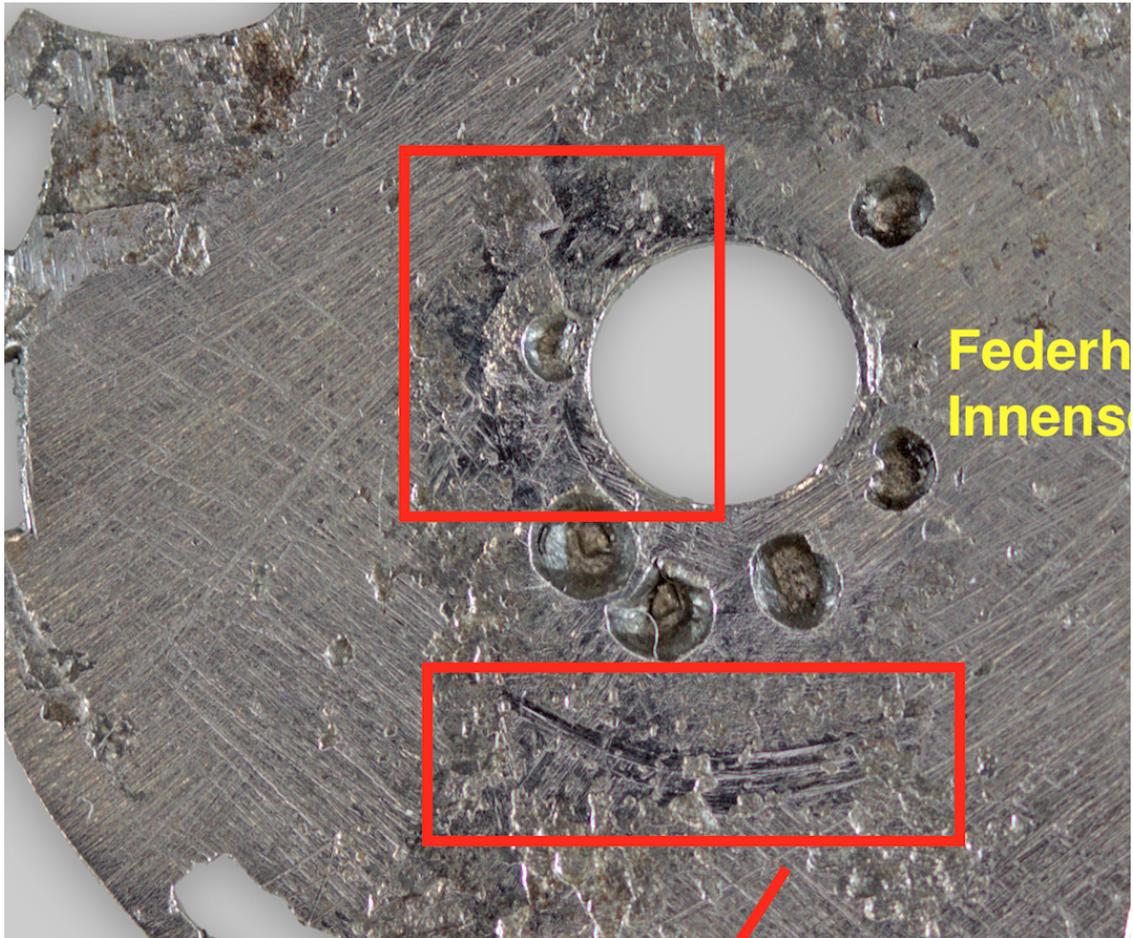
*Illustration: Mainspring Barrel Cover Interior - Bearing Hole for the Mainspring Arbor*  
© Layout: Restoration studio Jürgen. Ehrt  
Photo: R. Schewe, G. Janßen (GNM)

The manipulative alterations are clearly evident in the above illustrations of the mainspring barrel cover. Initially, an old, overly wide hole was closed by six punch strikes and then reamed to the required size for the mainspring arbor. Also noted here, as previously observed on the mainspring barrel bottom, are the missing expected coherent running traces of the mainspring arbor on the cover.

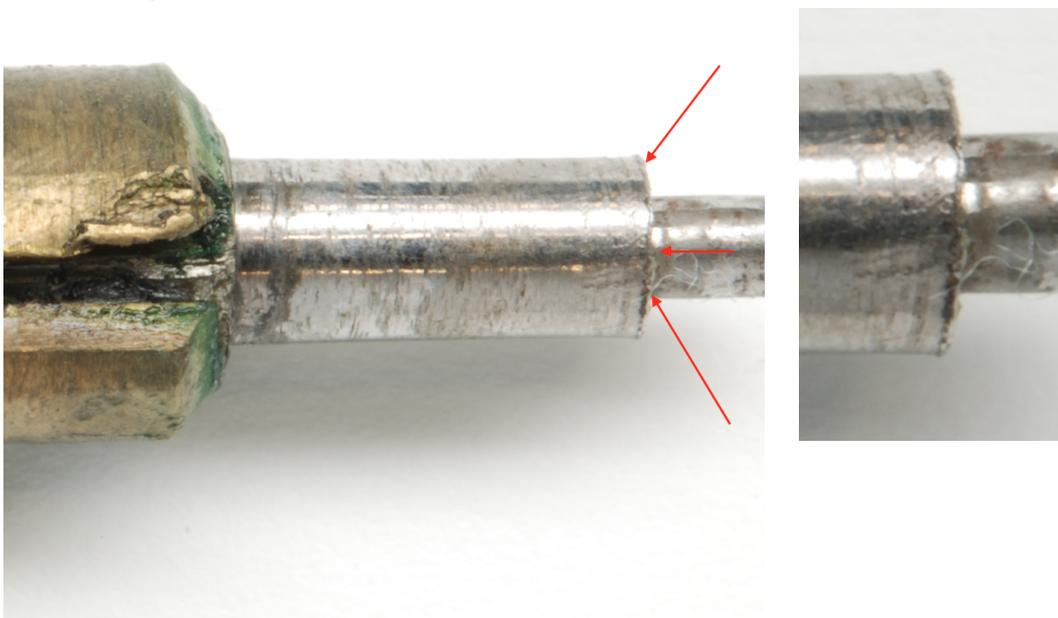
Computed tomography reveals that the brass sleeve was soldered onto the arbor to hold the unspecified pocket watch springs on the arbor.

*Illustration: Mainspring arbor, not deburred, with soldered brass sleeve*

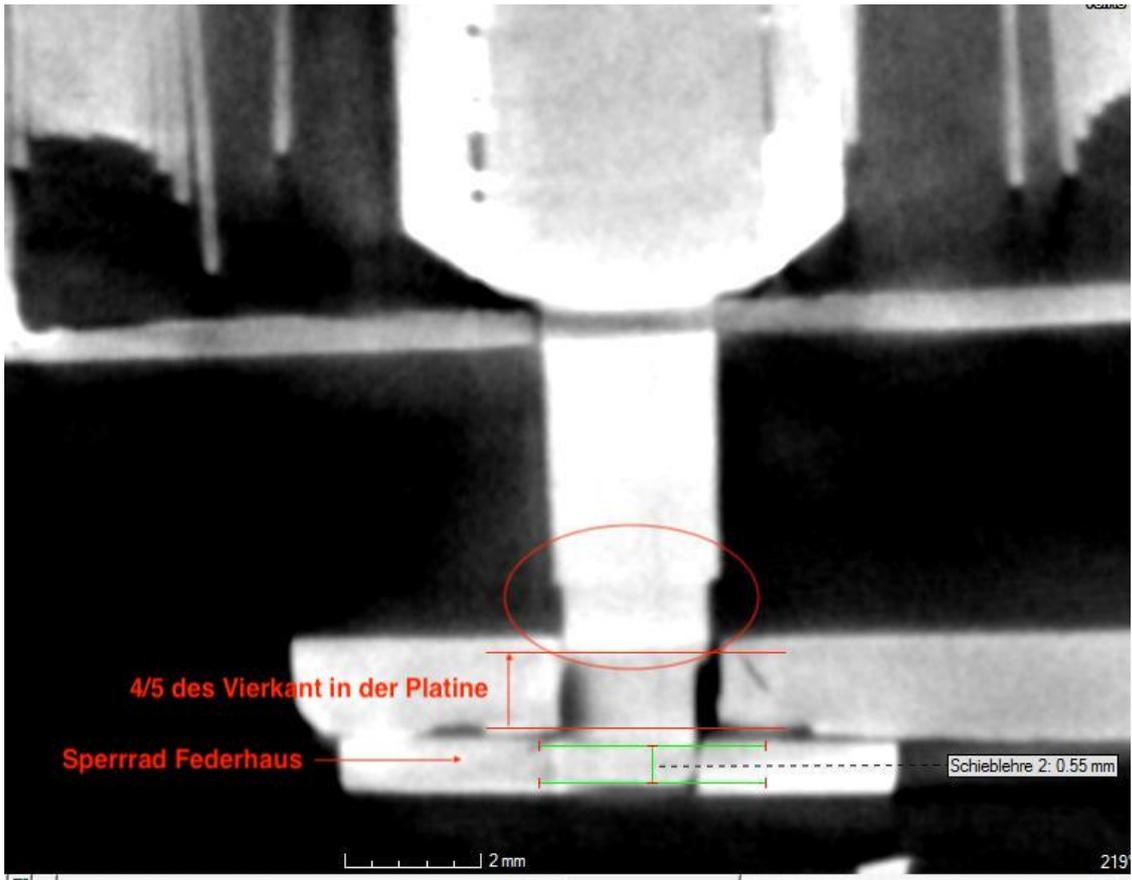
*Image CT: Mainspring arbor with square and ratchet wheel*

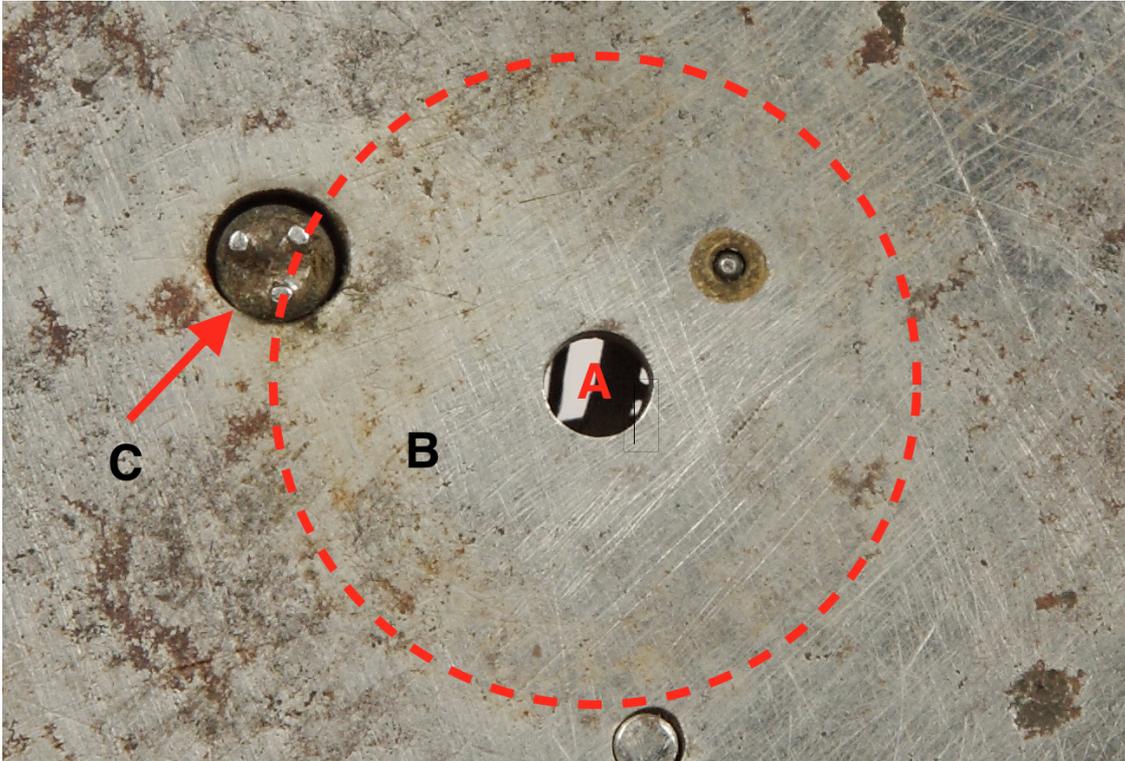
*Image: Upper plate outer side*

The upper plate should exhibit coherent running traces of the hour wheel on its surface (B). The barrel bearing for the drive wheel (C), with its three teeth, represents an inhomogeneous circular runoff pattern, which is not expected. Assuming that the bearing was circular in its original state, it must acquire an oval structure through usage-related wear from the hour wheel, thus resulting in an uneven circular shape. Also, no running traces corresponding to the hour wheel were found on the drive wheel's drive pins. The corrosive and incoherent surface of the drive wheel in its bearing to the hour wheel also does not indicate originality.

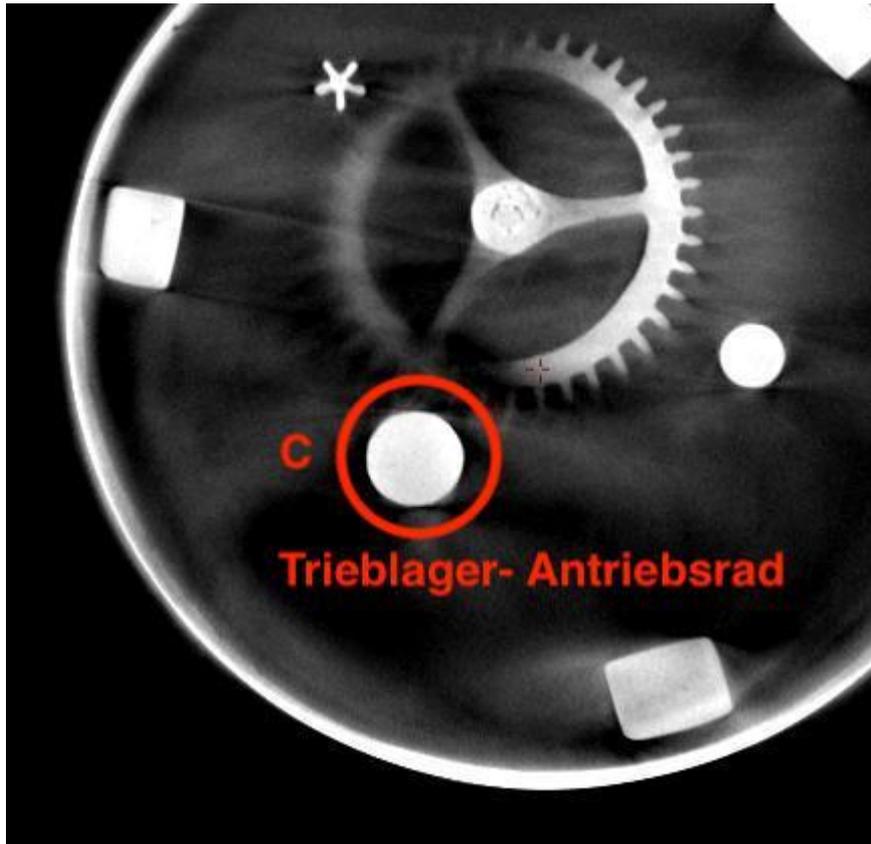
*Image CT: Drive Wheel Arbor Bearing*

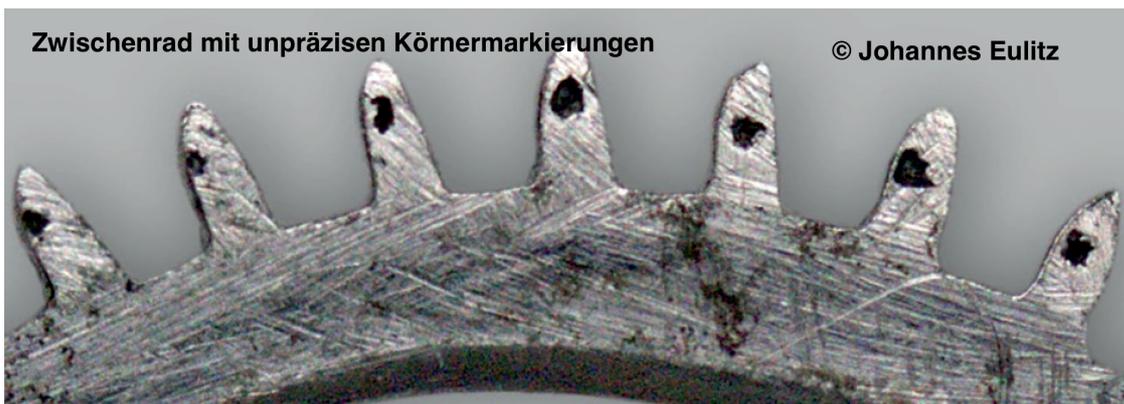
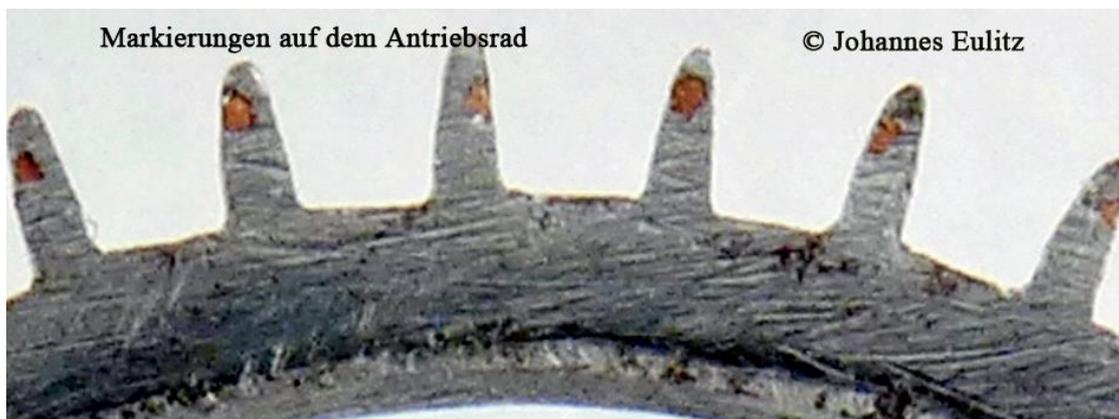
On the drive wheel mounted on the fusee as well as on the intermediate wheel, small grain markings can be observed on the gear teeth. These are commonly used in the manual production of gears to mark the division of the tooth spacing.

However, these markings are in absolute contradiction to the existing tooth division. The grain points are not placed as expected in the middle between the tooth flanks but seem to be randomly applied without centering.

After thorough research of the image and X-ray documents, I come to a different assessment. The measurement of the punched marking distances on the drive wheel results in markings accurate to tenths. The distances range from approximately 1.53 mm to 1.62 mm. The marking distances of the intermediate wheel move precisely between 1.4 mm and 1.51 mm. This very precise marking, to be evaluated, would be counterproductive if it were not used afterward, and a rudimentary division measure, as found here, was produced. It is correct that we have two gears from an earlier production or other clocks with a precise module, which were empirically modified for use in the examined clock with incompatible modules.

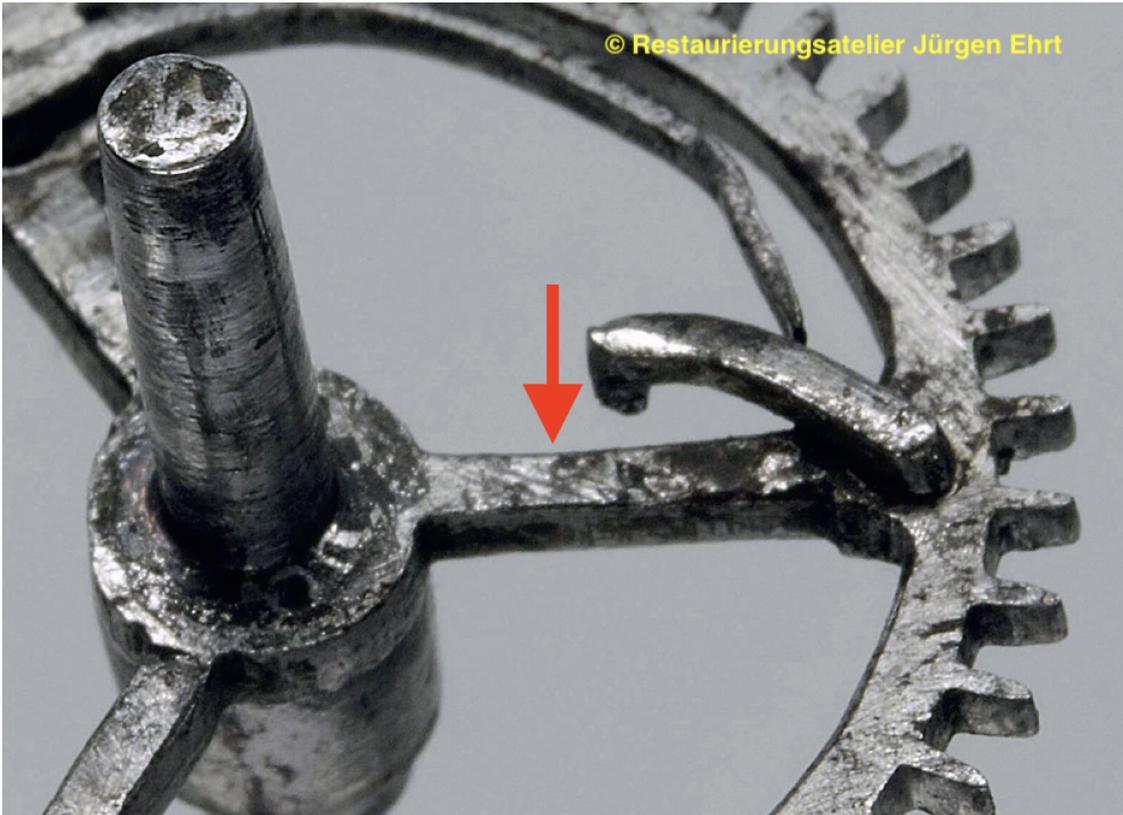
The components placed on the drive wheel, namely the detent and detent spring, were not originally positioned as they are in the wheel's holes. The detent is mounted "up-

side down" compared to the escapement wheel. This is an extremely rare configuration, as seen, for example, in the Dresden Table Clock by Jakob Zech from Prague (see photo) and its counterpart in London.

*Illustration: Locking mechanism on the drive wheel*

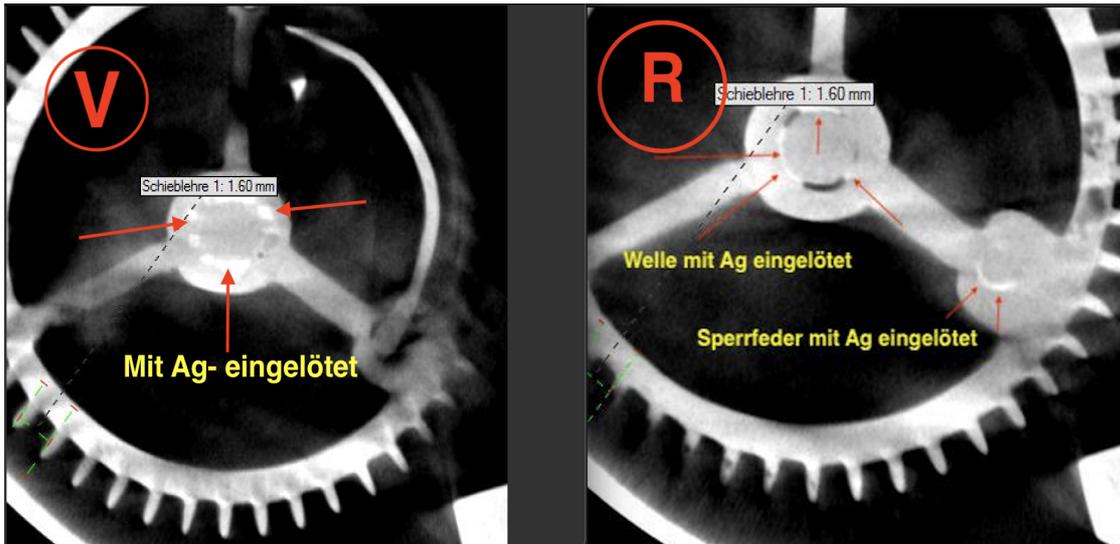
Illustration CT: Modifications to the Drive Wheel

"...The Pull-out piece (locking cone) seated on the fusee wheel is angled at its end. This form would only make practical sense if the locking wheel were dimensioned in such a way that the angled end of the Sperrkegel could rest against the wheel spoke. However, this possibility does not exist since the diameter of the locking wheel is too large. This could indicate a former locking wheel, including fusee, with a smaller diameter that was later replaced by the current parts".

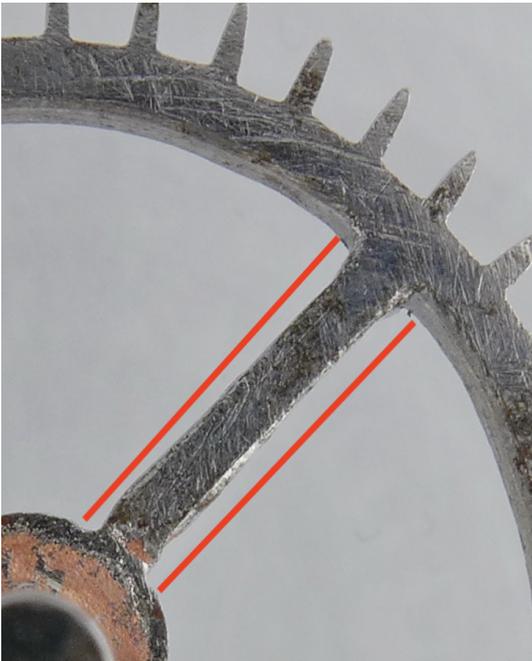
*Illustration: Driving wheel - Intermediate wheel*  
Photo: R. Schewe, G. Janßen (GNM)

Driving wheel - Intermediate wheel  
© Layout: Restoration studio Jürgen Ehart  
Photo: R. Schewe, G. Janßen (GNM)
