# **A Myth under Scrutiny**

**Investigations on the so-called Peter Henlein Clock  
at the Germanisches Nationalmuseum Nuremberg**

**Jürgen Ehrt**

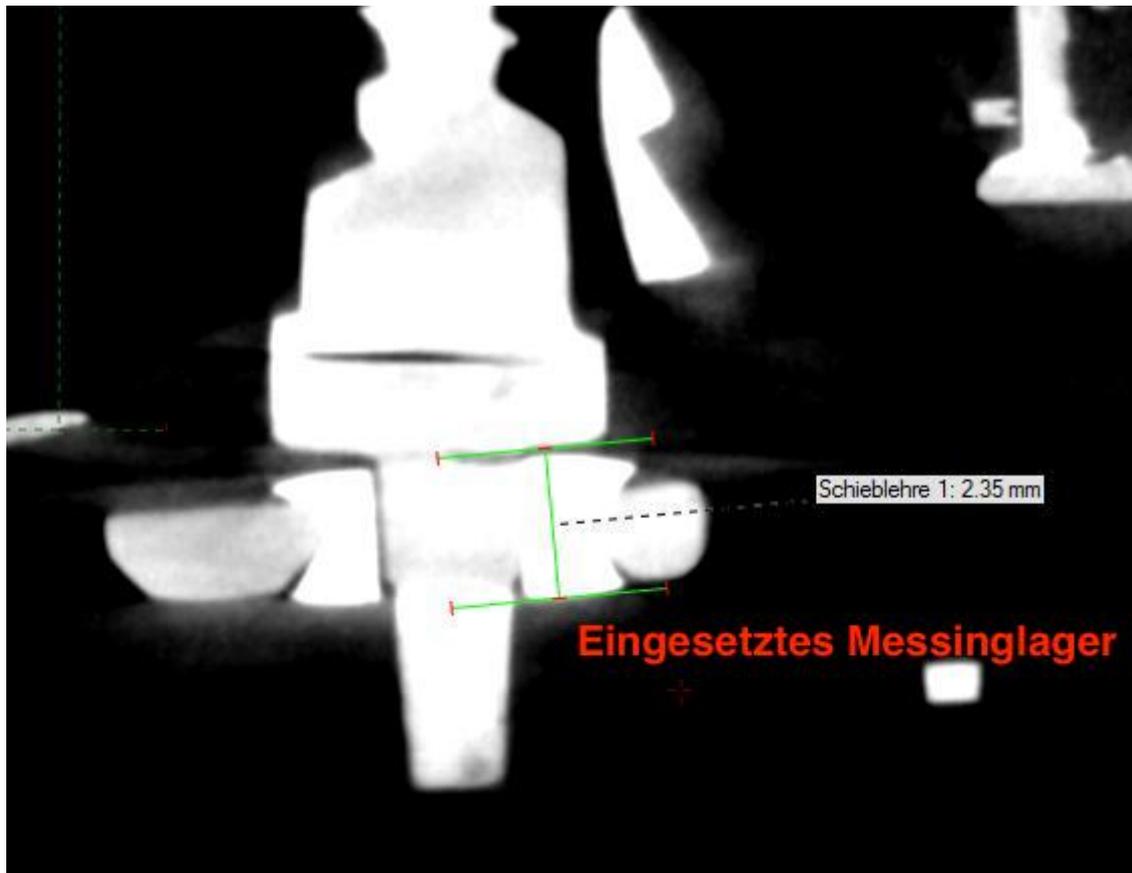
Significantly, the fusee and fusee wheel are both too short in their overall height by the same measure as the mainspring shaft. This results in another error with excessive height play. To compensate for this error, a brass bearing, filling the missing dimension, was driven into the fusee shaft bearing.

*Illustration CT: Inserted brass bearing*

It can be assumed that this bearing, among other functions, also prevents the escape wheel pinion from engaging in the void due to excessive play between the fusee and the escapement wheel during winding. The resulting damage to the movement could potentially be irreversible.

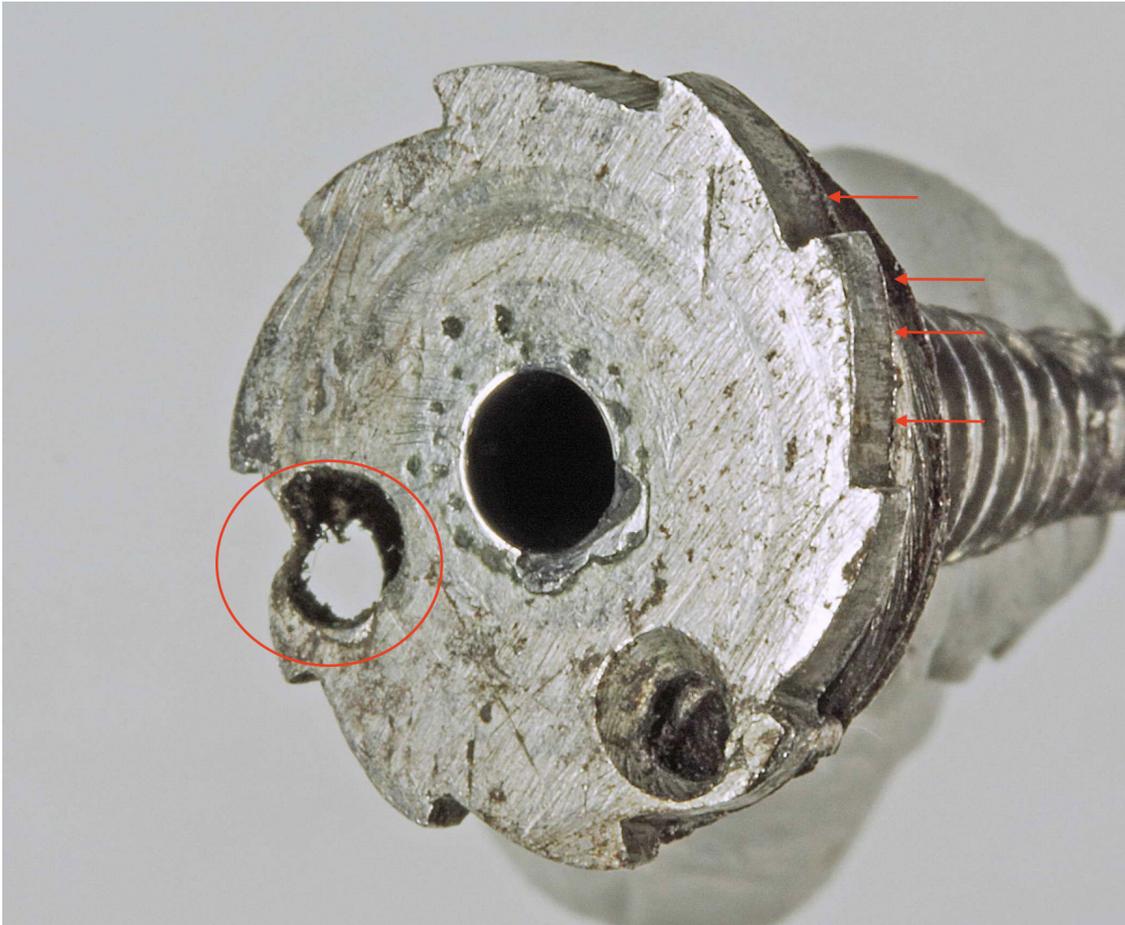
Furthermore, we observed that a hole in the escapement wheel, intended to accommodate the end knot of the gut strings, is located immediately and thus too close to the tooth of the escapement wheel. As expected, the pallet fork has pressed in the outer wall at this point.

*"Surely, since this intervention, the clock has hardly been used or could be used. This is not a repair to restore operability. Well-preserved file marks across the functional direction and a clearly raised burr on the end faces of the teeth indicate this".*

*Abbildung: Hole for holding the gut or cord and un-deburred filing marks*

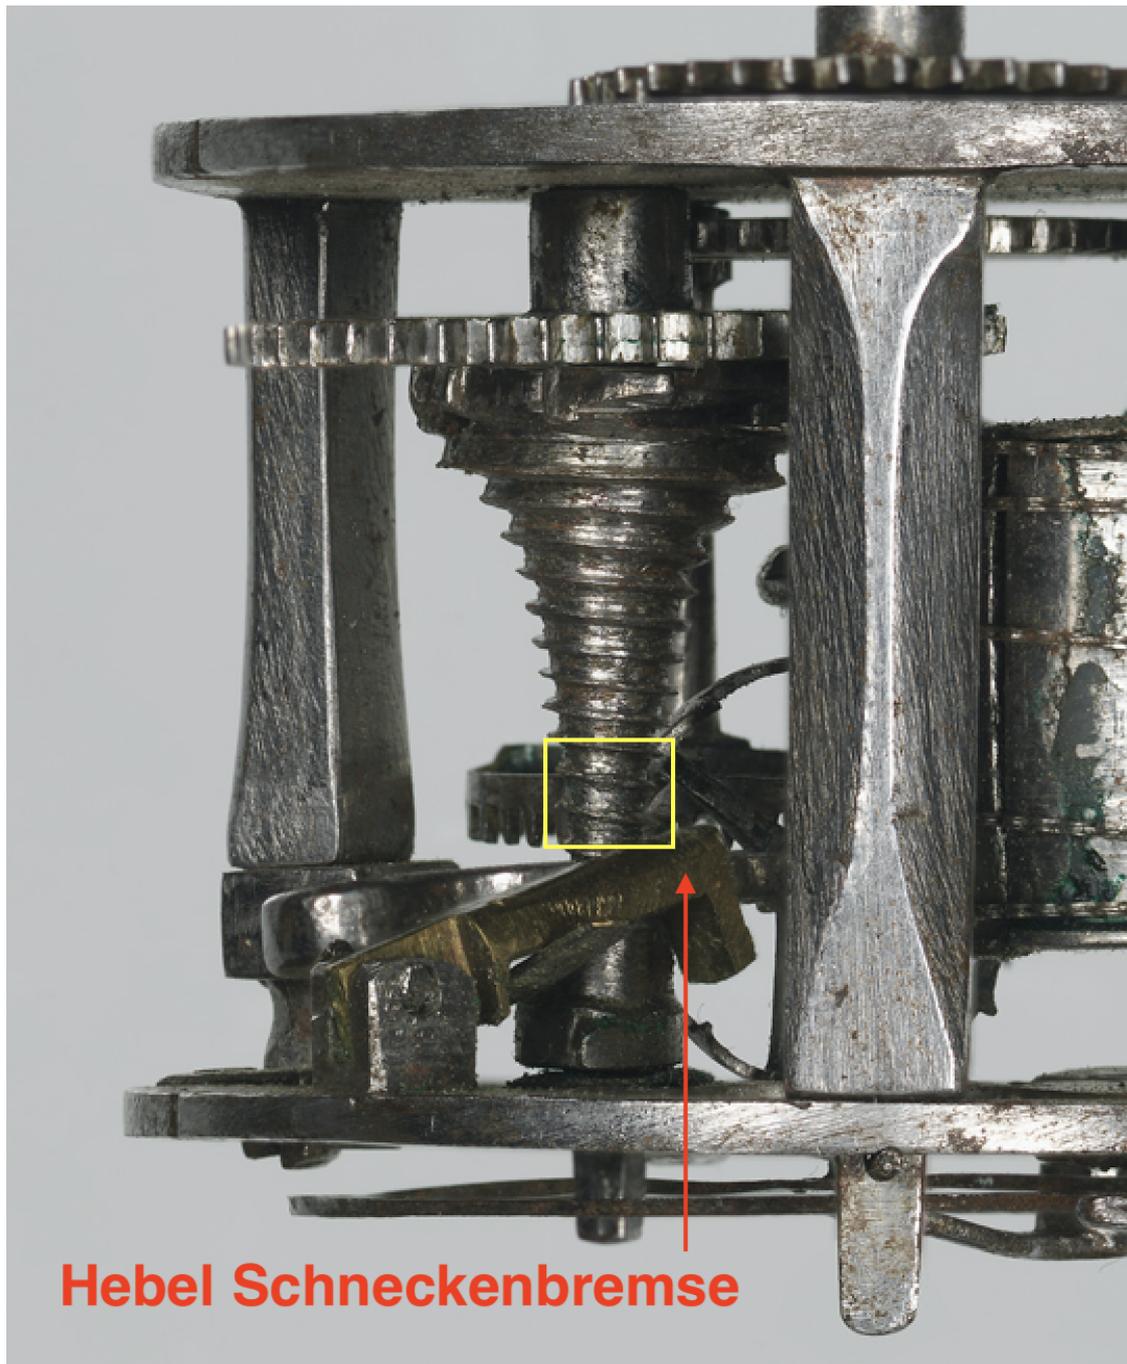
*Illustration: Constriction on the lever of the fusee brake*

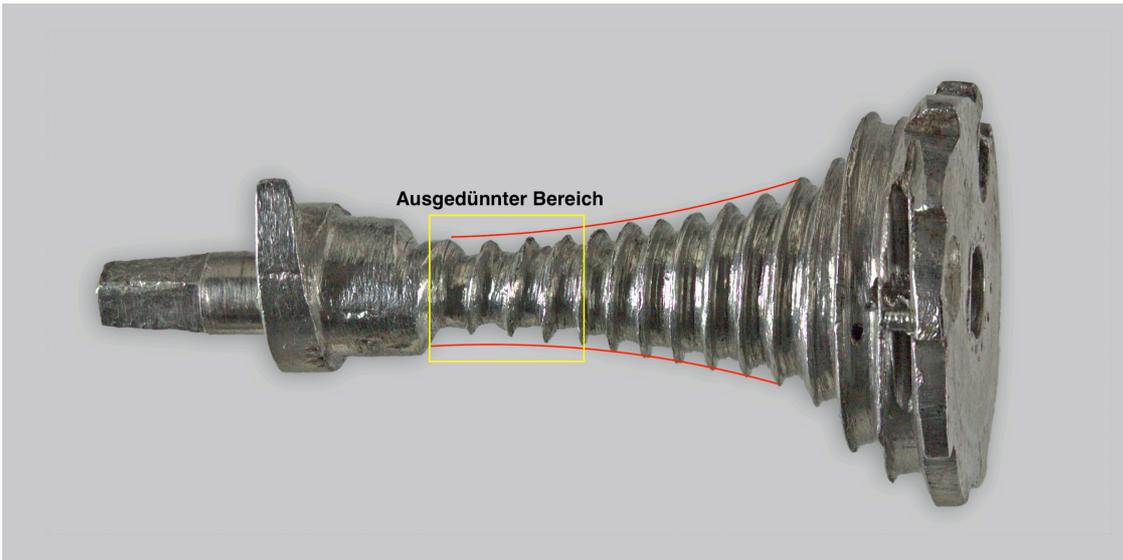
*Illustration: fusee with filed-down fusee windings*

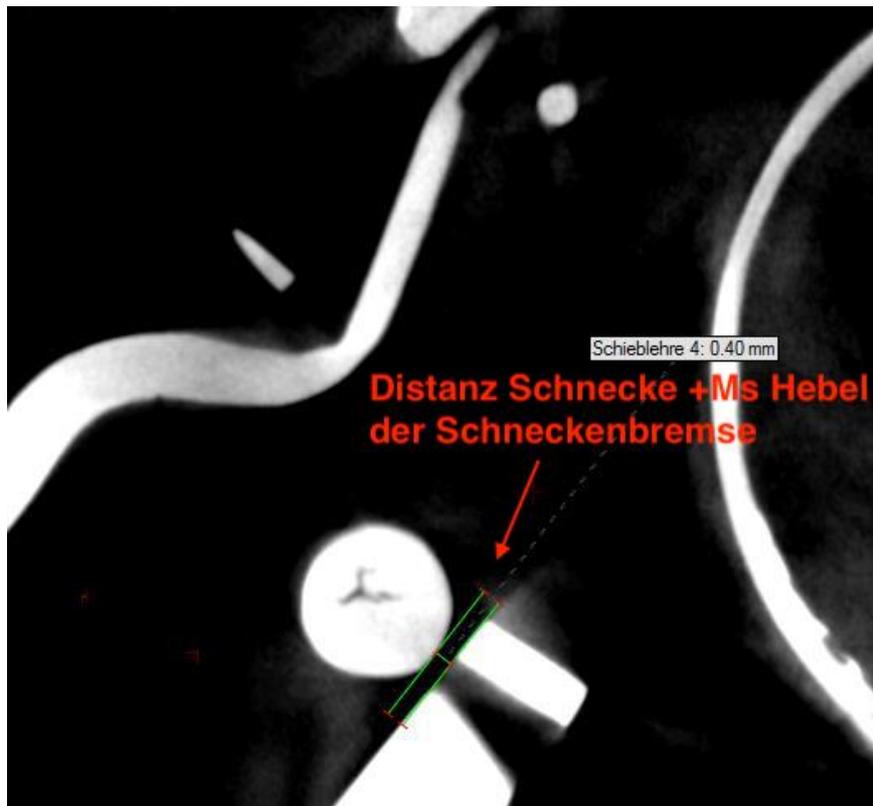
*Illustration CT: Distance between fusee and the lever of the fusee brake*

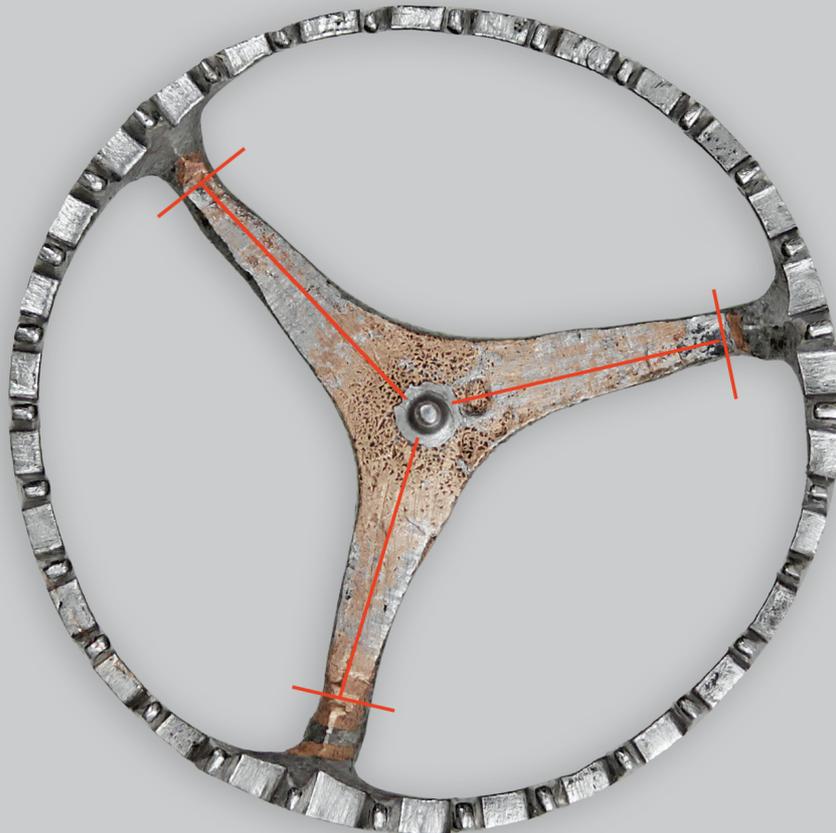
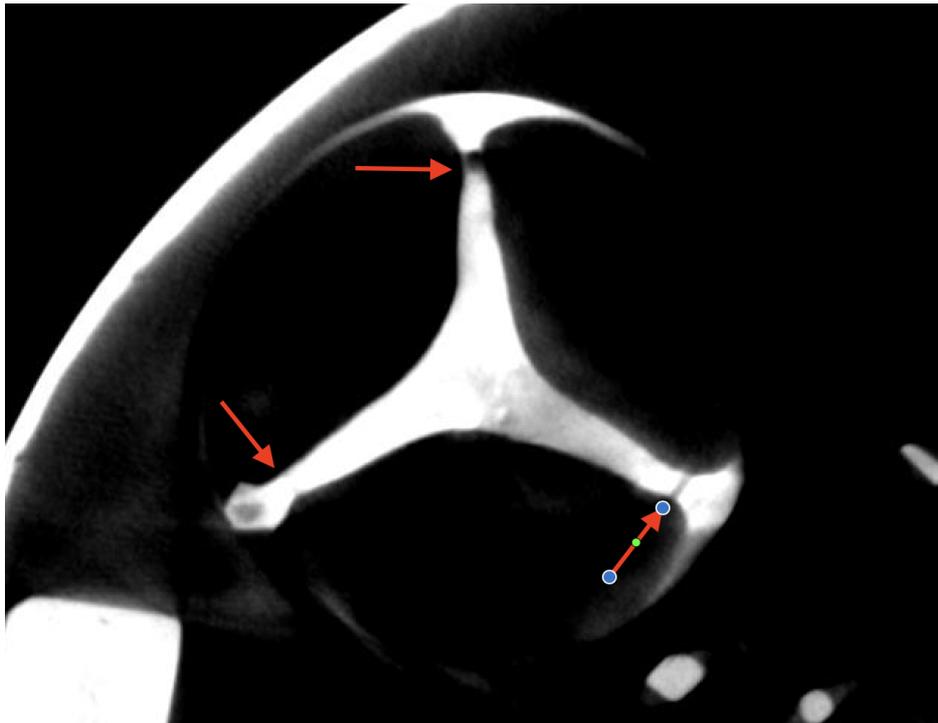
**Die Radspeichen, ursprünglich dreieckig,  
wurden abgeflacht.**

*Illustration CT: Modified wheel spokes on the crown wheel*  
 © Layout: Restoration studio Jürgen Ehrt  
 CT: Fraunhofer-Institut für Integrierte Schaltungen, Fürth

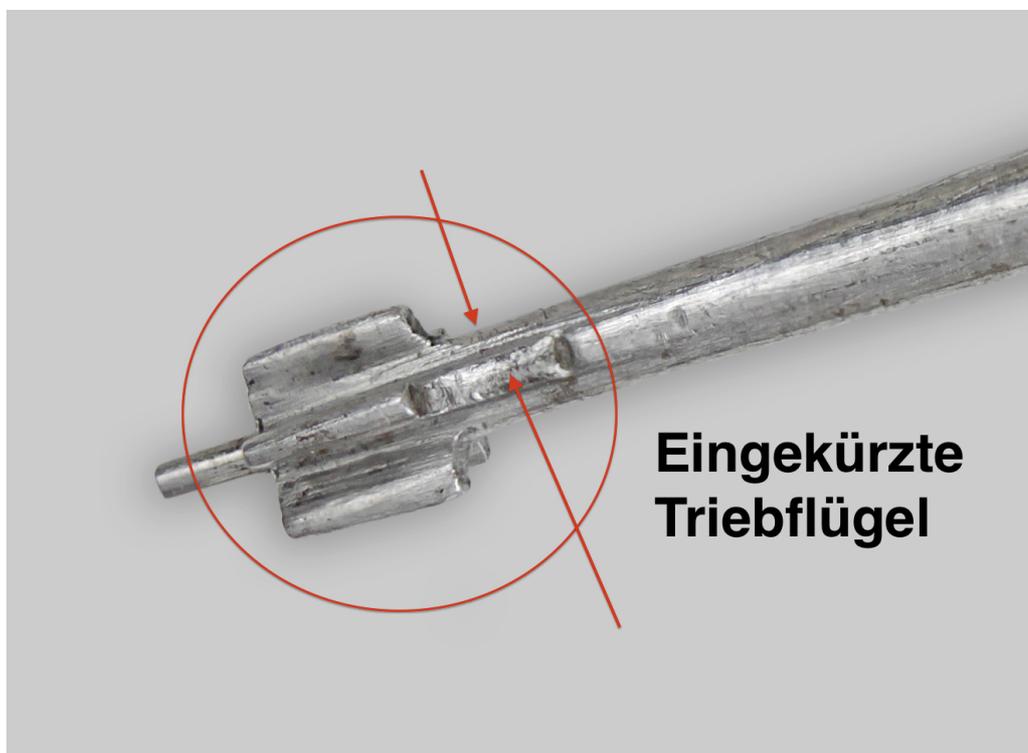
*Illustration: Shortened arbor on the crown wheel*

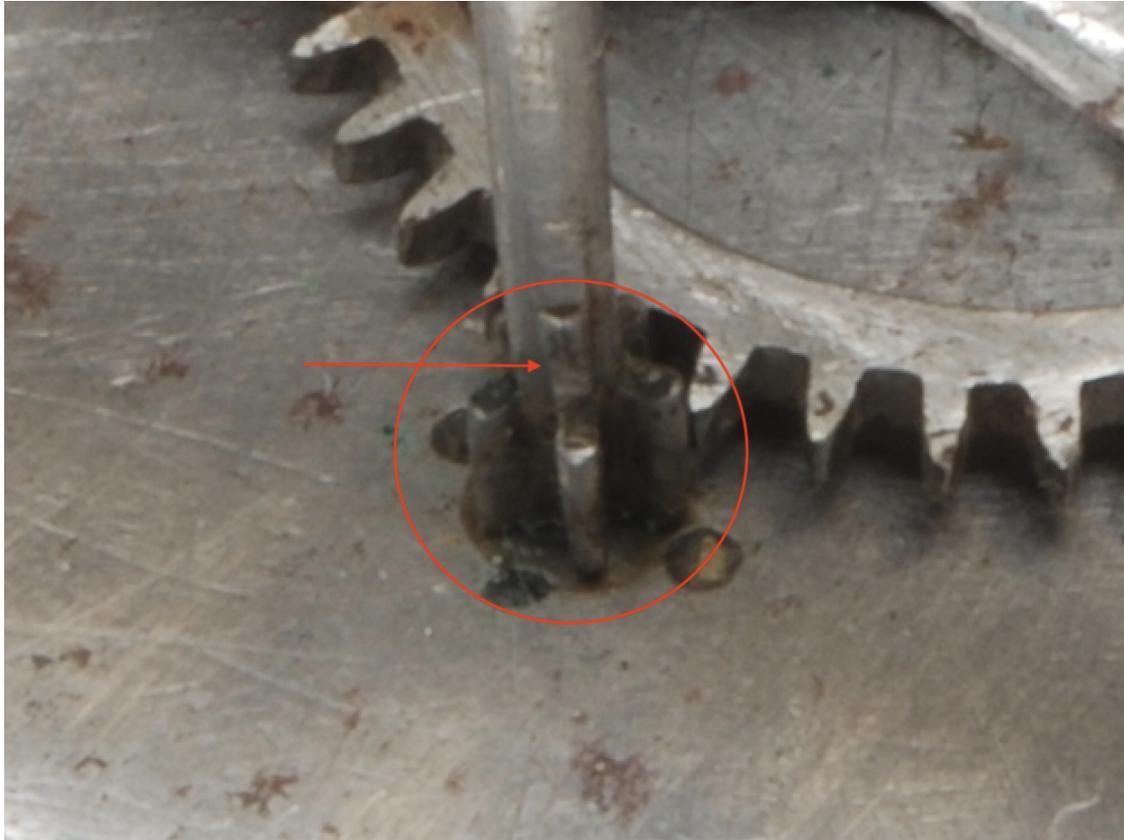
*Illustration: Modified drive on the crown wheel engaging with the intermediate wheel*

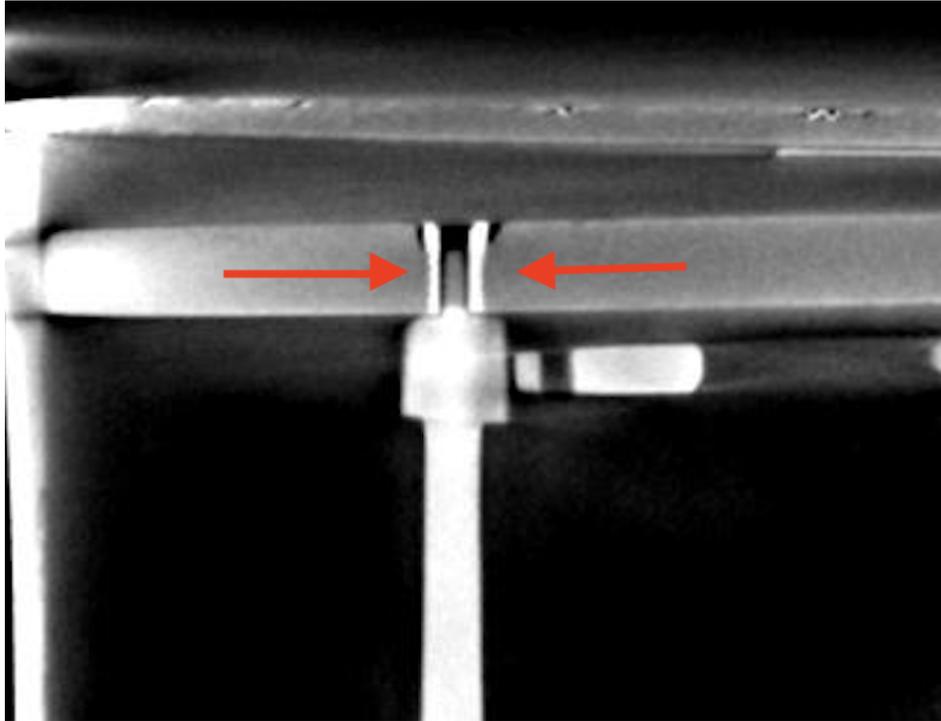
*Illustration CT: Screwed-in pinion bearing of the crown wheel*

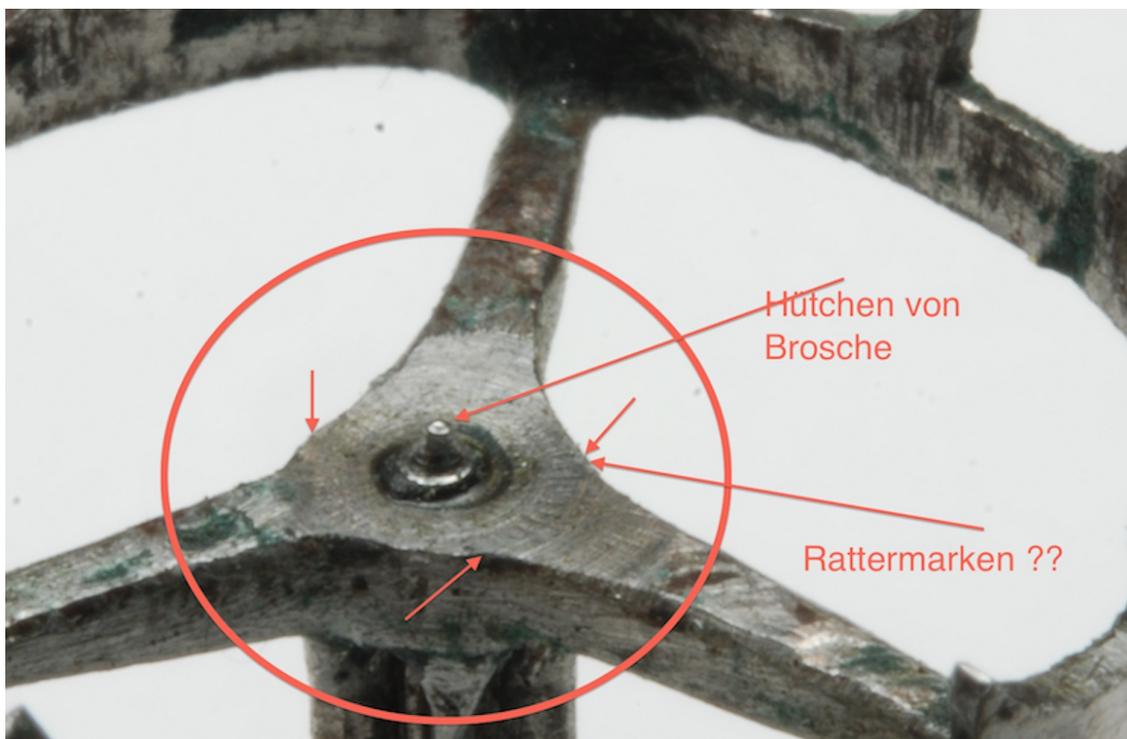
New pivots were inserted here as well, and a machine operation (lathe) - indicated by the ratchet marks - was performed to create clearance for the engaging pallet lever arm. The expected pivot shoulder from the original configuration is also missing here.

*Illustration: Supplementary pivot, pallet wheel.*

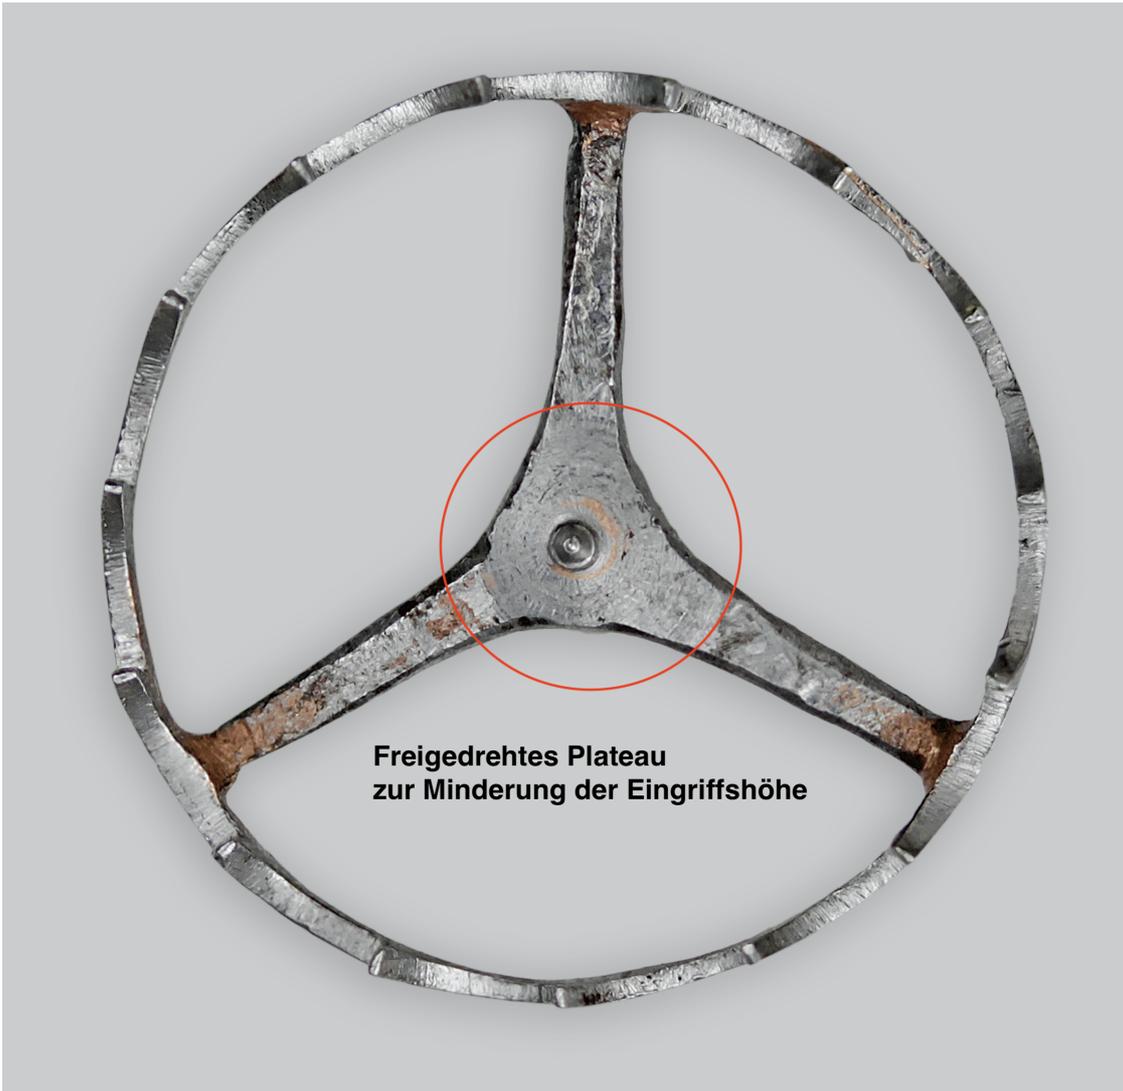
*Illustration: Supplementary pivot and machining marks on the pallet wheel.*

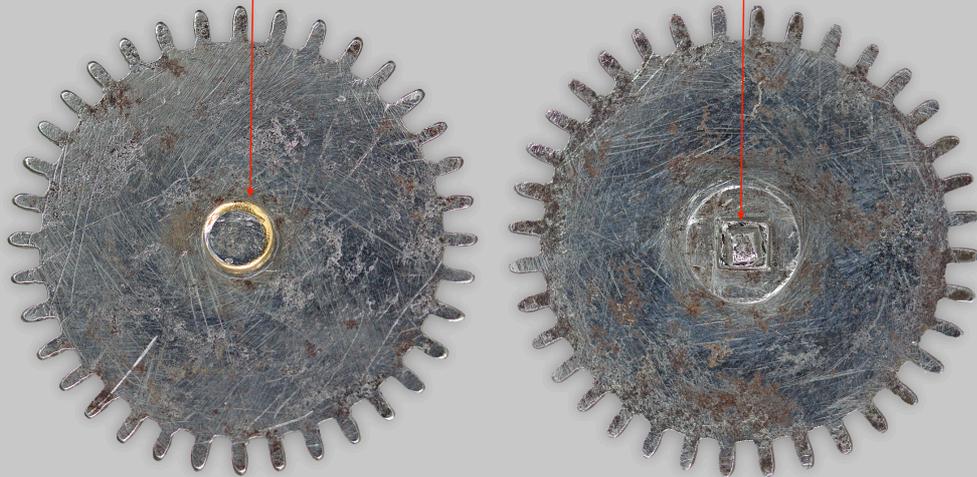
*Illustration: Modified hour wheel*

Mit Ms gefütterte Radachse

Auf das Maß des ergänzten  
Zeigers abgefeilter Vierkant

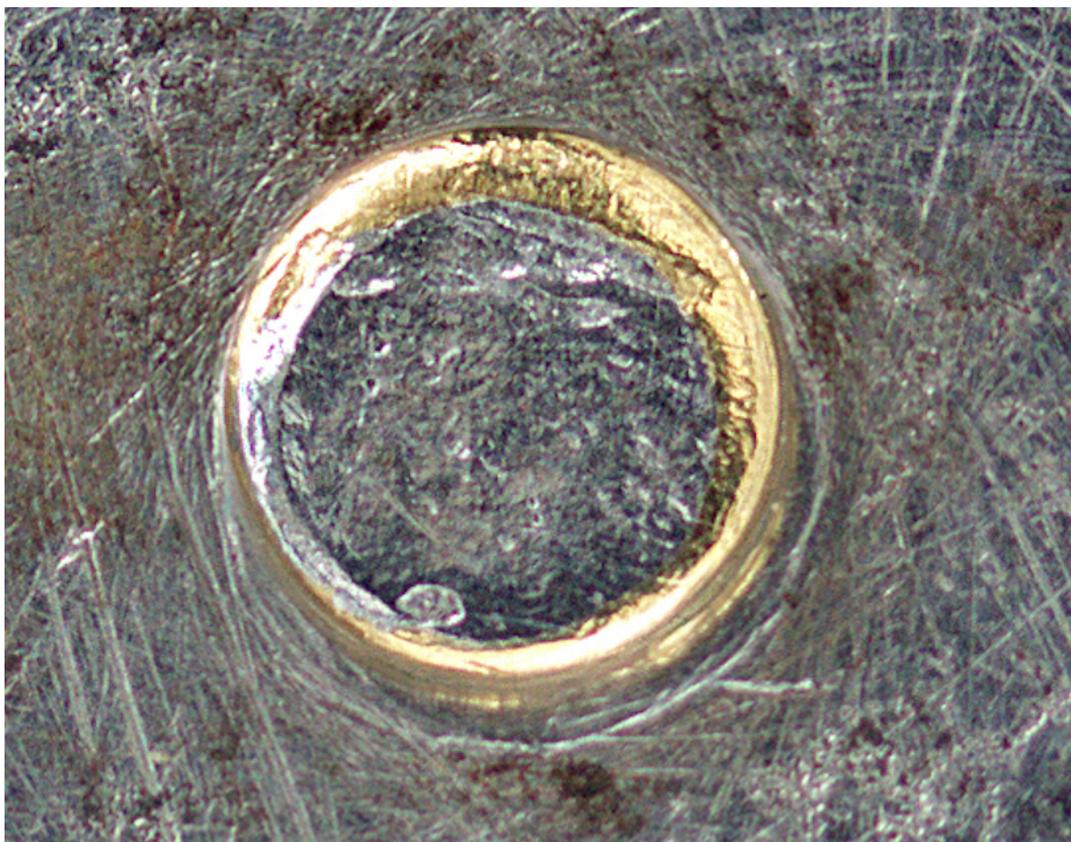
*Illustration: Lined wheel axle on the hour wheel*

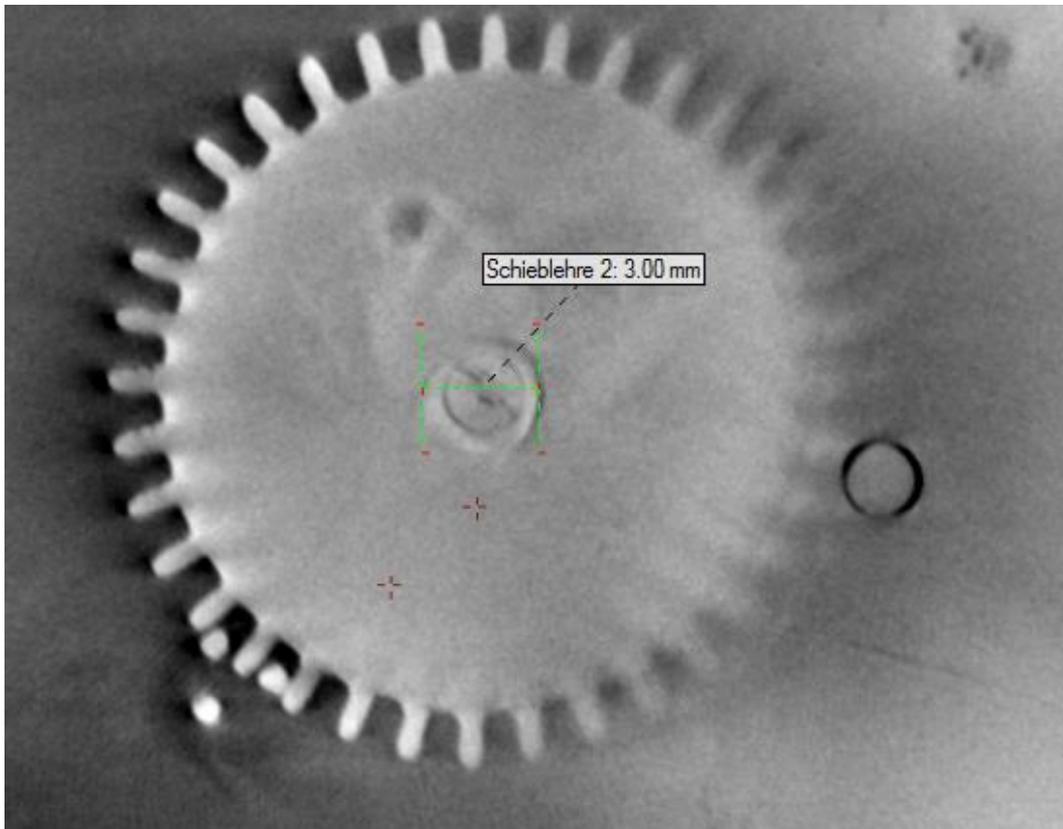
*Illustration CT: Lined wheel axle of the hour wheel - outer diameter*  
© Layout: Restoration studio Jürgen Ehrt  
CT: Fraunhofer-Institut für Integrierte Schaltungen, Fürth

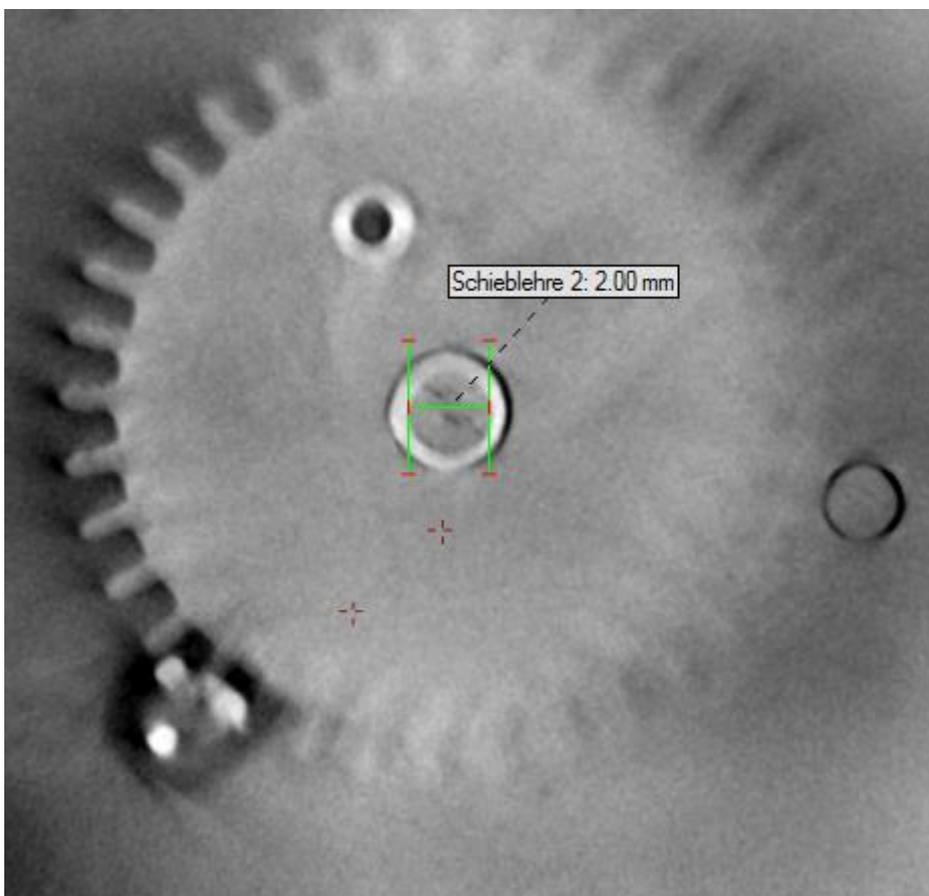
*Illustration CT: Lined wheel axle of the hour wheel - inner diameter*  
© Layout: Restoration studio Jürgen Ehrt  
CT: Fraunhofer-Institut für Integrierte Schaltungen, Fürth
