Real or Fake?

Examination and Analysis of a Clock Presenting Itself as a "Horizontal Table Clock from the 16th Century" with Astronomical Display

from Jürgen Ehrt

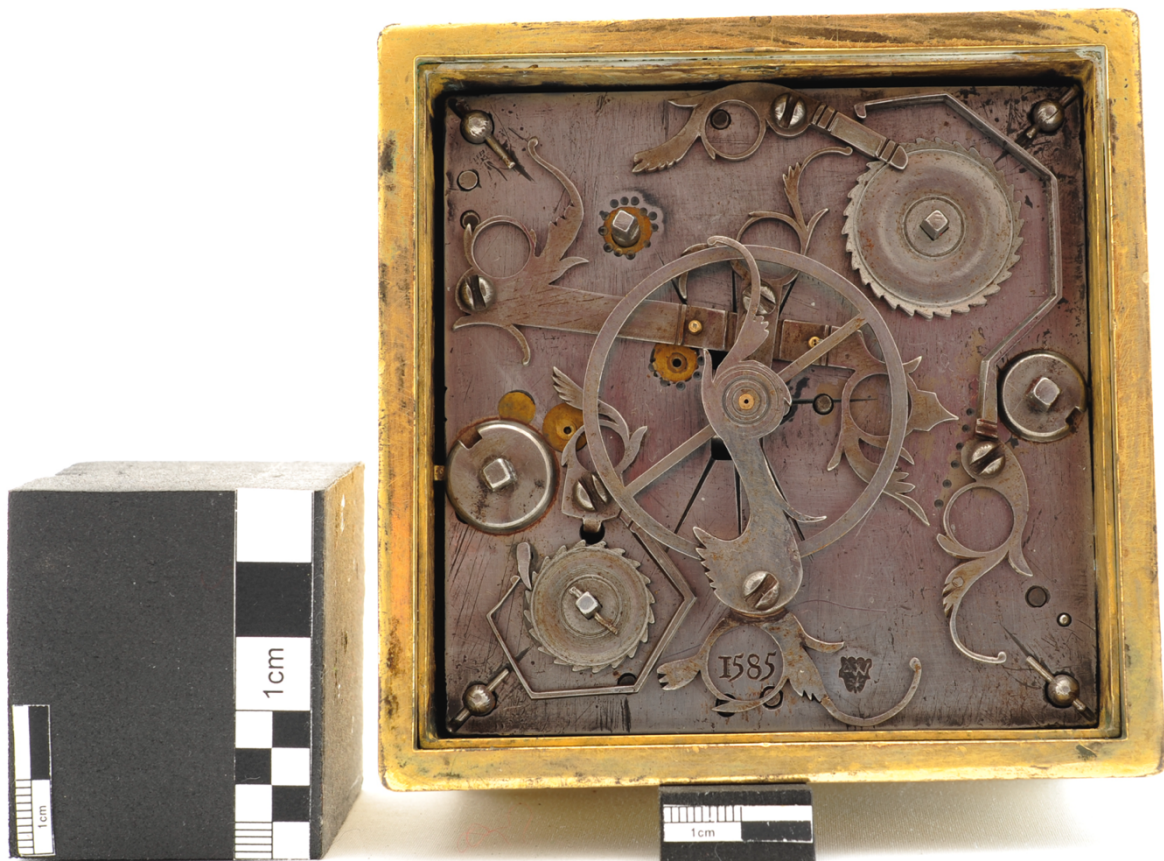
View into the opened watch case of the examined watch.

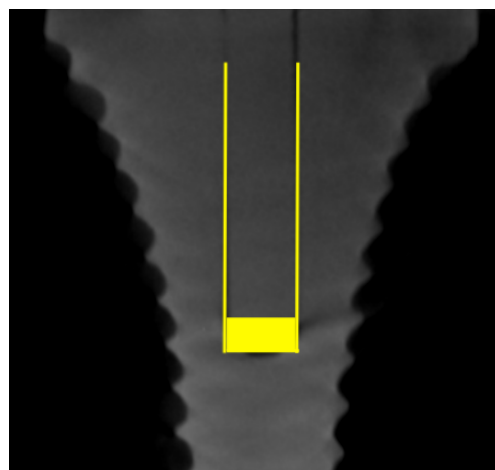
The central blind hole for the reception of the fusee wheel arbor was not suitable for it. Traceable marks of a subsequently inserted deep milling cutter with a flat milling head at the bottom of the blind hole indicate this later operation.

**The CT scan shows a different fusée as a comparison and demonstration model.
© Restaurierungsatelier Jürgen Ehrh**

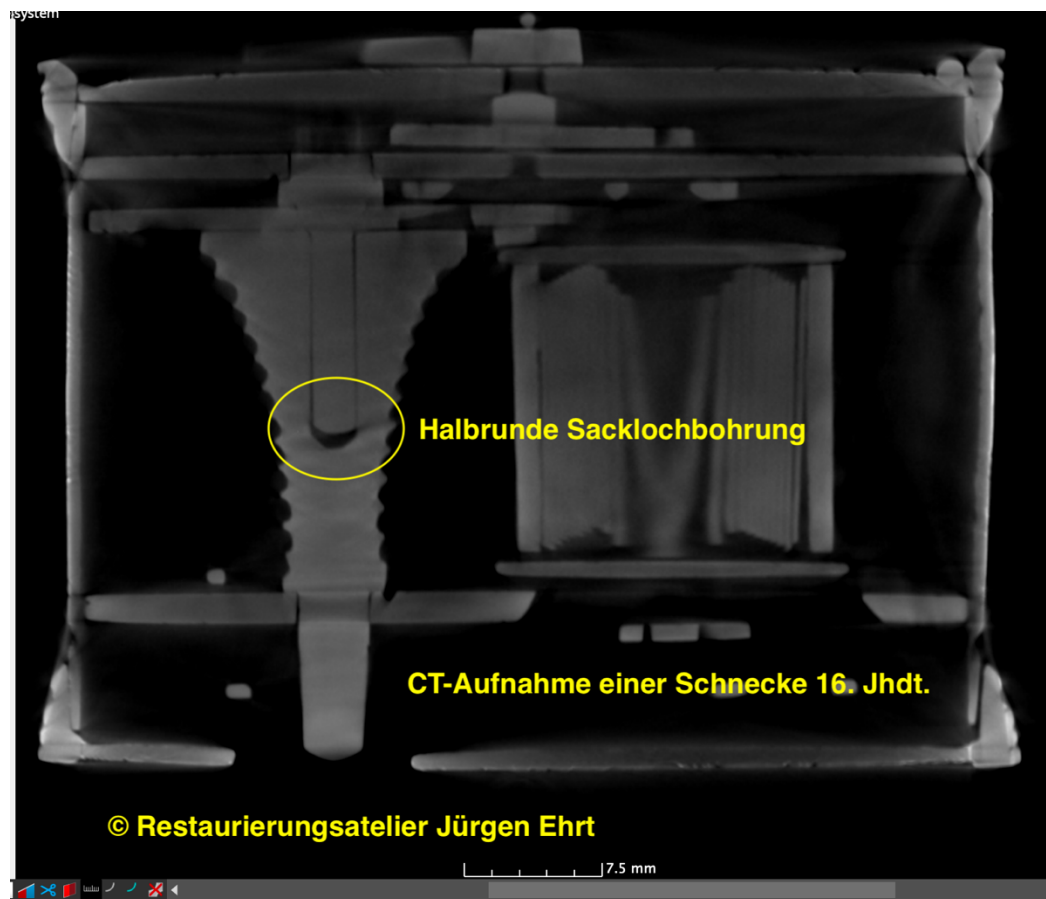
The blind holes of old and unmodified fusees have a semicircular finish. See the example in the following tomogram:

The CT scan shows a different fusée as a comparison and demonstration model.
© Restaurierungsatelier Jürgen Ehart

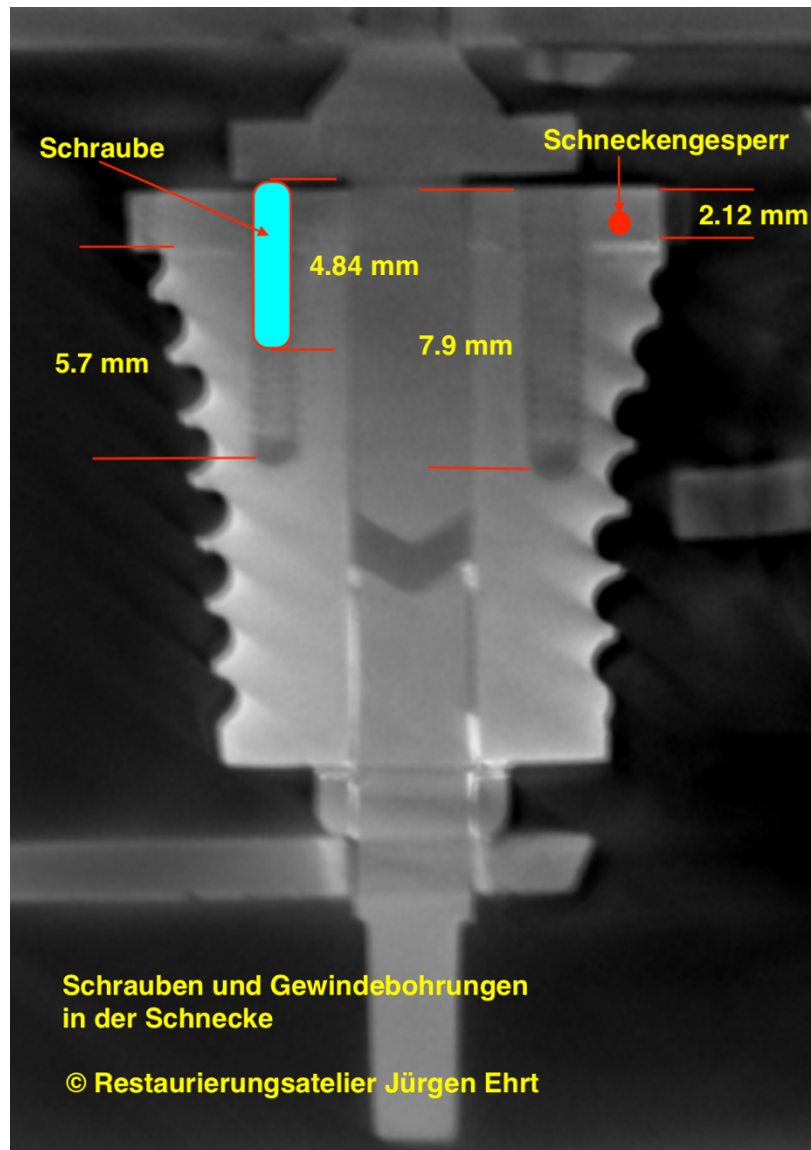
The CT scan shows a different fusee as a comparison and demonstration model.
 © Restaurierungsatelier Jürgen Ehrt

Perforated outer wall of the fusee.

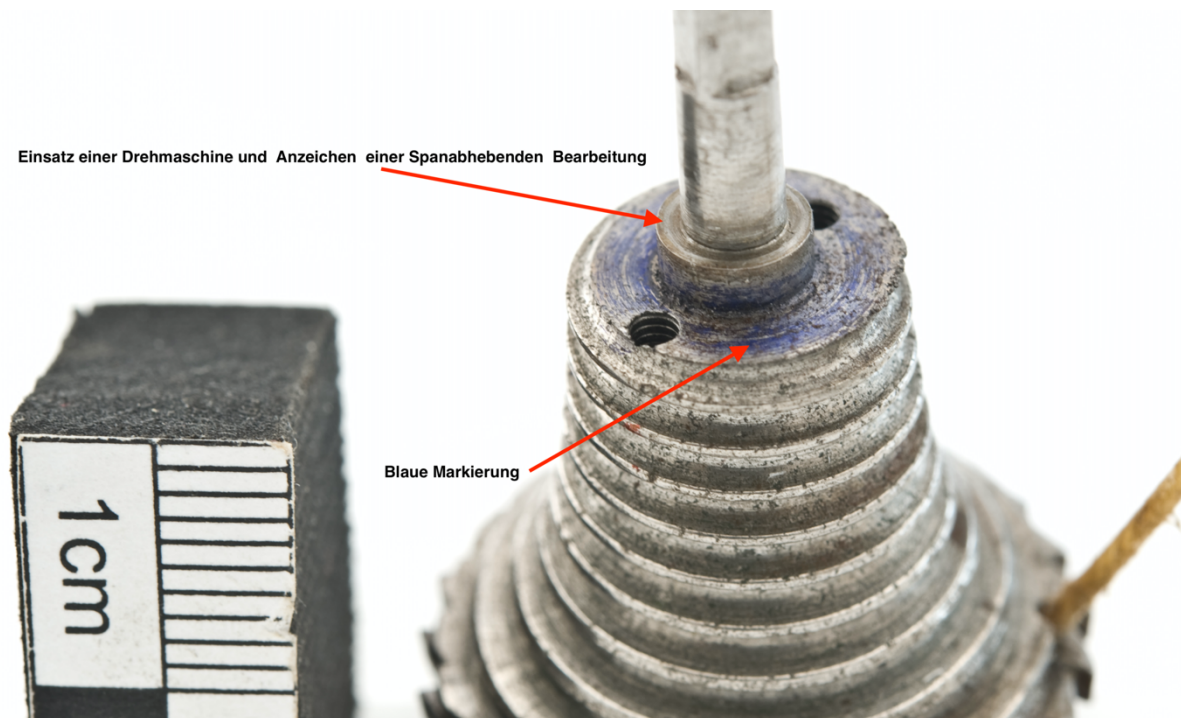
The disassembly of the fusee snout shows clear signs of being a new fabrication.

The assembly of the fusee snout onto the neck of the fusee involved modifications to the fusee neck. The worker used blue paint to mark their working dimensions. Since this marking was later covered by the attached fusee snout, the worker likely did not consider it necessary to remove their telltale traces.

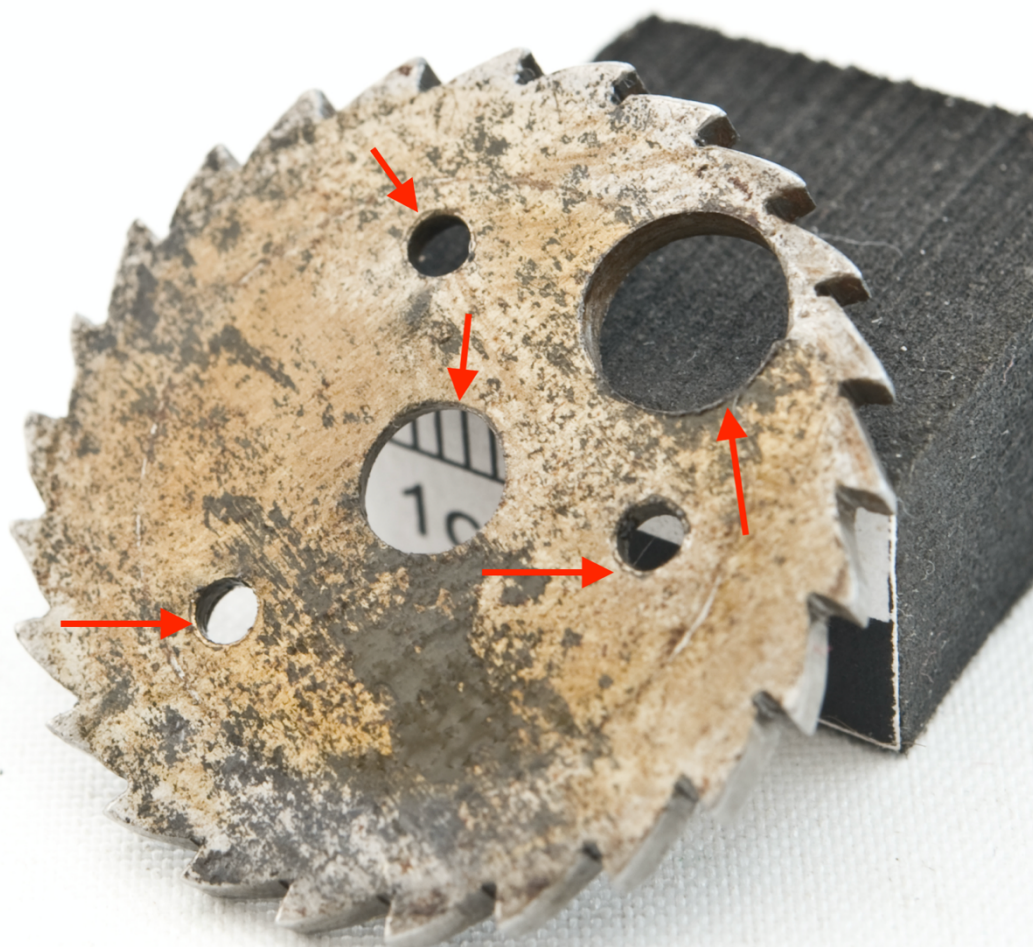
**Rückseite des aus Alteisen angefertigten
Schneckensperrrades mit Bohrungen und Kantenfräsung**

Back side of the fusée stop wheel made of old iron, featuring drill holes and edge milling.©
Restaurierungsatelier Jürgen Ehrt

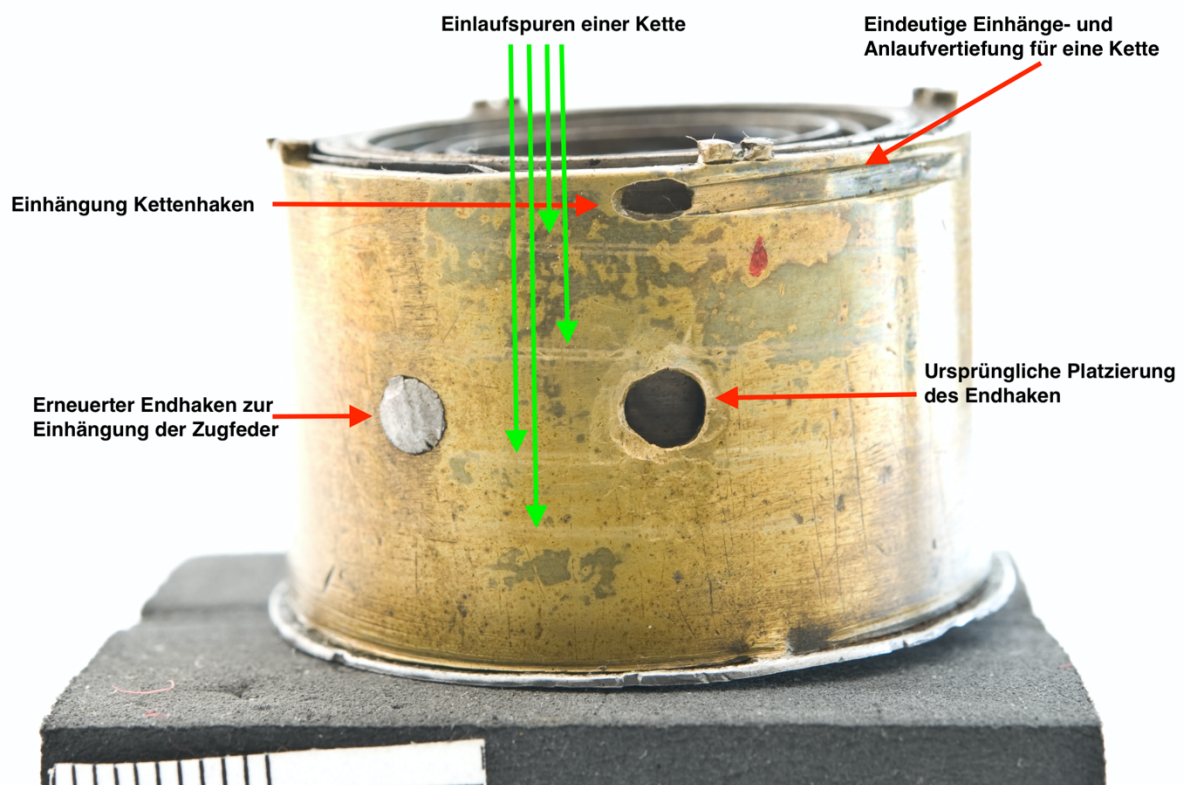
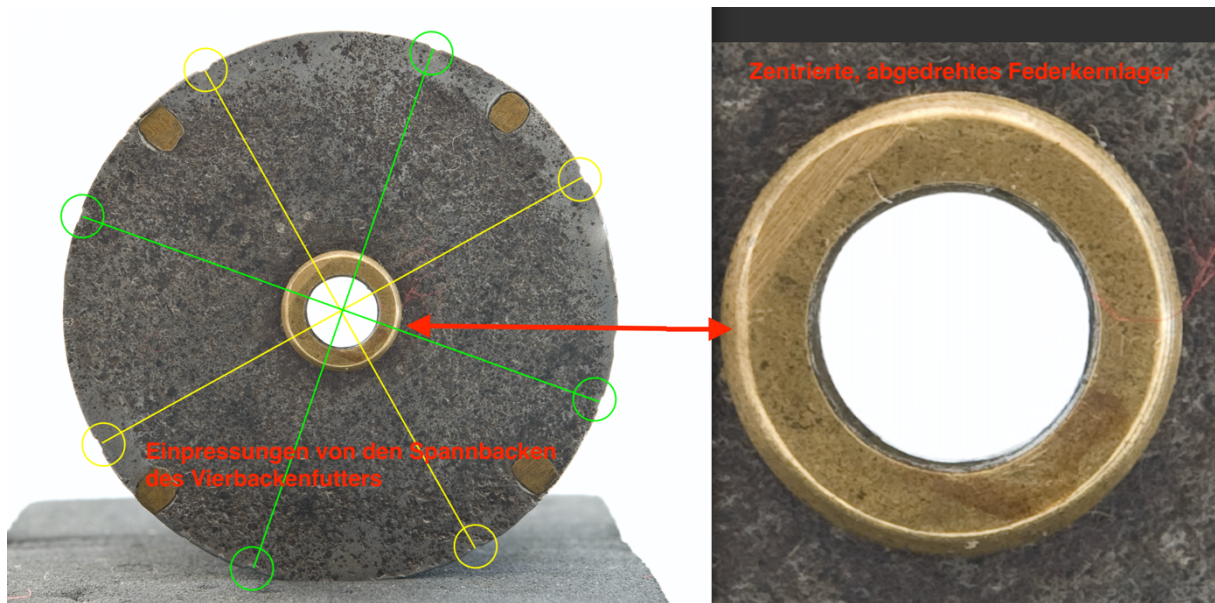
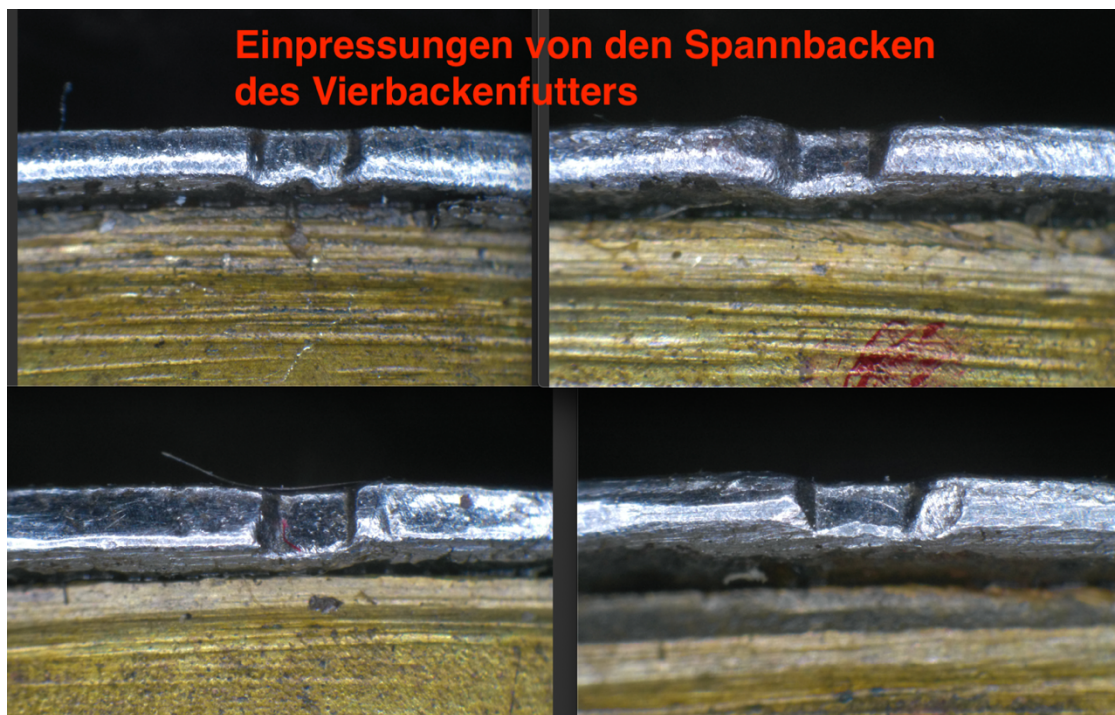
The mainspring barrel is a combination of brass and iron materials. The mainspring barrel was originally not operated with a gut string. The stereoscopic examination of the brass surface revealed that the mainspring barrel was previously used with a chain. This is further supported by the hook engagement on the barrel surface, which was designed for the locking of the chain hook.

Assuming that the fusee has an unchanged semi-circular running surface on its turns, as required for use with a gut string, it can already be postulated that the fusee and the mainspring barrel do not belong together for this reason.

It can be assumed that in order to fit the newly manufactured mainspring arbor (spring core), the mainspring barrel had to be modified at its cover openings. For this, the mainspring barrel was clamped into a four-jaw chuck (green), and after re-clamping, it was done a second time (yellow). The turning marks on the brass bearing are clearly visible on the outer edge and in the bore.

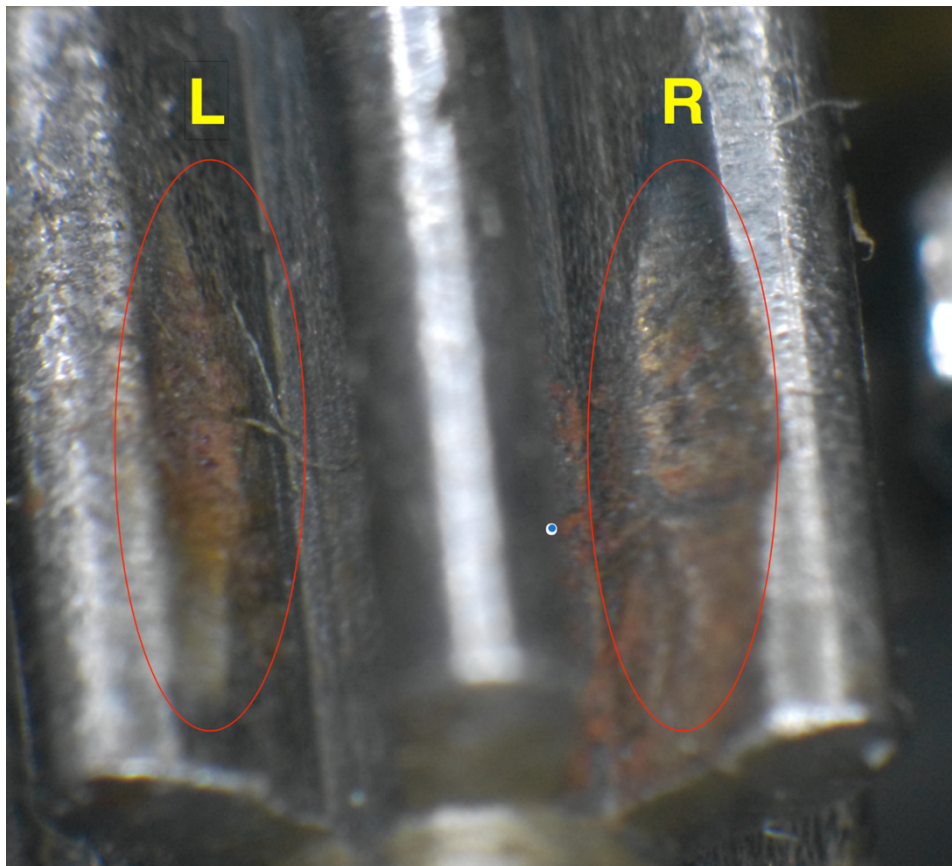
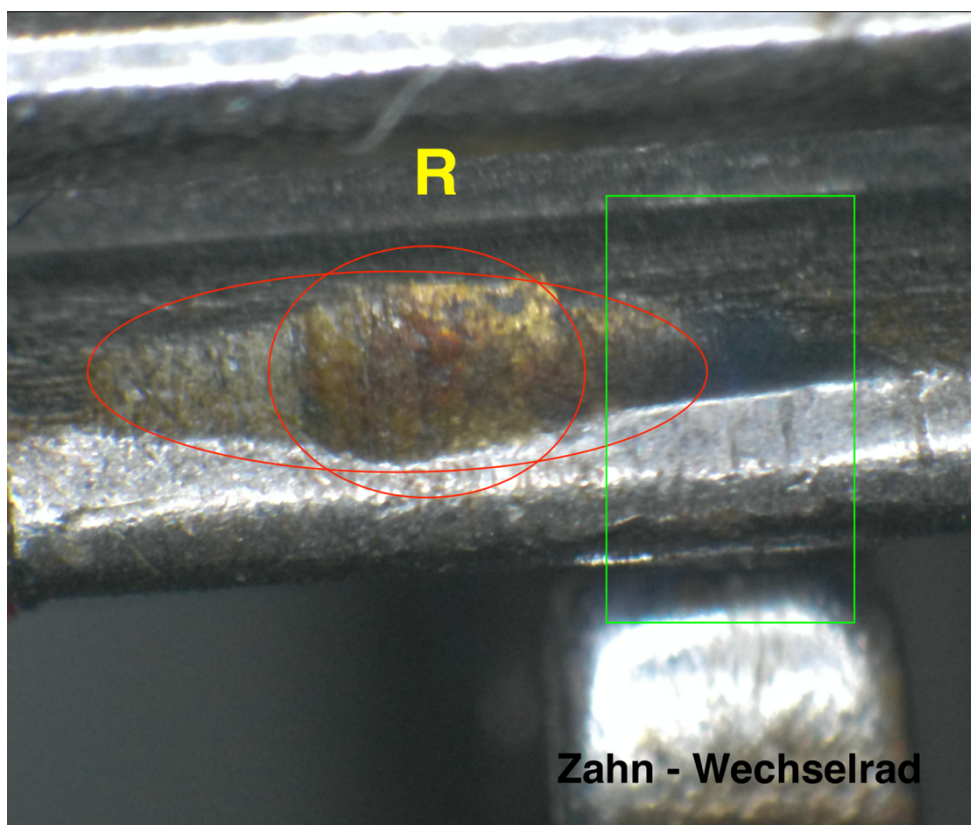
Mikroskopie 02 und 03

This drive shaft was previously operated in the opposite direction (**L**). However, for use in this clock, the reverse direction was required, so the previously unused drive flank (**R**) had to be worn in. To achieve this, material was milled off the unused flank using a milling cutter, in an attempt to simulate a worn drive flank.

A clear indication of the incompatibility of the drive engagement can be seen in **Microscopy 03**. Here, the tooth engagement of the escapewheel is outside the simulated wear marks.

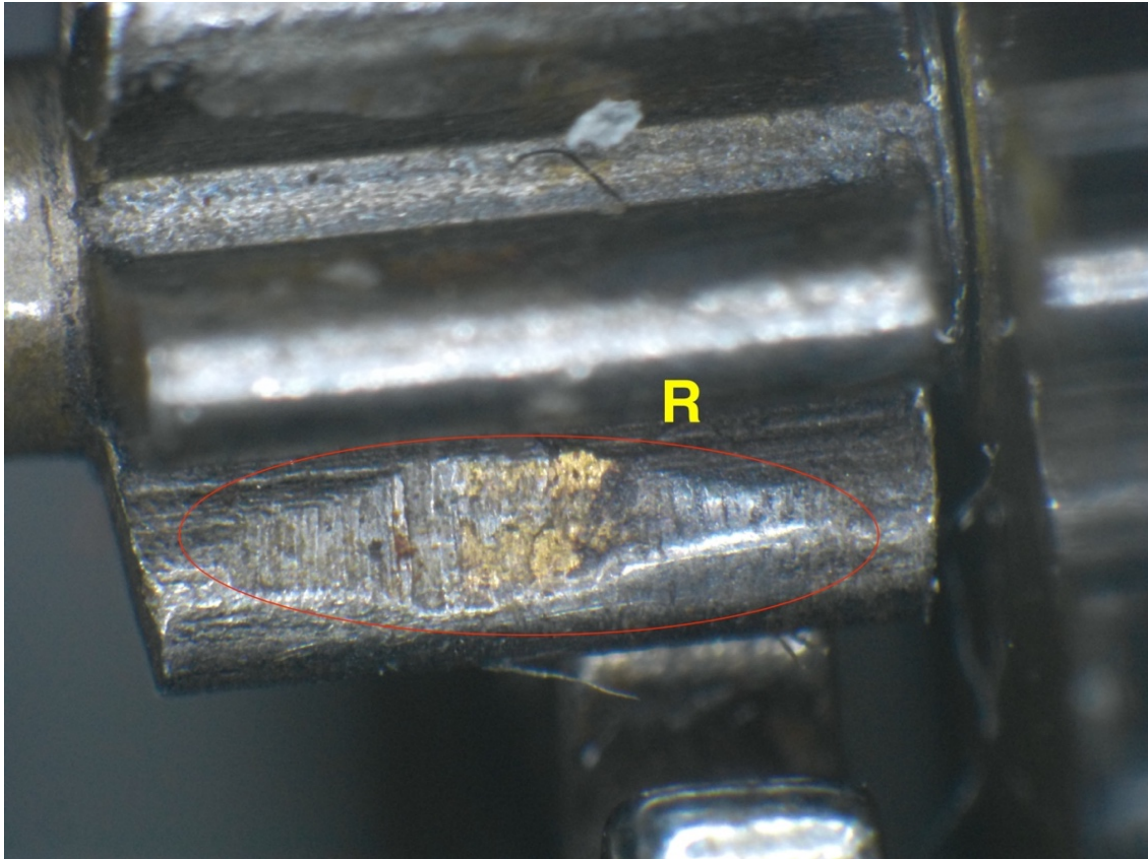
Mikroskopie 04

Tooth profile on the crown wheel

The tooth profile of the crown wheel also shows no usage-related traces on the tooth flanks and cycloids.

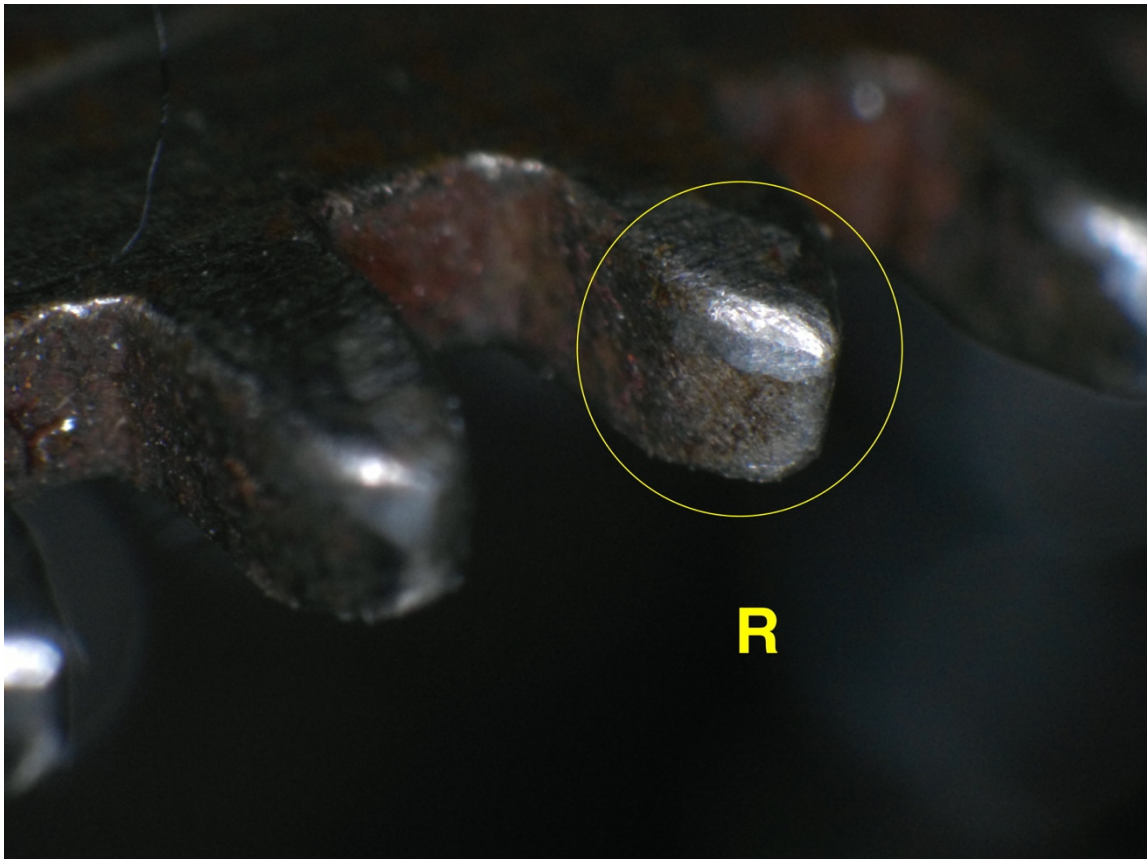
The tooth root of the crown wheel shows the typical pattern of machine-assisted milling. Here, one would expect to see filing marks, as the manufacturer attempts to suggest at other places in the movement.

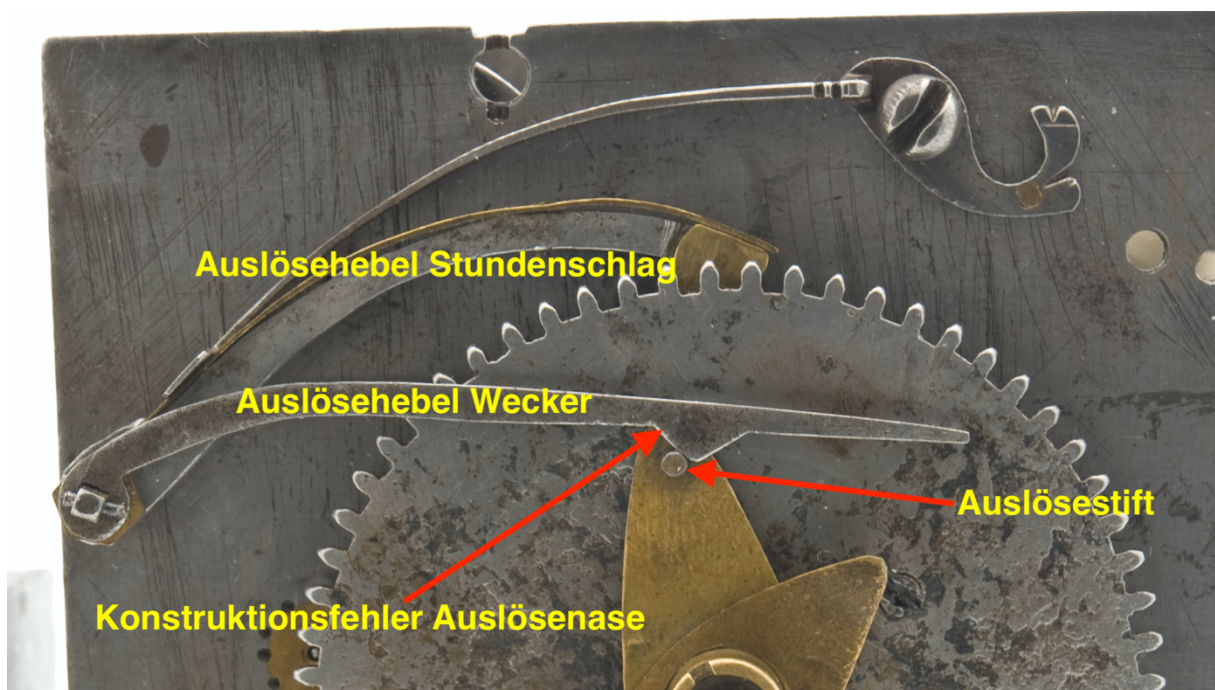
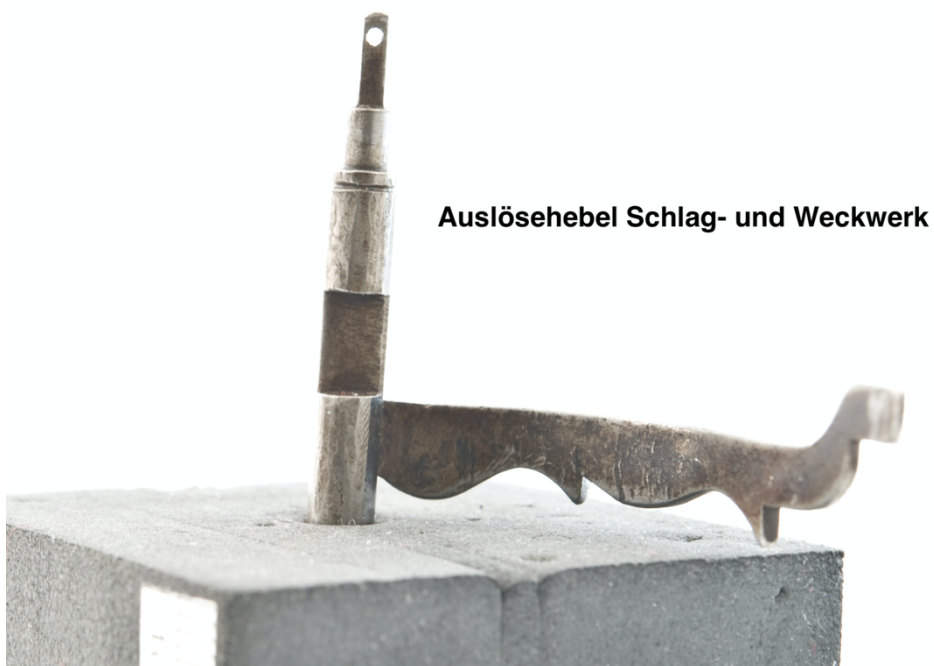
Hemmrad Schlag- und Weckwerk

A lug soldered to the escape wheel (see photo) is intended to keep the escape wheel free until the complete winding down of the alarm spring when the trigger lever is lifted to a certain height. The wear marks on the driving wheels show artificially introduced traces and, additionally, on the non-engaging side, old identical wear marks, which, however, do not correspond to any engagement in this movement. This evidence proves that the shaft is an old, reworked shaft from another clock with an inverted running direction.

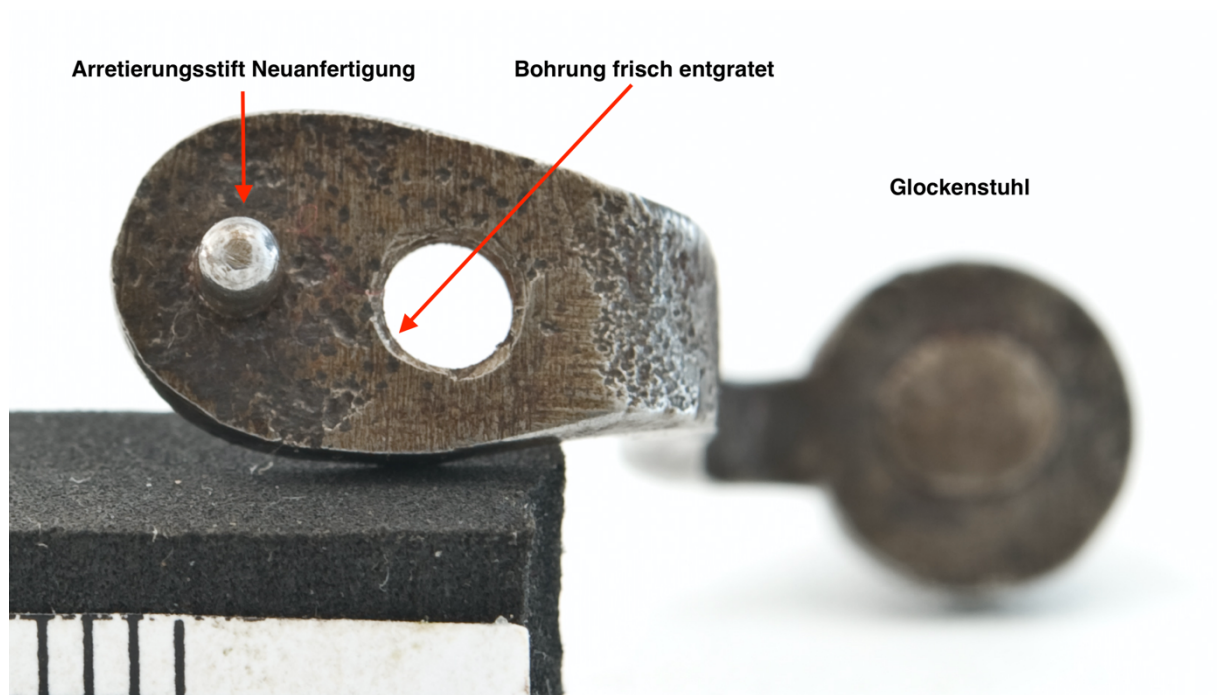
The use of modern machine technology cannot be concealed in this component either. For example, ratchet marks, created by the cutting tool of a high-speed lathe, are visible on the bottom surface. As with the previously described anomalies, we also find the absence of coherent corrosion transitions in the direct adaptation of components here.

**Fehlende Korrosionsspuren
den Stirnflächen des Federhauses**

Rattermarken

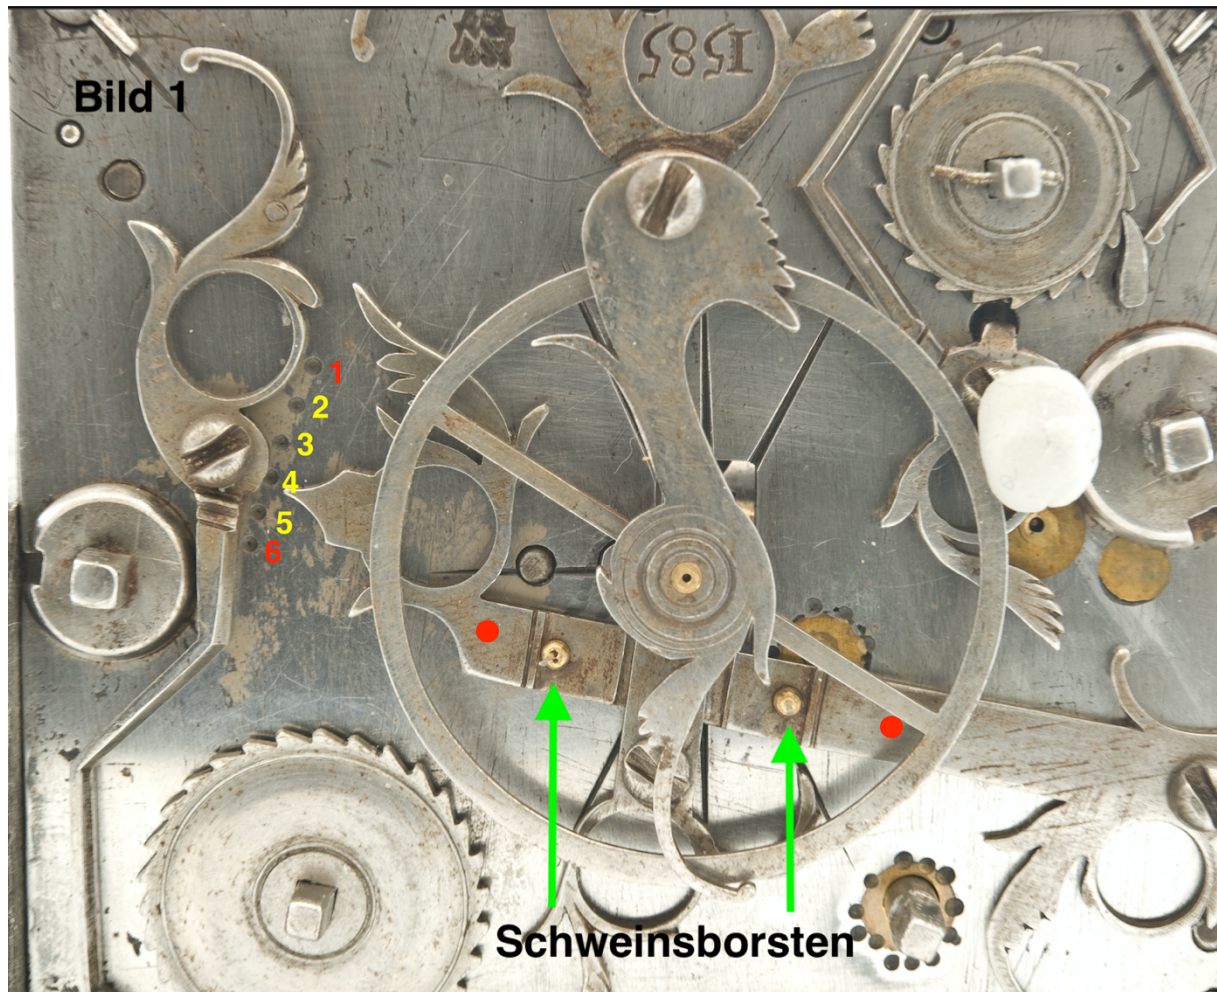
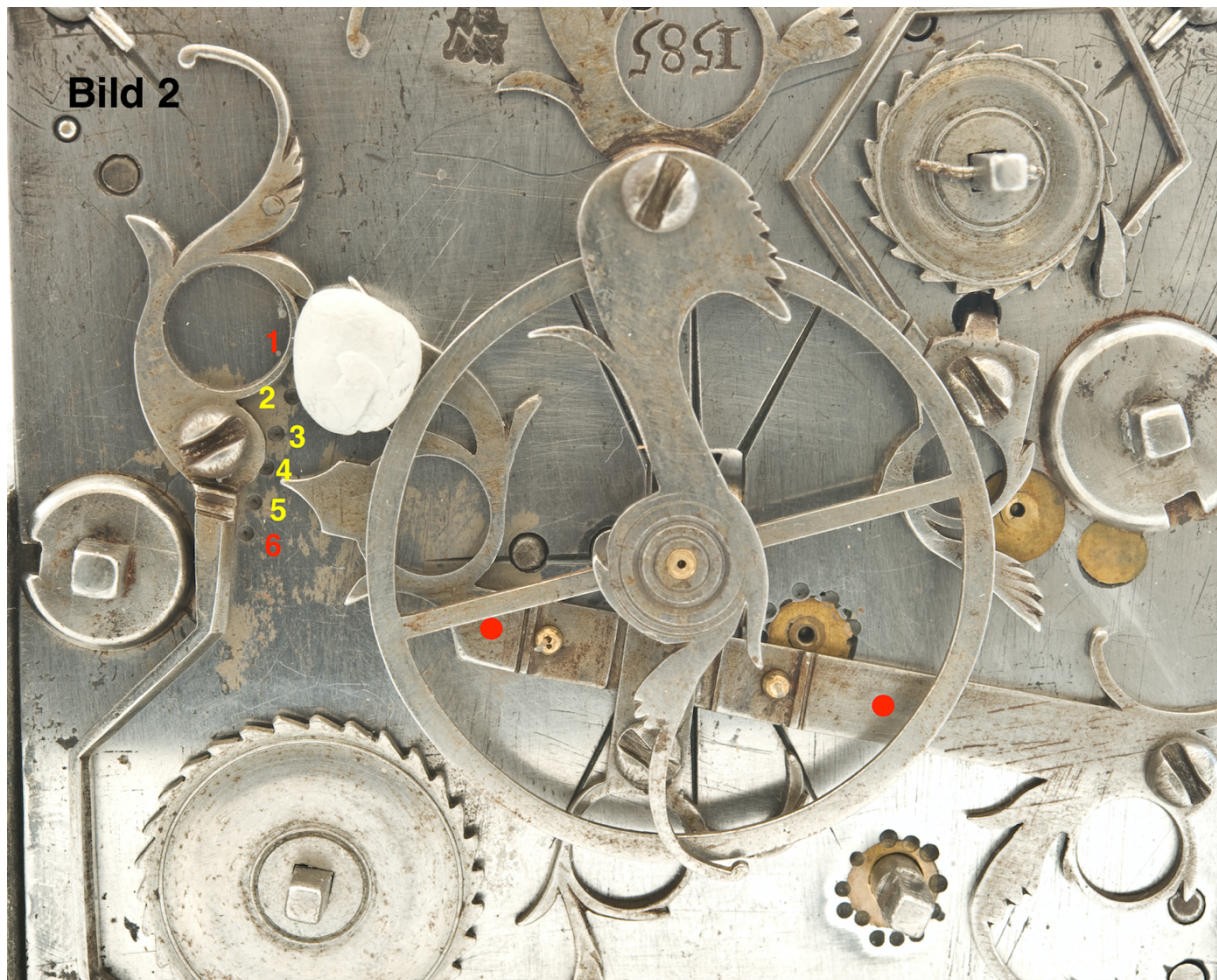
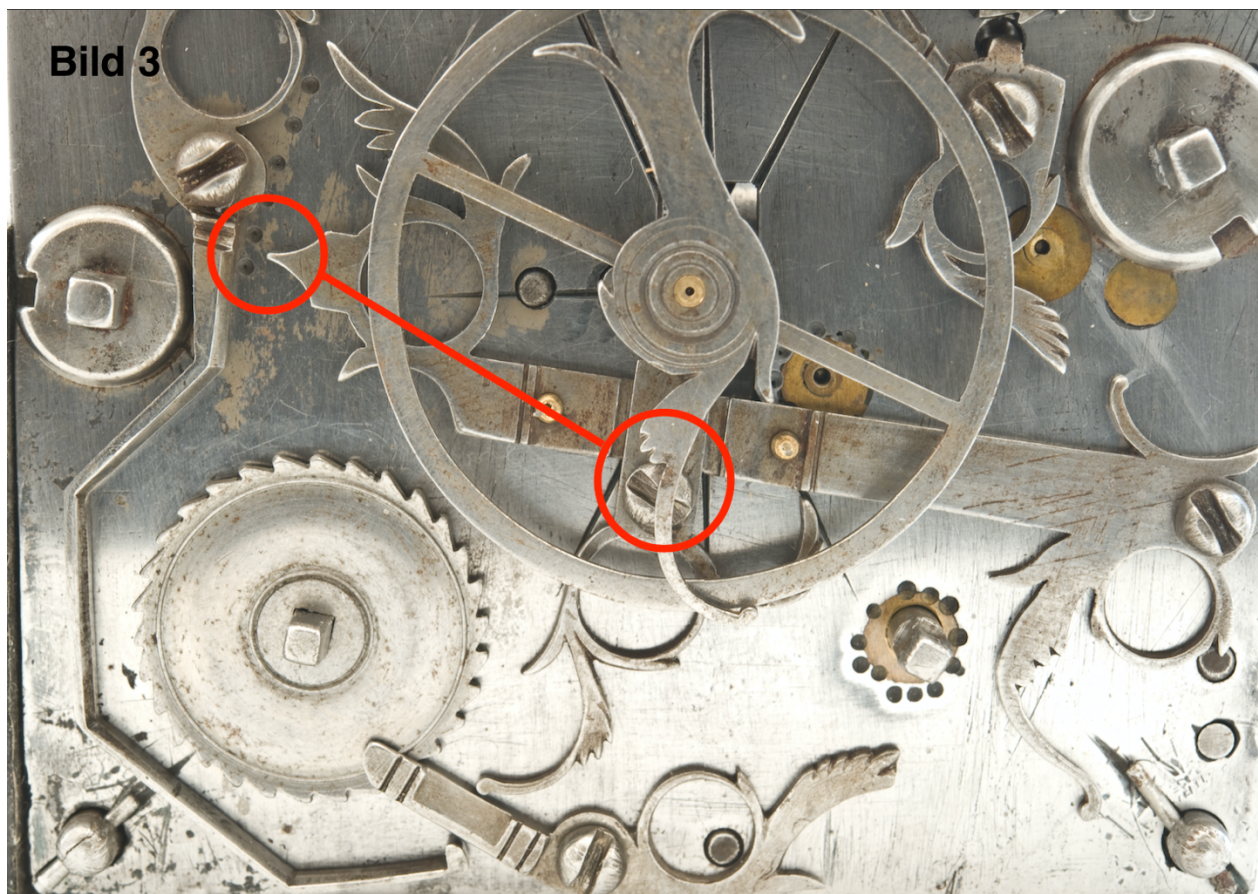
Amplitude limitation of the verge
So-called pig's bristle regulation

The oscillating verge receives a trigger pulse through the lifting of the verge pallets, which is transmitted via the verge wheel. The amplitude of the verge is limited by two opposing pig's bristles. See the green marking, which is inserted into the movable regulation arm, riveted to the plate (in this clock, plastic threads are used instead of pig's bristles).

The pig's bristles, marked with green arrows, are positioned absolutely incorrectly and are non-functional as amplitude limiters.

It is noteworthy that the red-marked regulation points 1 and 6 are irrelevant. At position 1, the opening angle is so narrowly positioned that the verge only reaches a brief tremor. Meanwhile, regulation point 6 cannot even be reached by the regulation slider with the bristles on it. The regulator lever already hits the screw that locks the guide arm of the regulator lever shortly after leaving point 5. (See red circle marking on image 3).

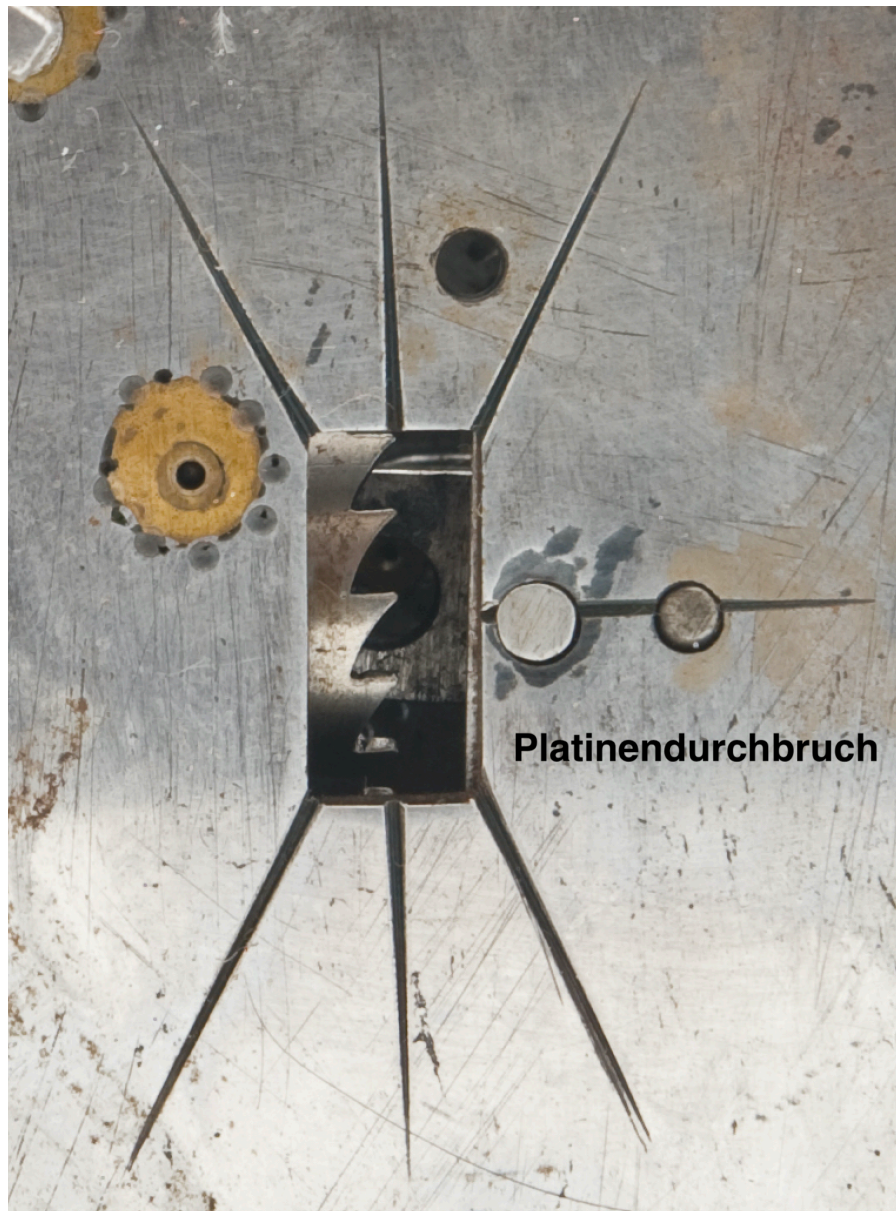
In the stereoscopic analysis, it can be proven that the hole for the verge in the upper plate was machine milled.

This evidence alone disqualifies the upper plate under investigation for this timepiece. This implies that the signature "**1585**" and the punch with the ligature **AW** on the plate cannot be original.
