Real or Fake?

Examination and Analysis of a Clock Presenting Itself as a "Horizontal Table Clock from the 16th Century" with Astronomical Display

from Jürgen Ehrt

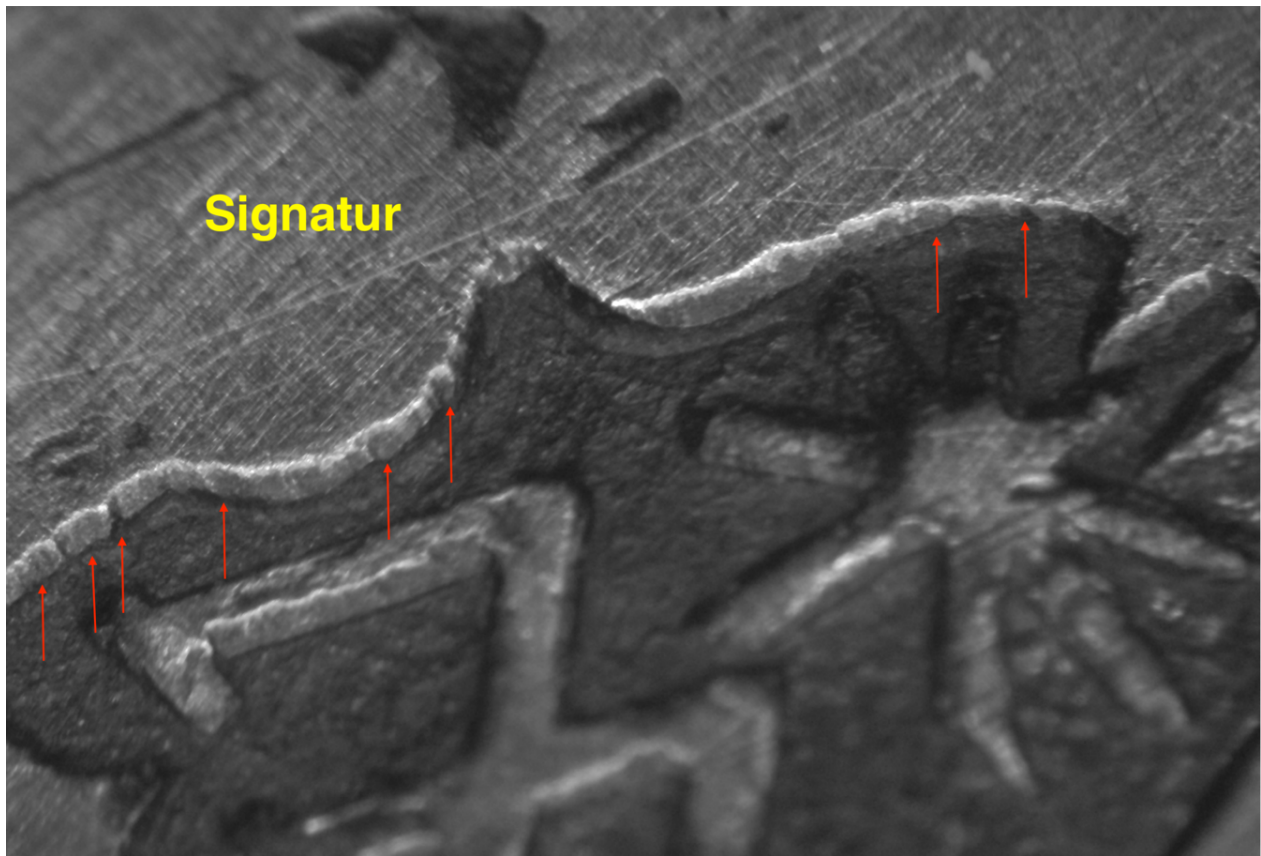
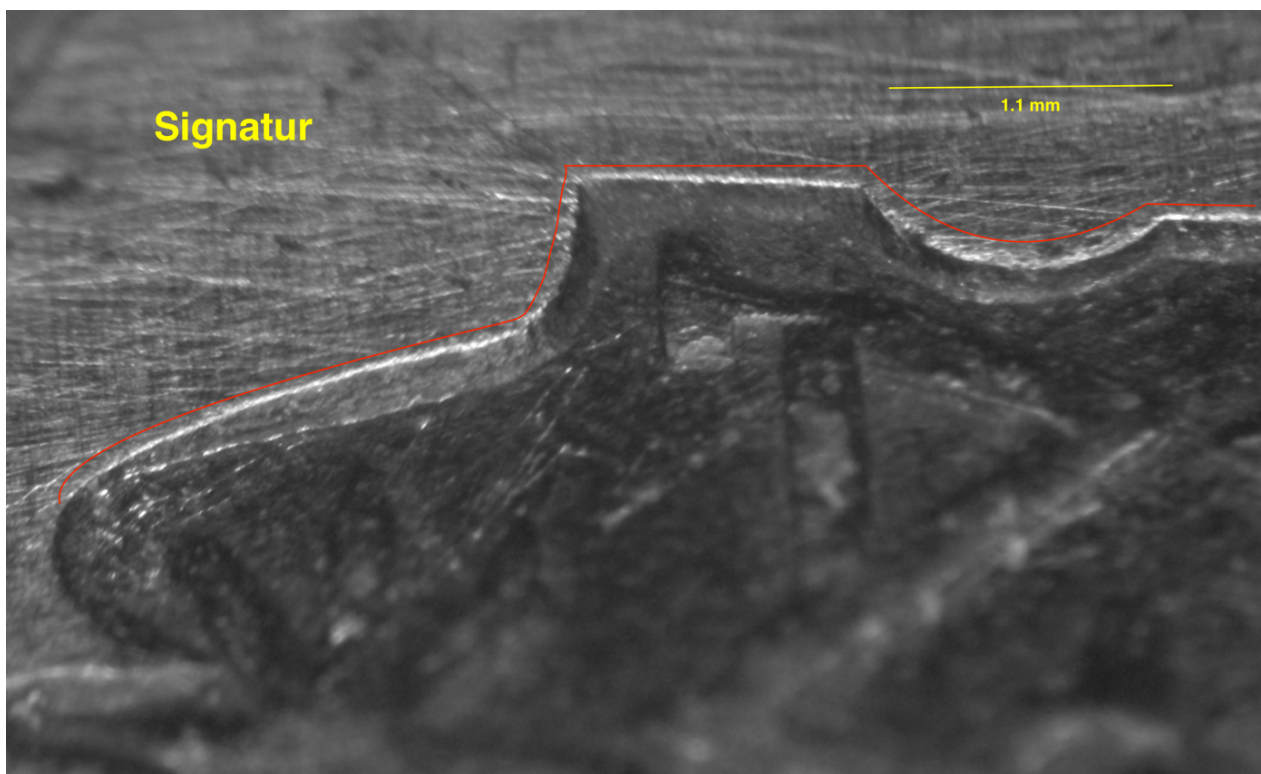
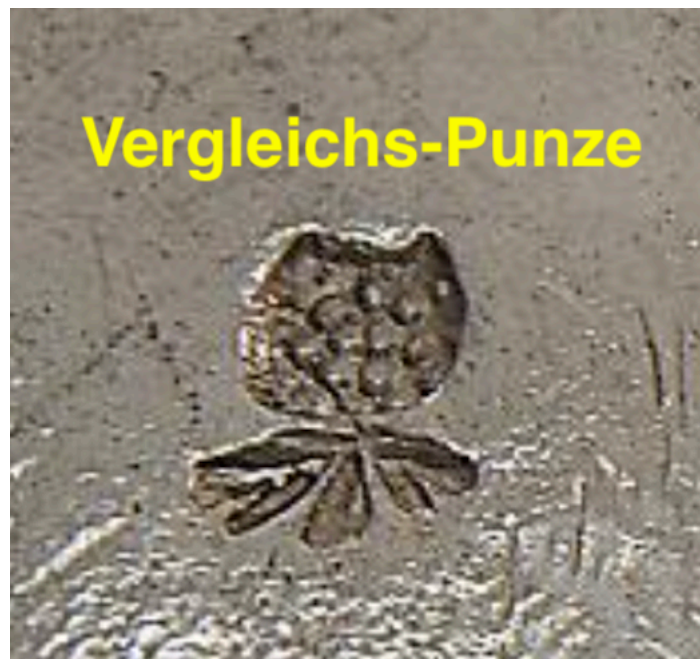
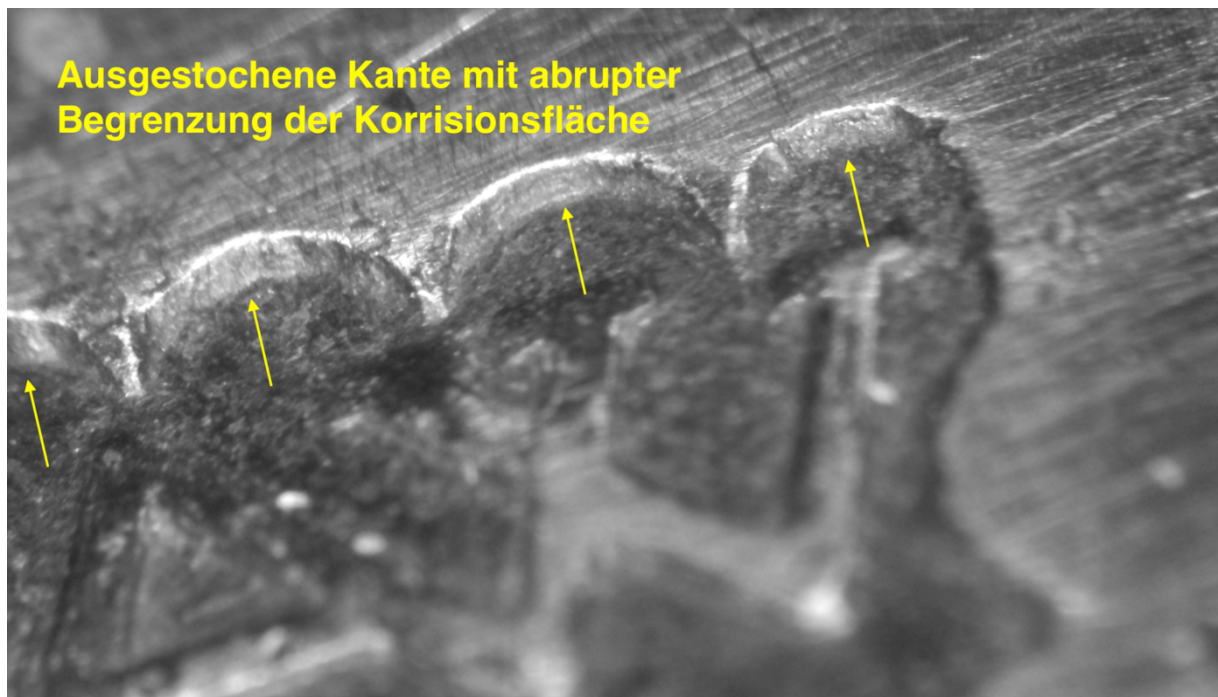
The corrosion covering the base of the signature forms a closed pattern, which would not be expected. The etched edges of the signature in the indentation are free of corrosion, as seen in the red arrows and the red edge. This is not possible, as homogeneous corrosion would not remain on the edges. Moreover, this corrosion extends over the edges of the ligature AW and the star, covering them as well as the surface. The yellow markings point to processing marks that were applied in the form of engraving strokes before the corrosion developed.

Conclusion: The corrosion was produced after the entire forged punch was stamped, by applying an etching medium. The edges of the coat of arms, the ligature, and the star were re-engraved, making a definitive identification of the punch's origin impossible. On one hand, the punch could have been made with a laser or micro-engraving computer, while on the other, a hand engraving is also a possibility. The seamless post-applied corrosion has made the work traces harder to read. However, the uniformity of the punches in the previously discovered watches suggests that they were likely produced with a computer-controlled laser or diamond cutter engraving, which was later touched up with a burin.

The manually engraved year "1585" on the plate has also been treated with an etching medium to simulate old corrosion.

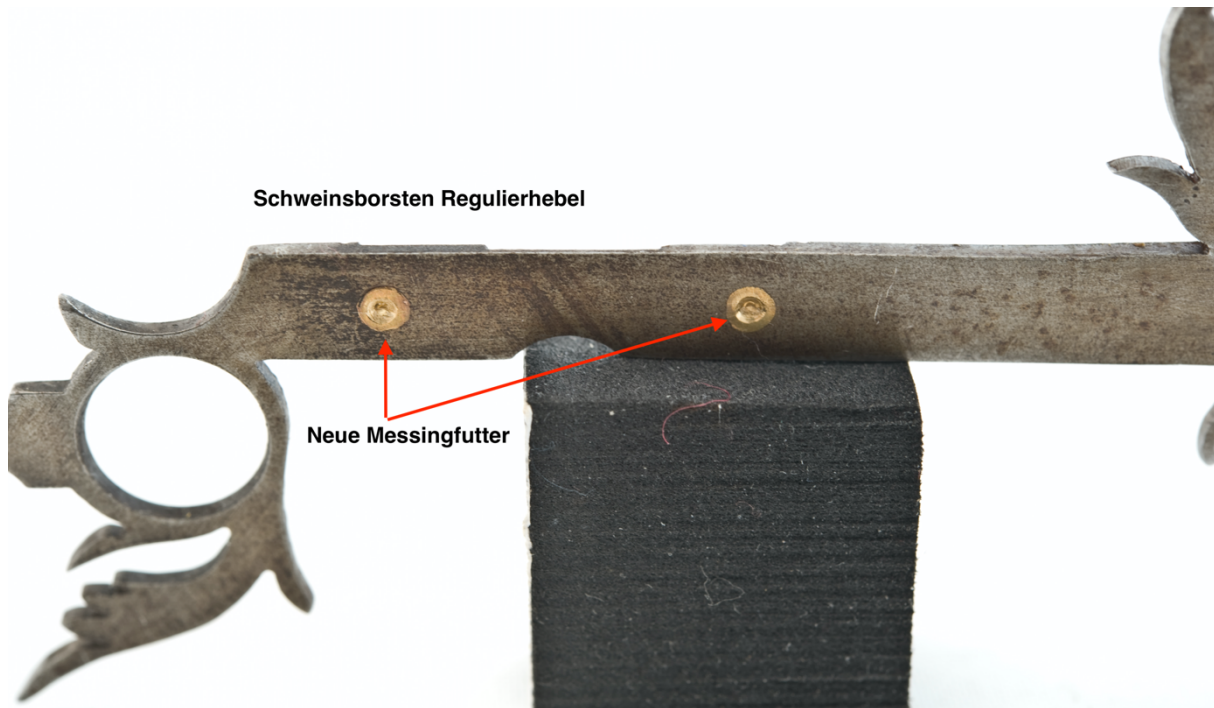
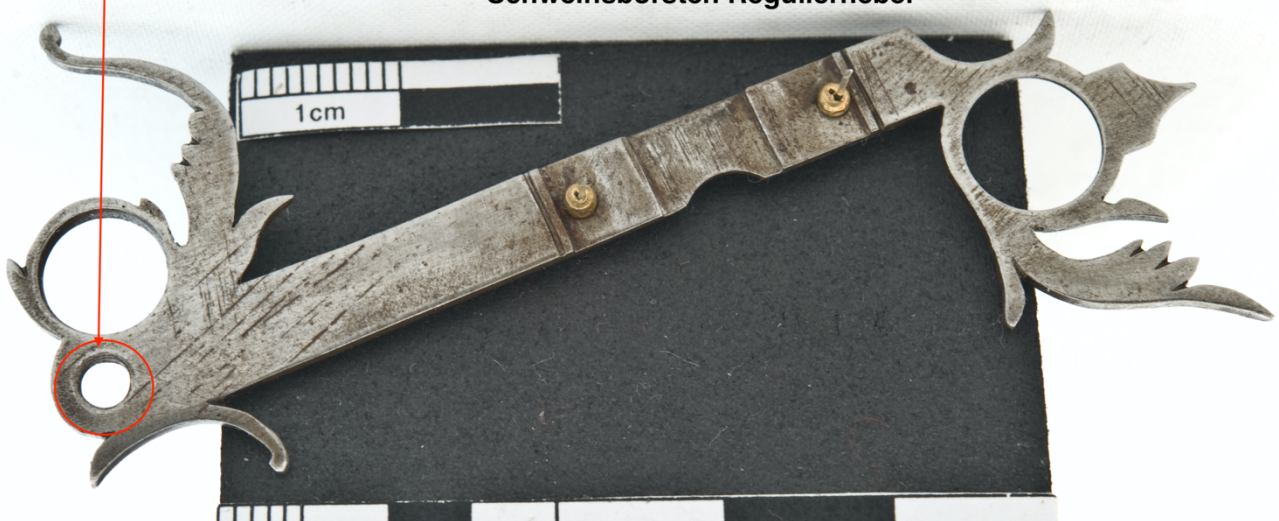
Maschinell gebohrtes Loch

D. The examination of the regulator lever revealed that it is also a newly made part created from old iron. In the microscopy, the cutting marks of an industrial spiral drill are detectable. As already described in the amplitude limitation, it also does not have a coherent function. The simulated pig bristles made of plastic are fixed in brass bearings that have been drilled into place.

Schweinsborsten Regulierhebel

The macro image clearly shows the cutting marks of a spiral drill. The attempt to rework these telling marks has only been inadequately done.

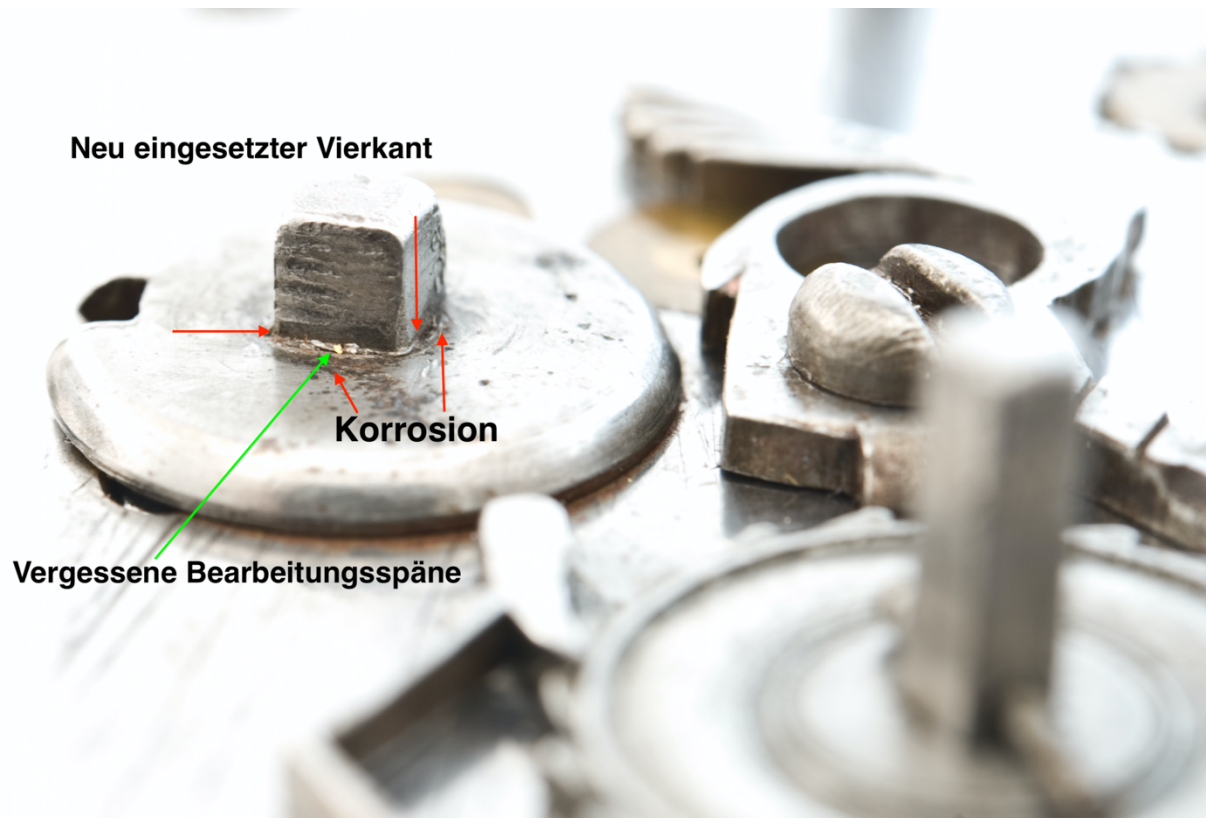
The square for adjusting the closure shows, notably, that there are no corrosion transitions at the junctions between the closure disc and the square. The corrosion on the surface of the closure stops abruptly at the square. This square was separately worked into the closure and is used below the movement plate for riveting. The macro image clearly shows machining shavings that were forgotten to be removed.

An investigation of the closures on the underside would have required rivet removal and was omitted for reasons of reversibility.

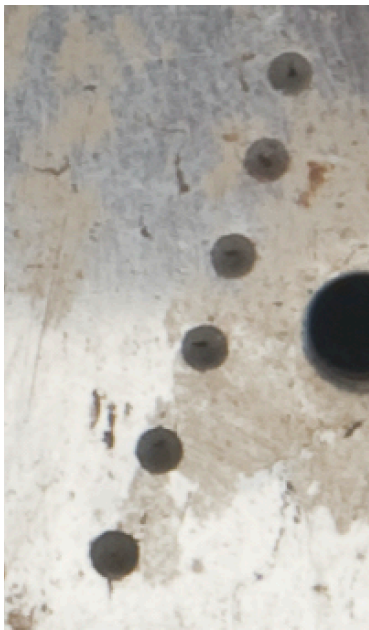
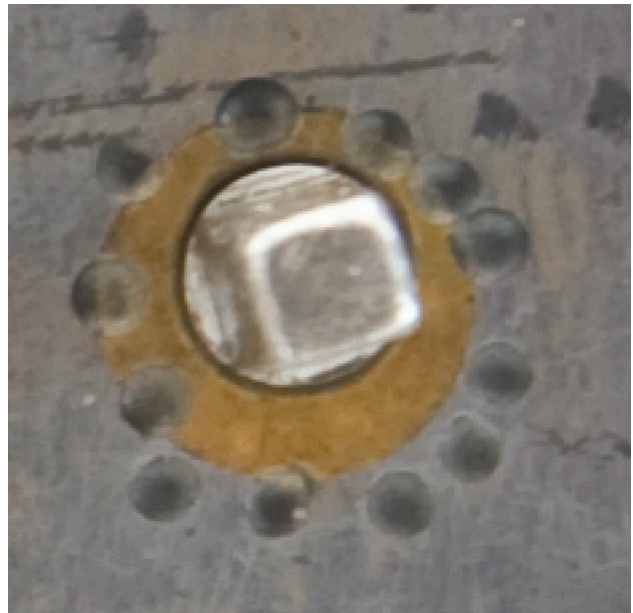
I+J The punches struck into the movement plate all show a dark discoloration at their base, which is typical when iron is heated. It can be assumed that the later described construction of the movement frame was created using hard soldering of the pillars. For this, significant heat was applied to the metal surfaces. The resulting thermal discoloration on the iron, particularly on the plates, was abrasively removed. However, the thermally induced discolorations in the recesses were not reached and thus retained their color.

Thermal discolorations in the recesses.

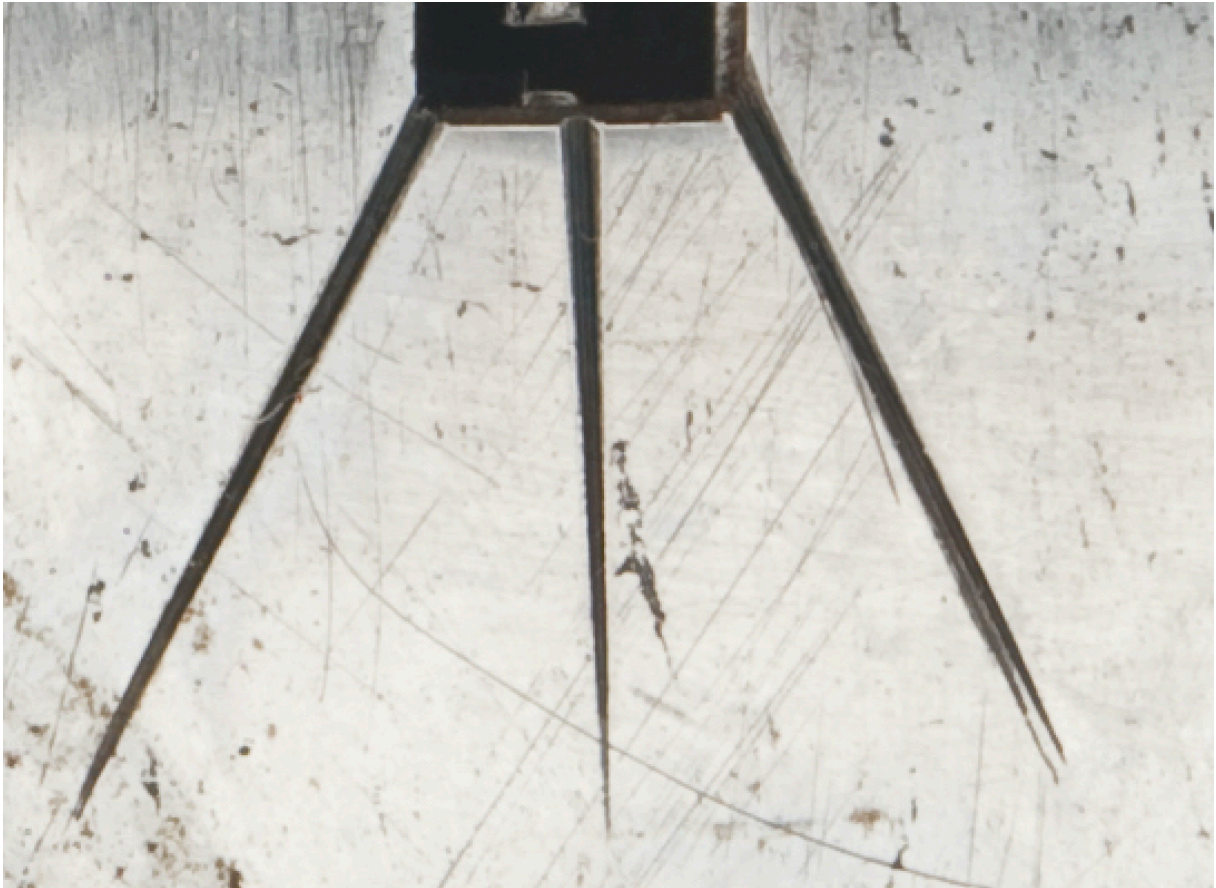
Thermal discolorations in the recesses.

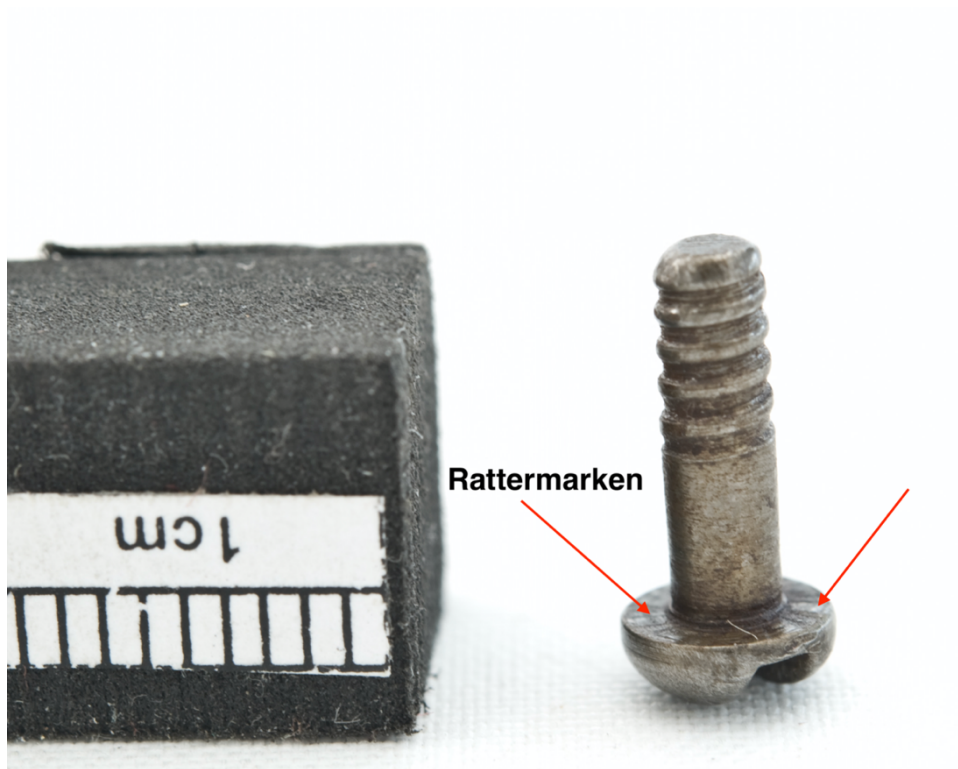
In the watch under investigation, the screws are uniform and interchangeable. They all have a thread size of approximately 2.8 mm and 2.25 mm and show no deviations in the pitch. The blanks for these screws were made on a modern lathe and show chatter marks under some of the screw heads. The characteristic brown coloring of the screws may result from a bluing process after manufacturing, where the screw is heated and then quenched in oil. However, there are other methods of bluing metal. This is not relevant for my investigation, as the other detected features in the watch already allow for a clear judgment at this point.

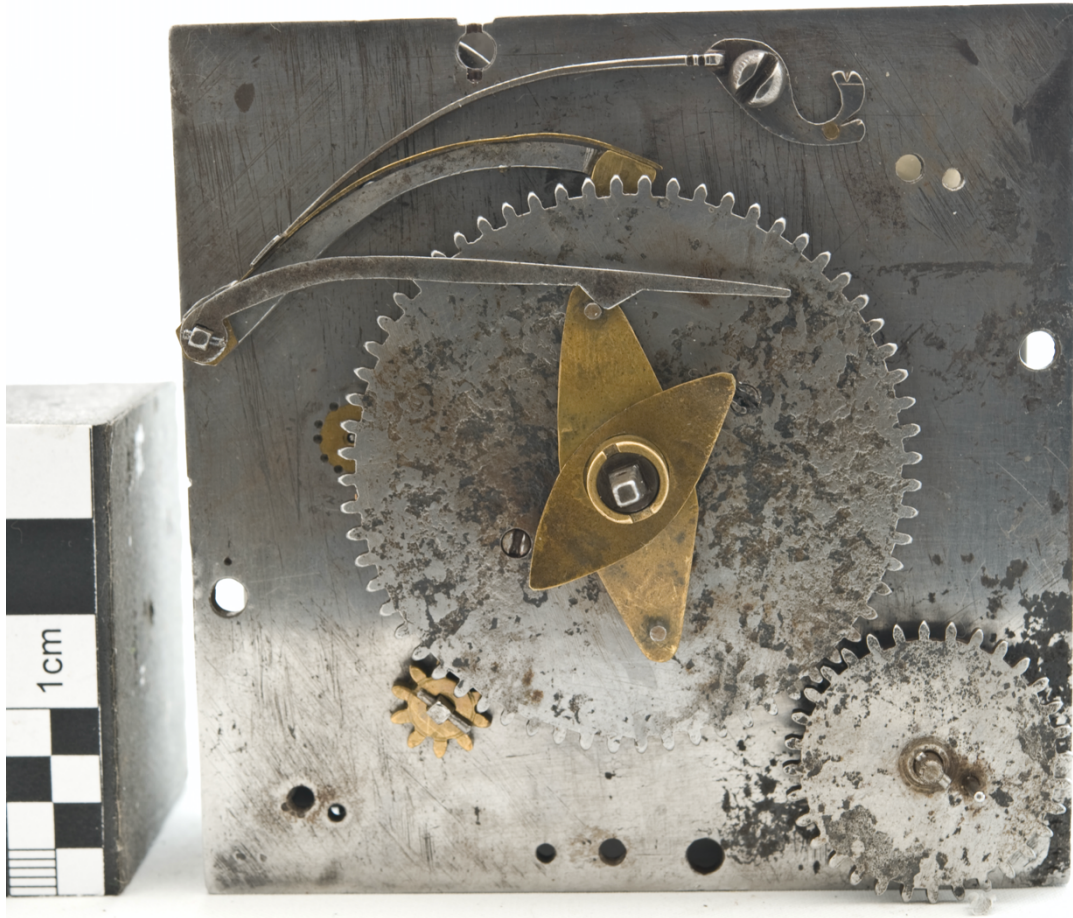
Evaluation of the lower plate

The lower plate is also a new construction made from old iron. It could possibly be an old plate from another timepiece from a later century. Under two of the four pillars that connect the plates, newer silver-solder connections could be visually detected under the microscope.

A classification of the entire movement frame into the second half of the 16th century is already ruled out due to the pillar attachment. The pillars of 16th-century table clocks were not soldered. Their common feature is found in a two-sided screw or rivet connection. Both construction methods were used in one timepiece, for example, the screws securing the pillars on the upper plate, while the pillars on the lower plate were riveted, and vice versa.

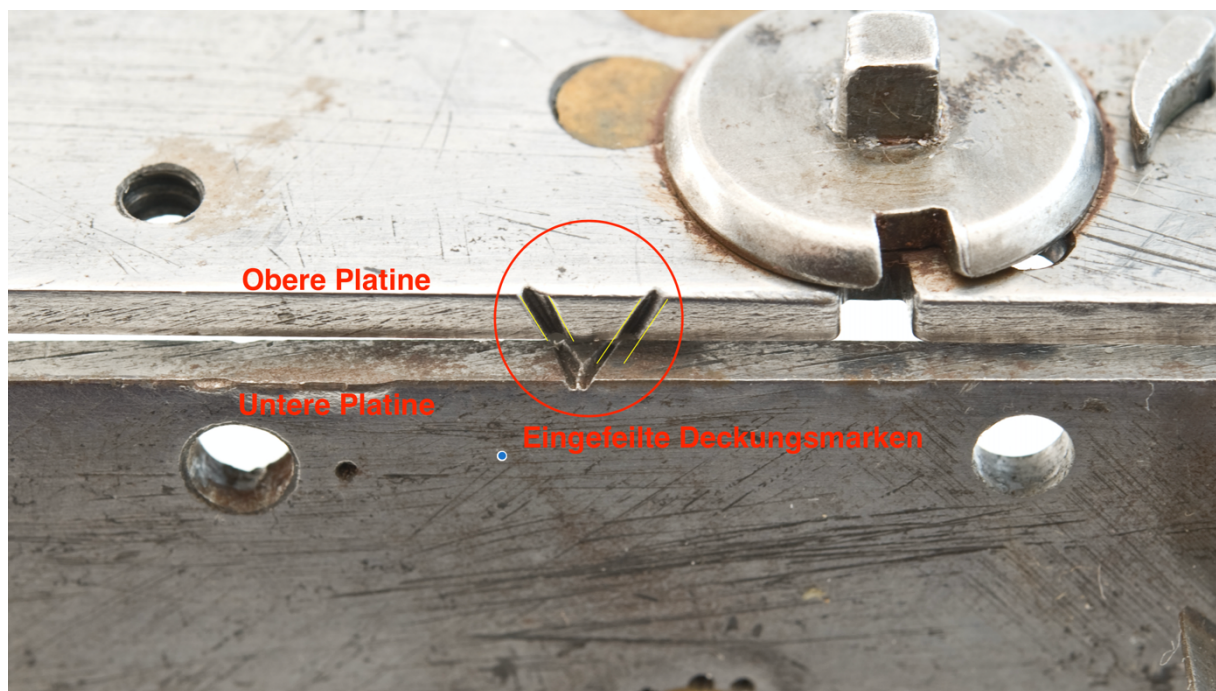
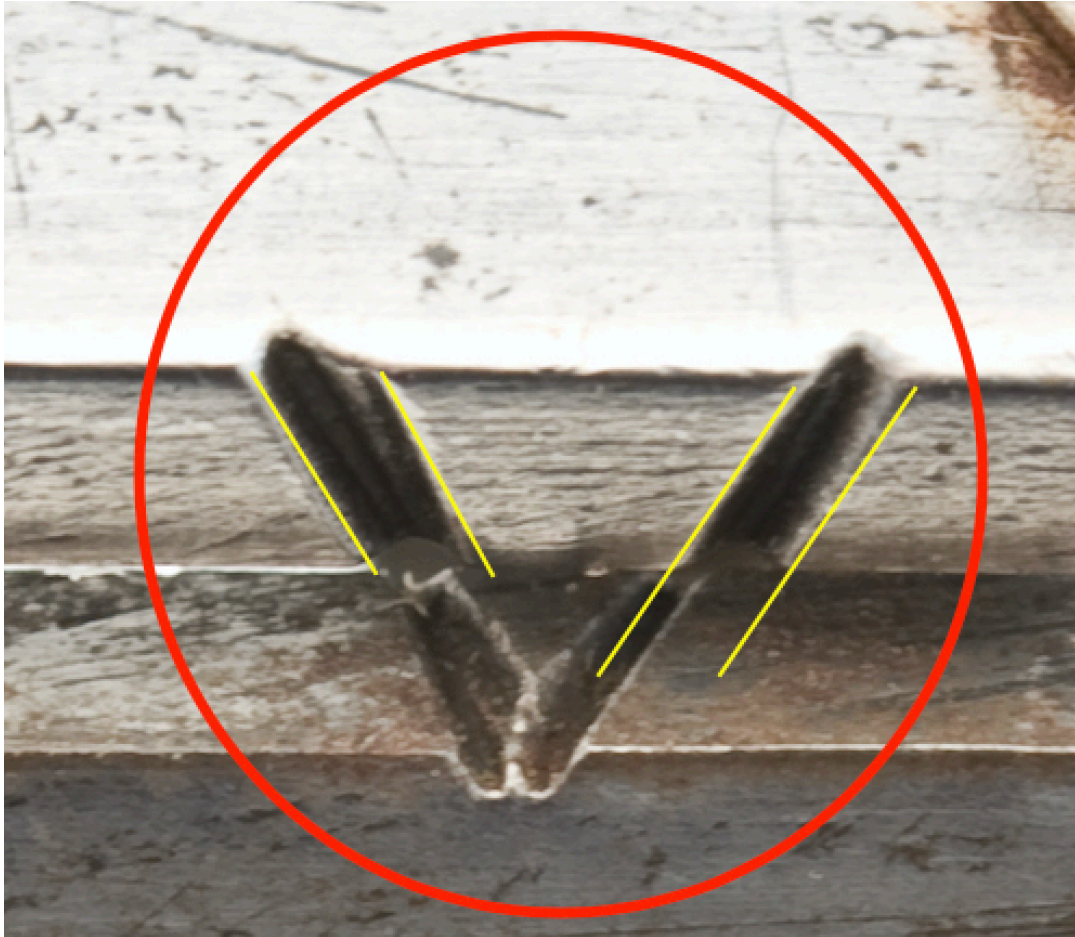
"Engraved coverage markings"

In the clock under examination, this marking is rudimentary and not aligned correctly. The marking on the lower plate differs significantly in nature from the marking on the upper plate. The upper marking was made with a different tool than the lower marking. However, the lower marking shows some authenticity, suggesting that the lower plate could be a fragment from an old clock.

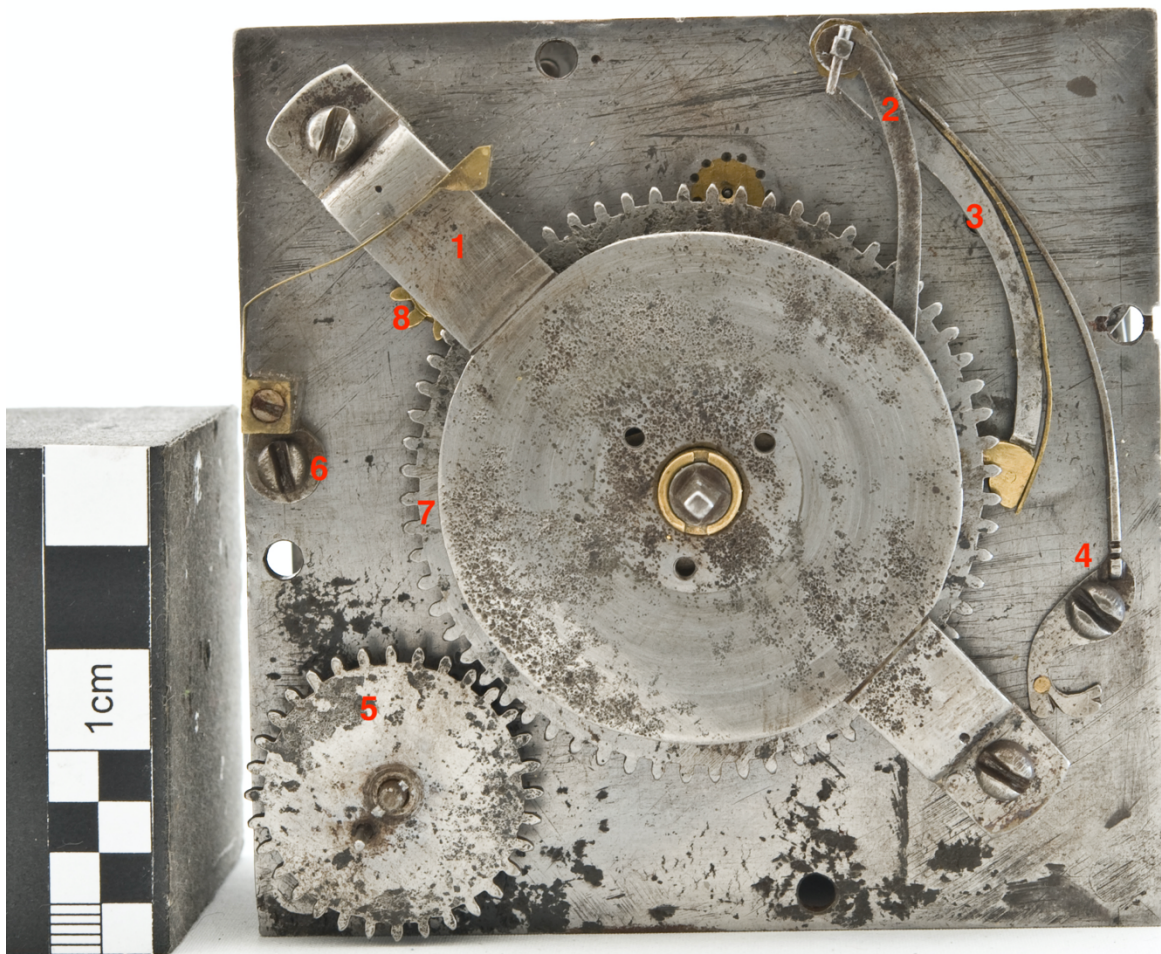
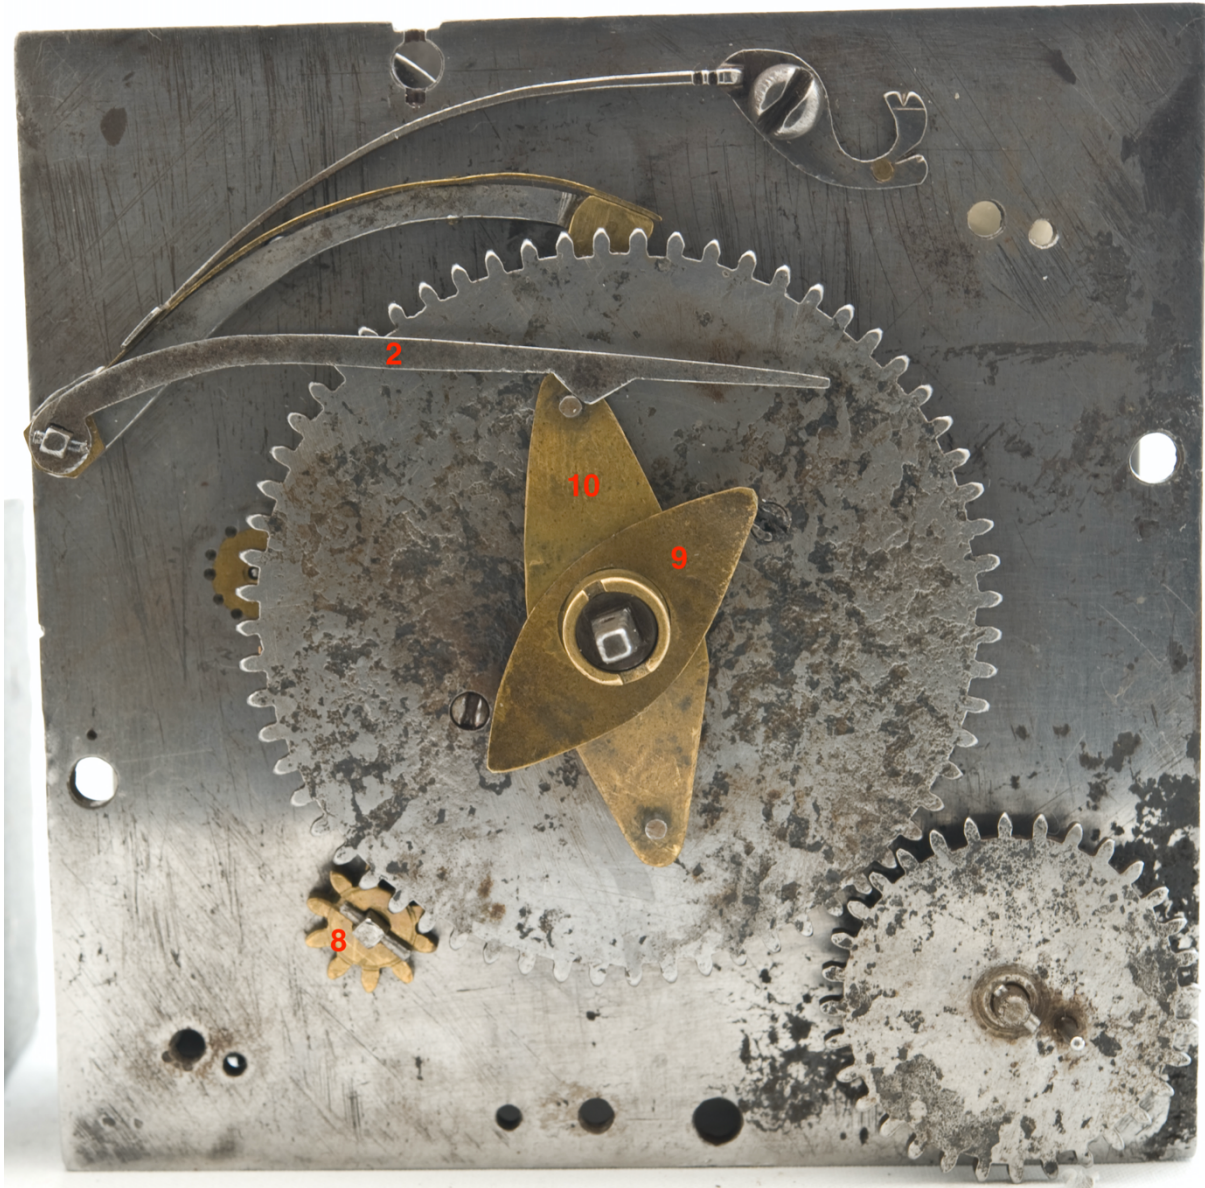
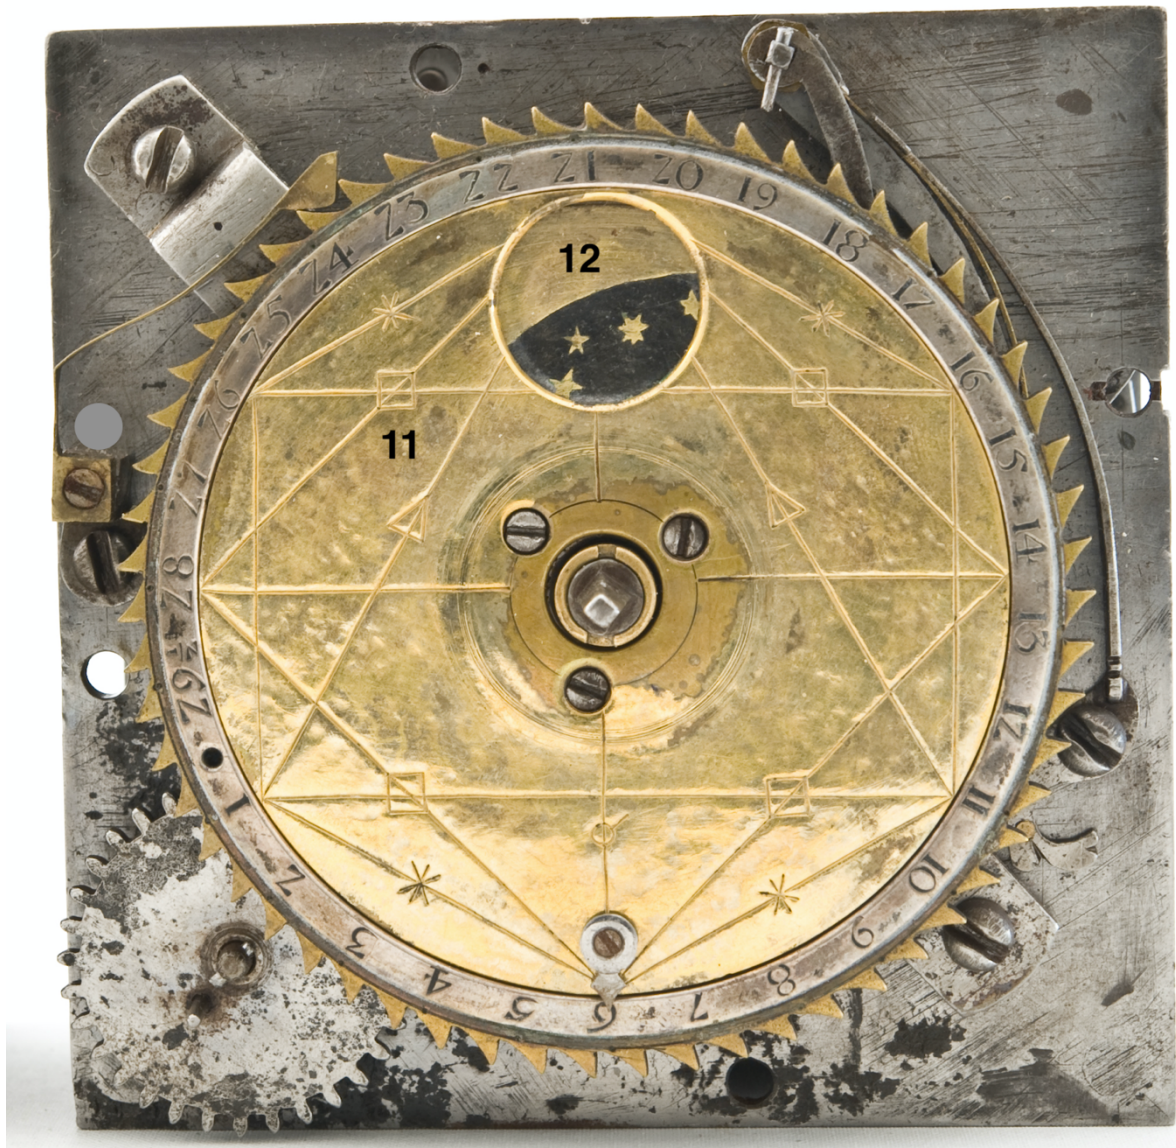
Bauteilaufistung

All of the components listed below and installed on the bottom plate, with the exception of the moon disc and the aspect diagram, are exclusively newly made from old materials.

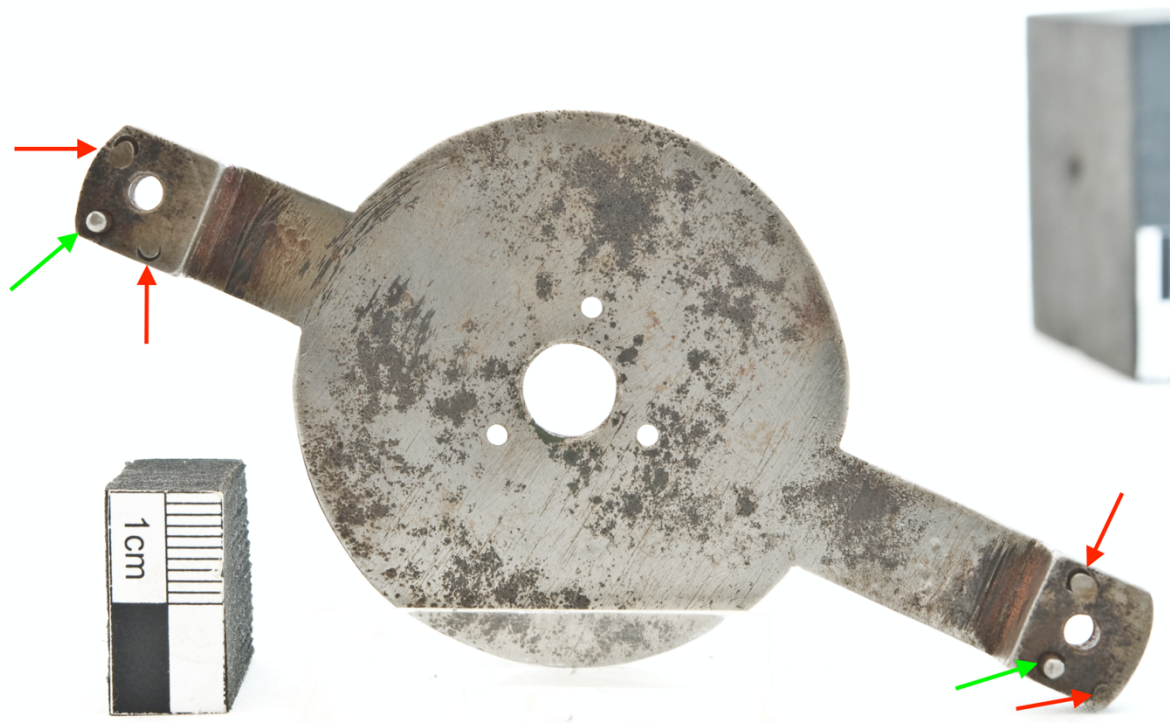
Bridge (1) The bridge is a new fabrication made from an indefinable old part. Former locking pins have been cut off (see **red arrows**) and replaced with newly placed pins (see **green arrows**). The central hole and the three threaded holes around the centrally arranged hole have also been newly added. The corrosion stops at the cut edges, indicating the part is newly made.

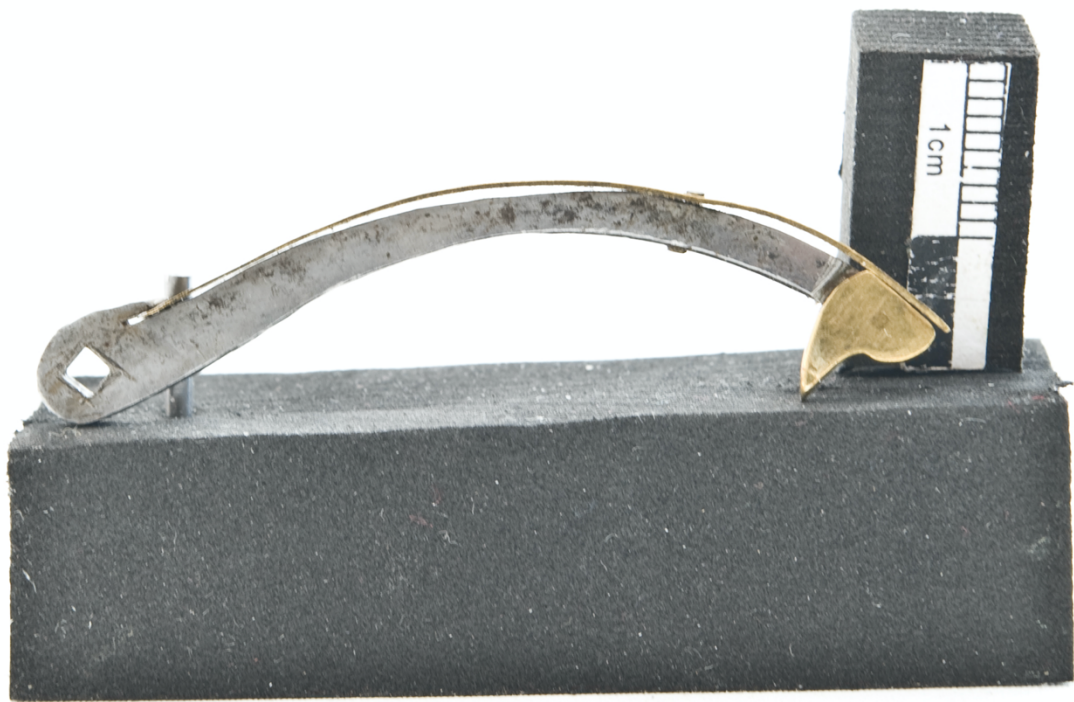
Trigger lever for the alarm mechanism (2) The previously described trigger lever is made from old sheet iron and shows no coherent signs of aging at its cut edges.

Trigger lever (stork's beak) for the hour strike (3) The trigger lever has been newly fabricated from old brass and iron.

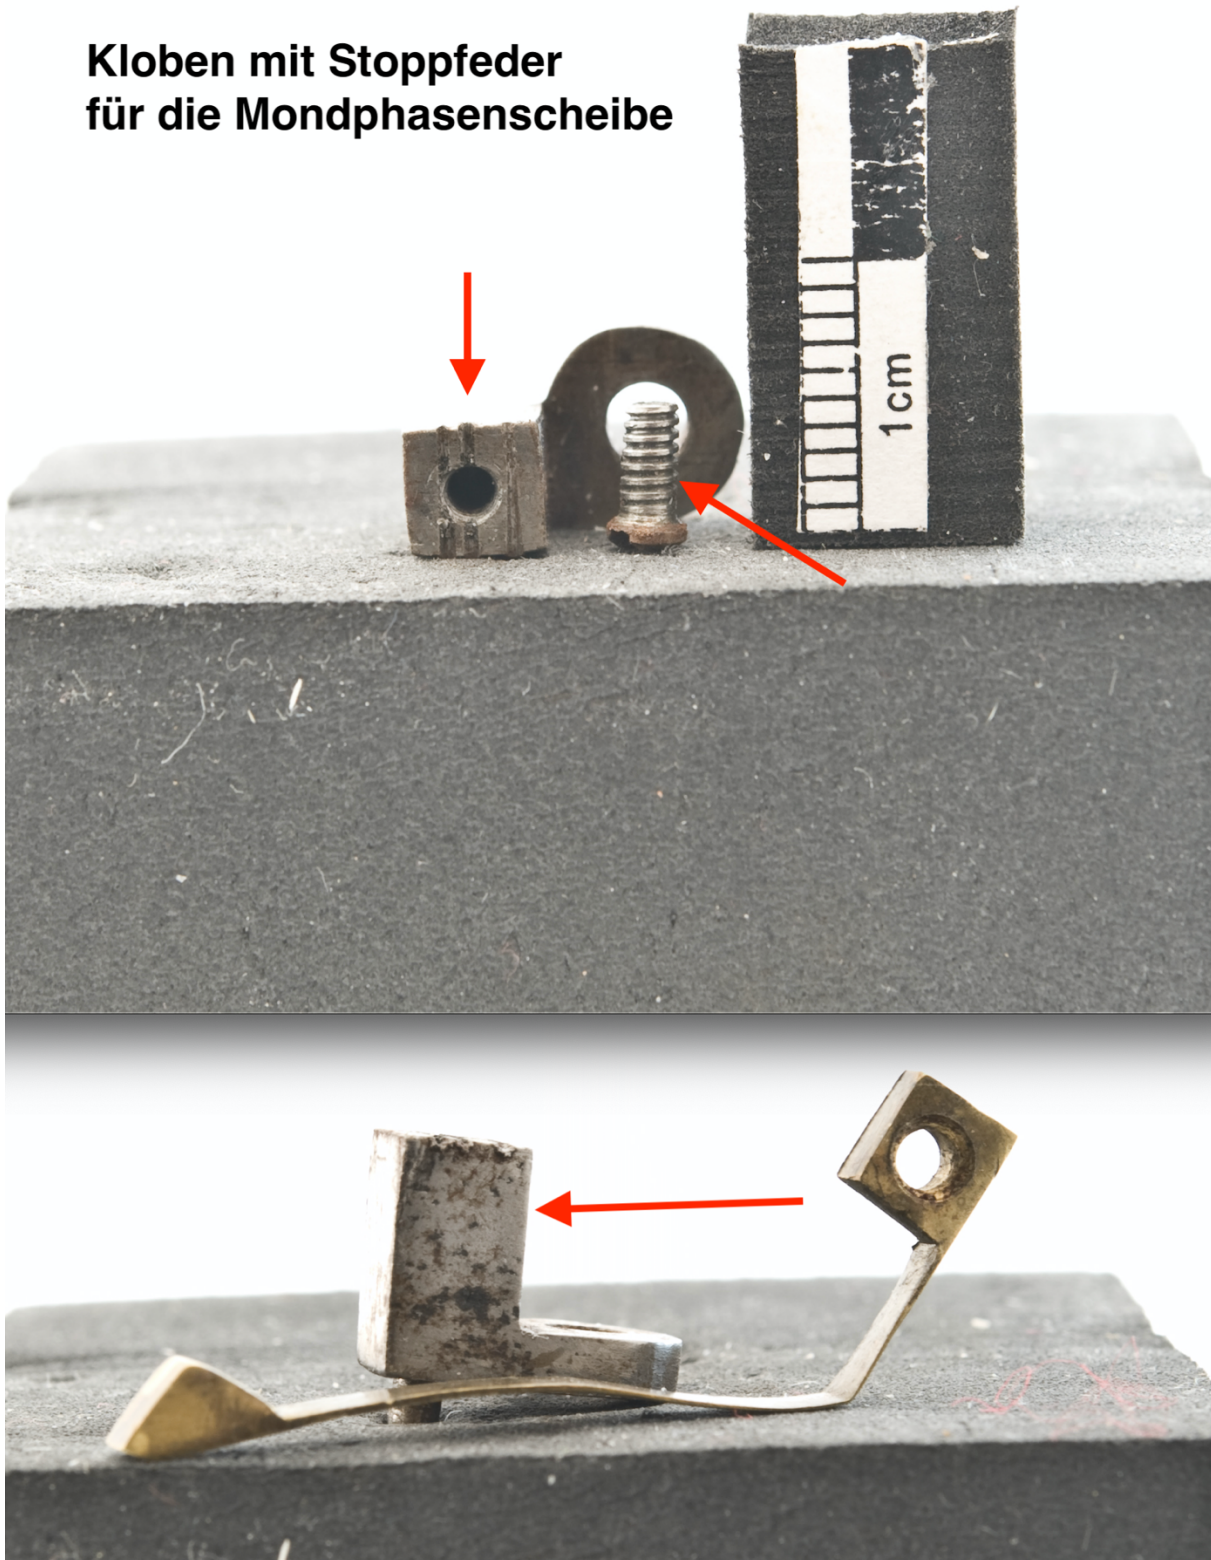
Kloben mit Stoppfeder für die Mondphasenscheibe

The clamp with the locking spring and screw for the moon phase wheel is a complete new construction. Its locking and mounting on the plate is located in a newly drilled locking hole and a newly cut threaded hole.

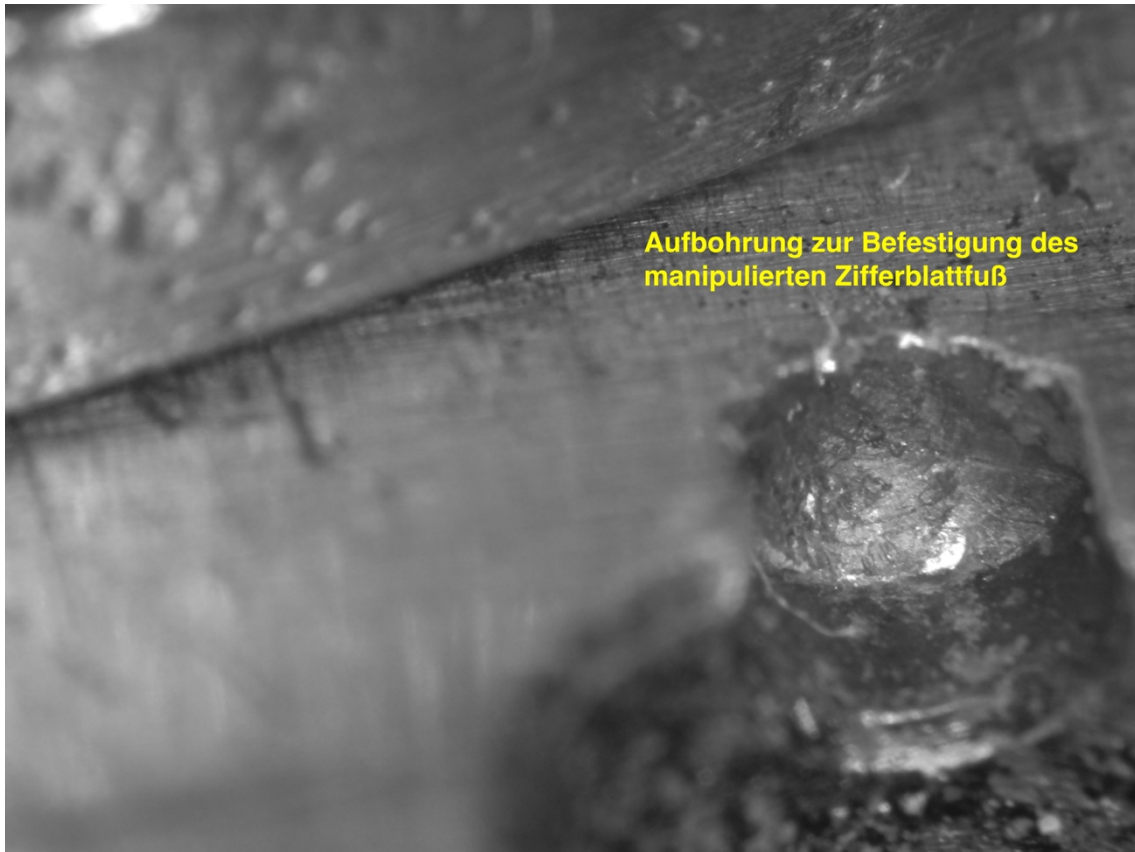
Of the four feet that anchor the dial of the clock case into the plate, one is destroyed and broken off in its upper third. As a replacement, a modern metric thread was drilled and cut into the foot. For the new anchoring, a hole was drilled horizontally through the end face of the plate via the vertical bore. This hole was drilled beyond the vertical bore as a blind hole.

Aufbohrung zur Befestigung des
manipulierten Zifferblattfuß

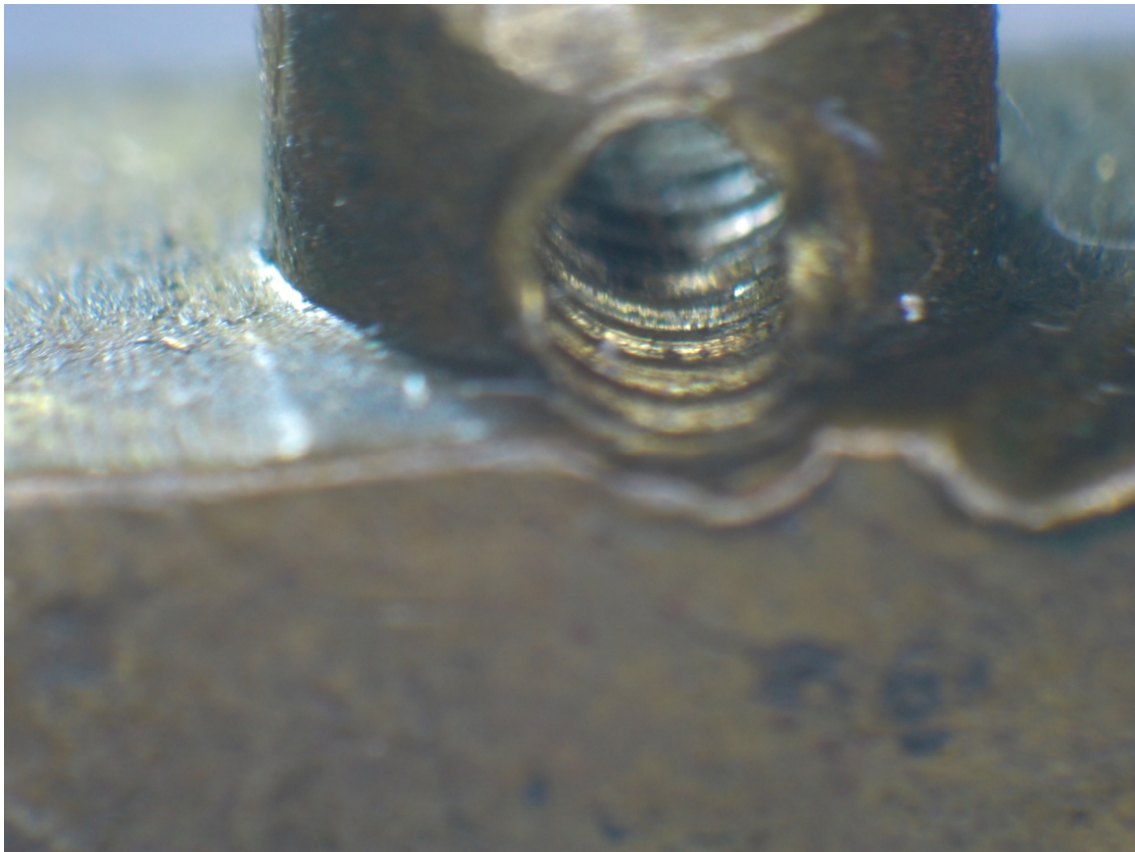
As revealed by the stereoscopy, the pillar with the replacement drilling was already produced with the breakage. The microscopic examination confirmed the initial suspicion that not only the dial but also the soldered dial attachments are cast replicas of dial feet from another clock.

Gussstruktur an Bohrung- Durchbruch für die Verstiftung
