Real or Fake?

Examination and Analysis of a Clock Presenting Itself as a "Horizontal Table Clock from the 16th Century" with Astronomical Display

from Jürgen Ehrt

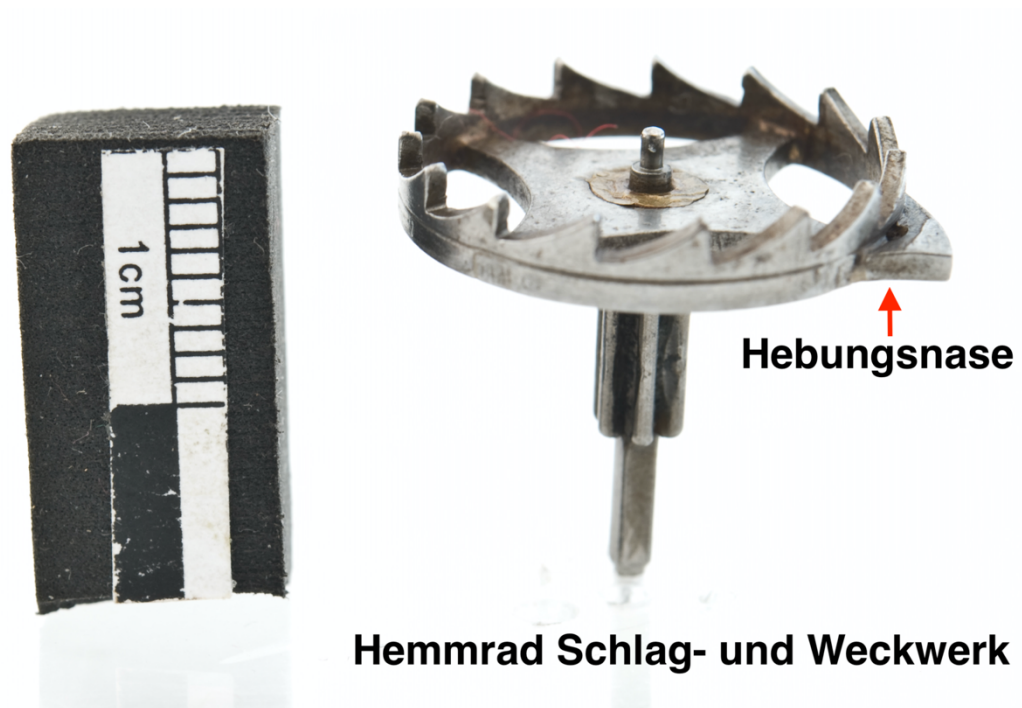
Another rudimentary empirical approach can be seen in the placement of the escape wheel for the striking mechanism. As previously mentioned in the "Investigations on the Striking and Alarm Mechanism" chapter, the escape wheel is a new creation, with a lifting nose soldered onto it. However, the builder of the movement was faced with an essentially unsolvable problem. The lifting nose did not have enough clearance from the plate to pass through. It had to get stuck, meaning the escape wheel would stop. At this point, a very crude emergency solution was implemented, where the plate was roughly hacked out.

A lug soldered to the escape wheel (see photo) is intended to keep the escape wheel free until the complete unwinding of the alarm mainspring, when the trigger lever is raised to a certain height.

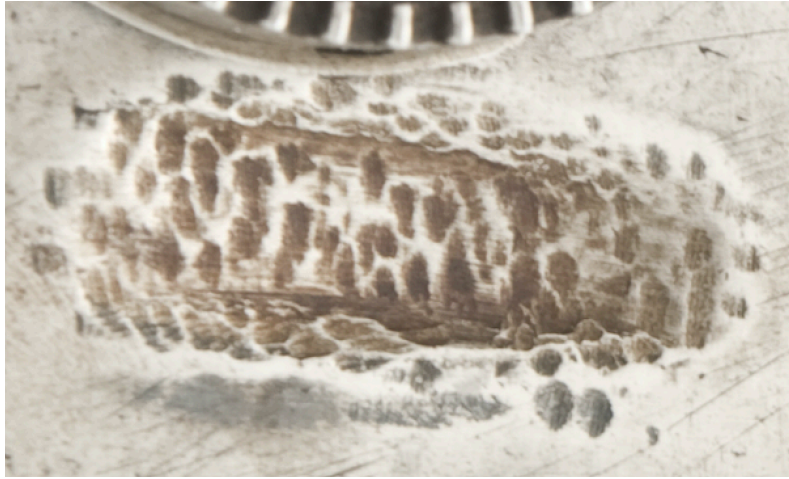
Milled and hacked plate bottom
© Restaurierungsatelier Jürgen Ehrt

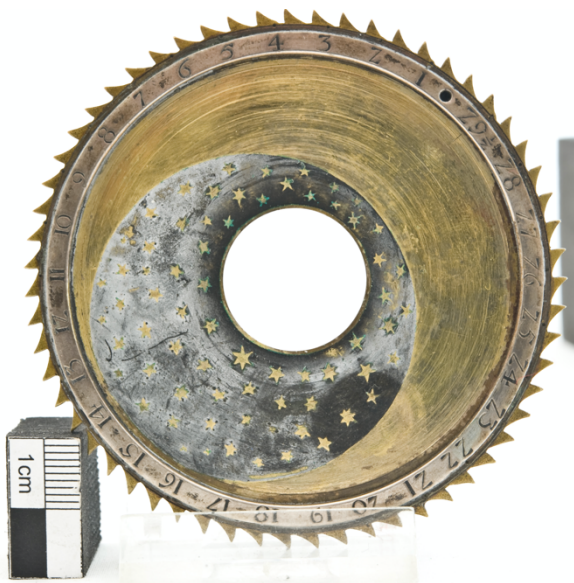
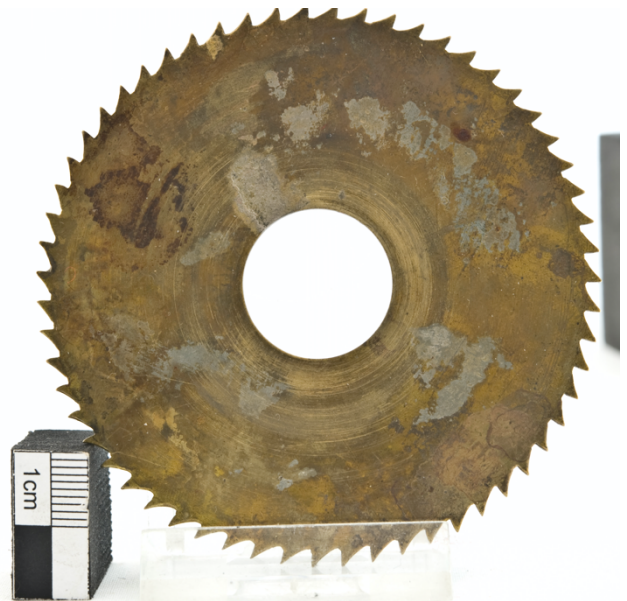
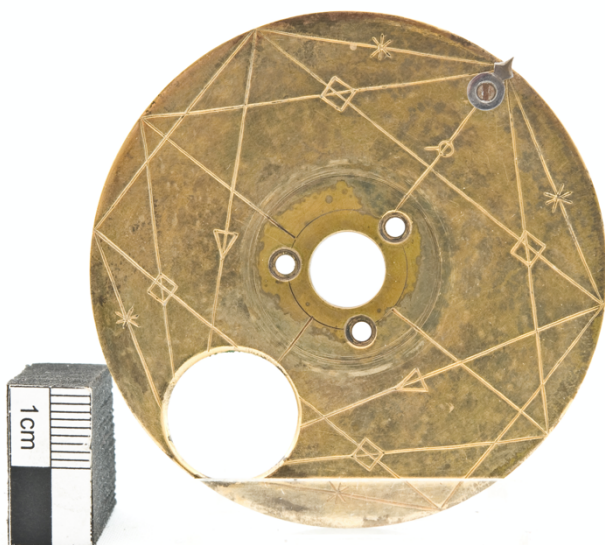
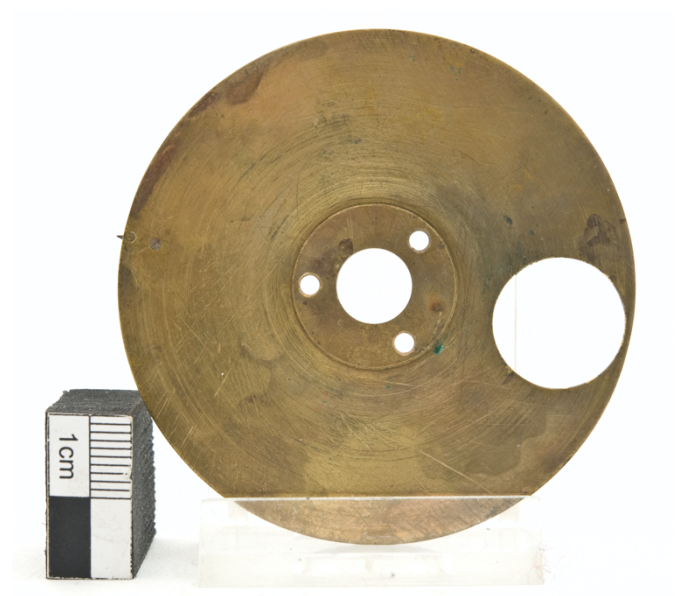
Display of the synodic lunar age

The lunar age display, along with the adapted moon dial in the case, has a toothed gear drive with 59 teeth. The aspect scheme located at the center of the disc is original and is likely taken from another clock.

The mechanical drive for this indication is powered by the gear train of the clockwork. The gears and wheels required for this drive are all new creations. Notably, the two drive gears with 64 and 60 teeth are worth mentioning.

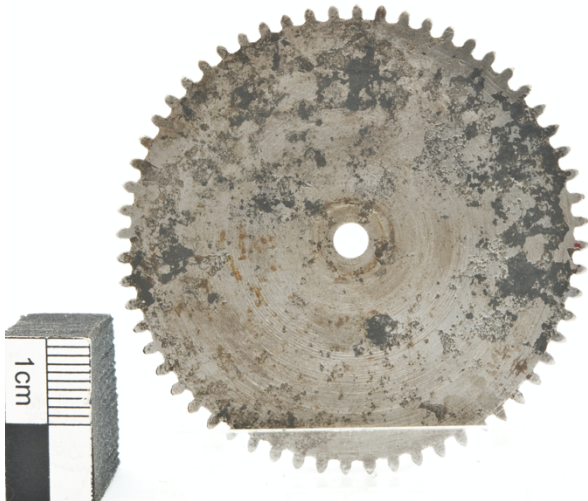
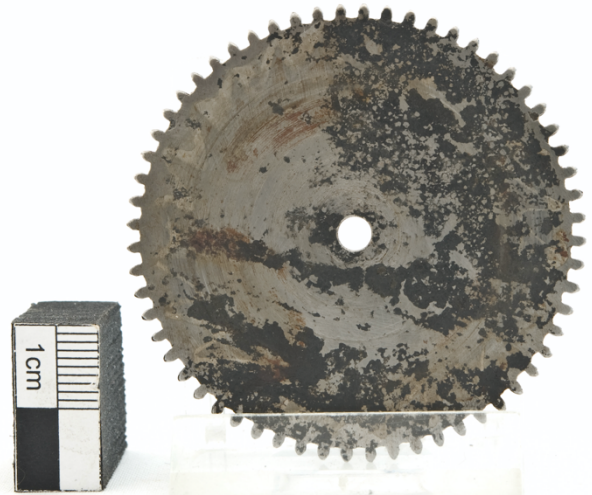
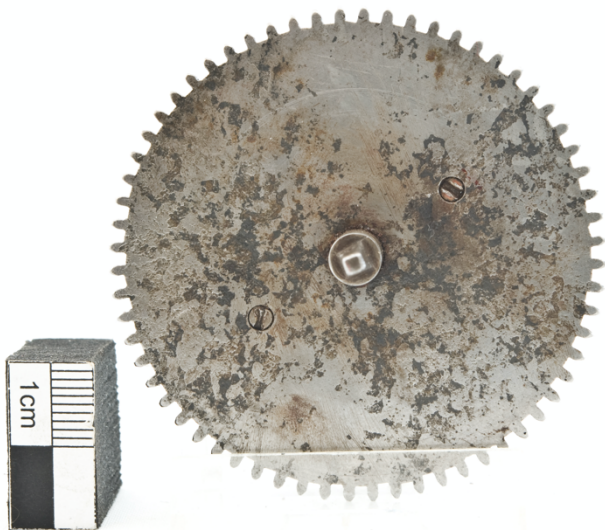
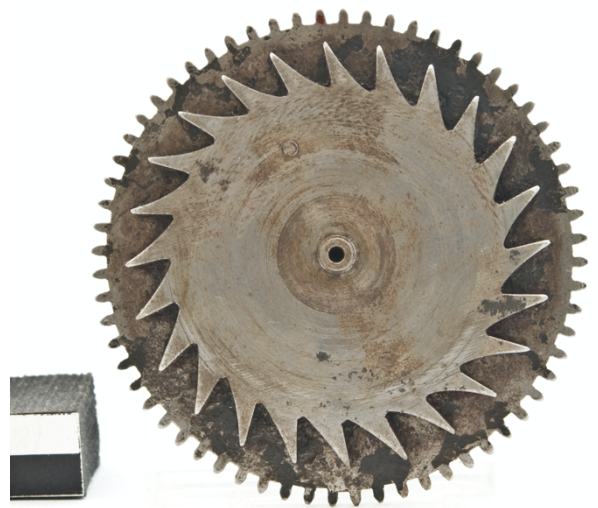
The gears and the 24-tooth release star adapted to the hour wheel for the hourly strike were made of old iron, heavily corroded with pitting corrosion. Notably, we also find no corrosion in the cut tooth flanks or the interior areas of the tooth cycloids on these gears. Stereoscopic examination revealed machine processing traces on these creations. The manufacturer tried, with rudimentary touch-ups, coarsely applied filing marks, and varying depths of tooth cutting, to obscure the machine-made traces. These are unmistakable evidence of the modern manufacturing of these wheels. See below microscopy 01 and 02 when examining the engagement of the tooth cycloids on the hour wheel and the change wheel.

Both gears are merely screwed together with a brass sleeve pressed into place. This allows for the possibility of shifting under friction between the two gears. This is intended to provide friction for adjusting the time on the dial. However, in practical testing, this construction proved to be useless. After frequent adjustments, the pressure of the screw connection loosened, and the pressed gear discs lost their mechanical adhesion. Furthermore, it was observed that the engagement between the hour wheel and the change and transport wheel for the moon disk exhibited uneven surfaces, which also precluded a coherent operation between these wheels.

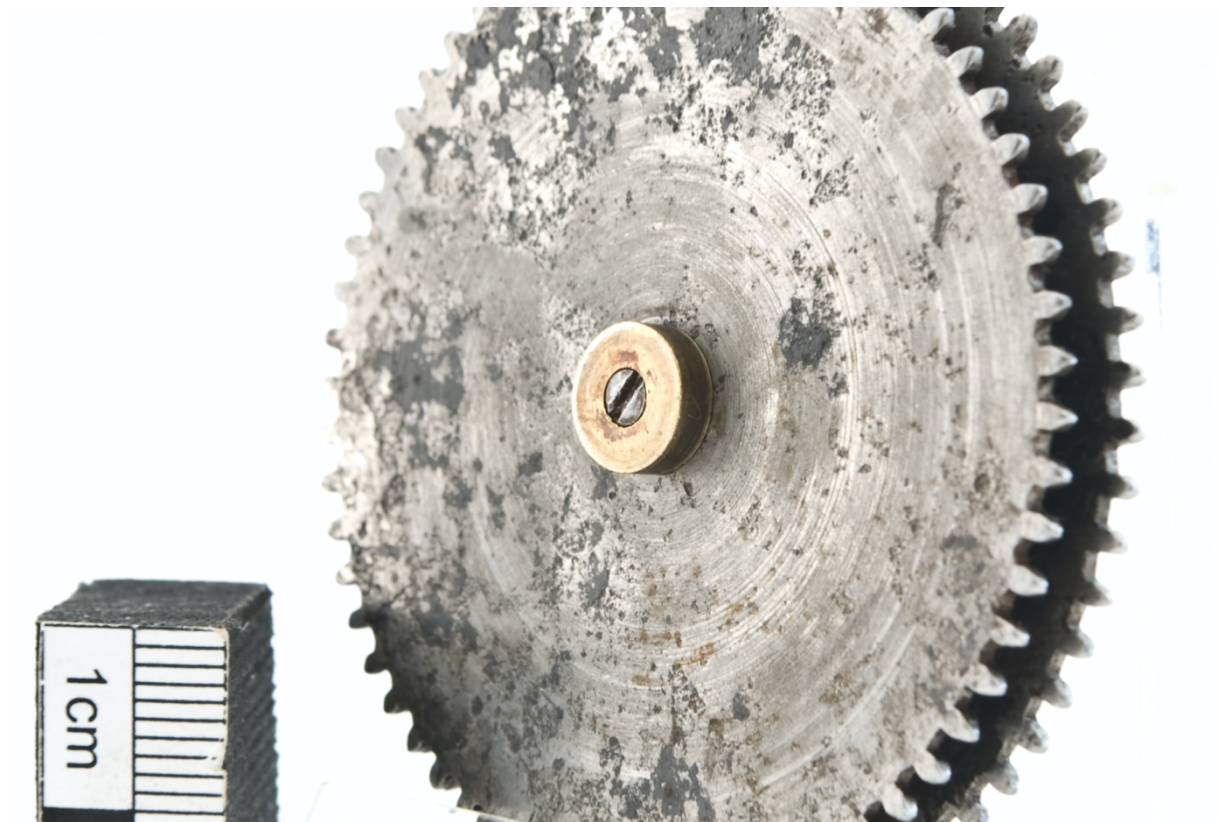
The hour wheel with its screwed-on 24-tooth release wheel for the hourly strike was also subject to a detailed examination. Like the previously described hour wheel, the star wheel was also made from old iron. The drilling and thread cuts also show authentic signs of a modern fabrication. Clearly visible on the screwed inner side are traces of a machine lathe. After disassembling the star wheel, previously trapped brass shavings were found on the inner surface of the hour wheel. It would be plausible to assume that these came from a corrosion surface cleaning of the heavily corroded iron of the hour wheel and were then screwed in together.

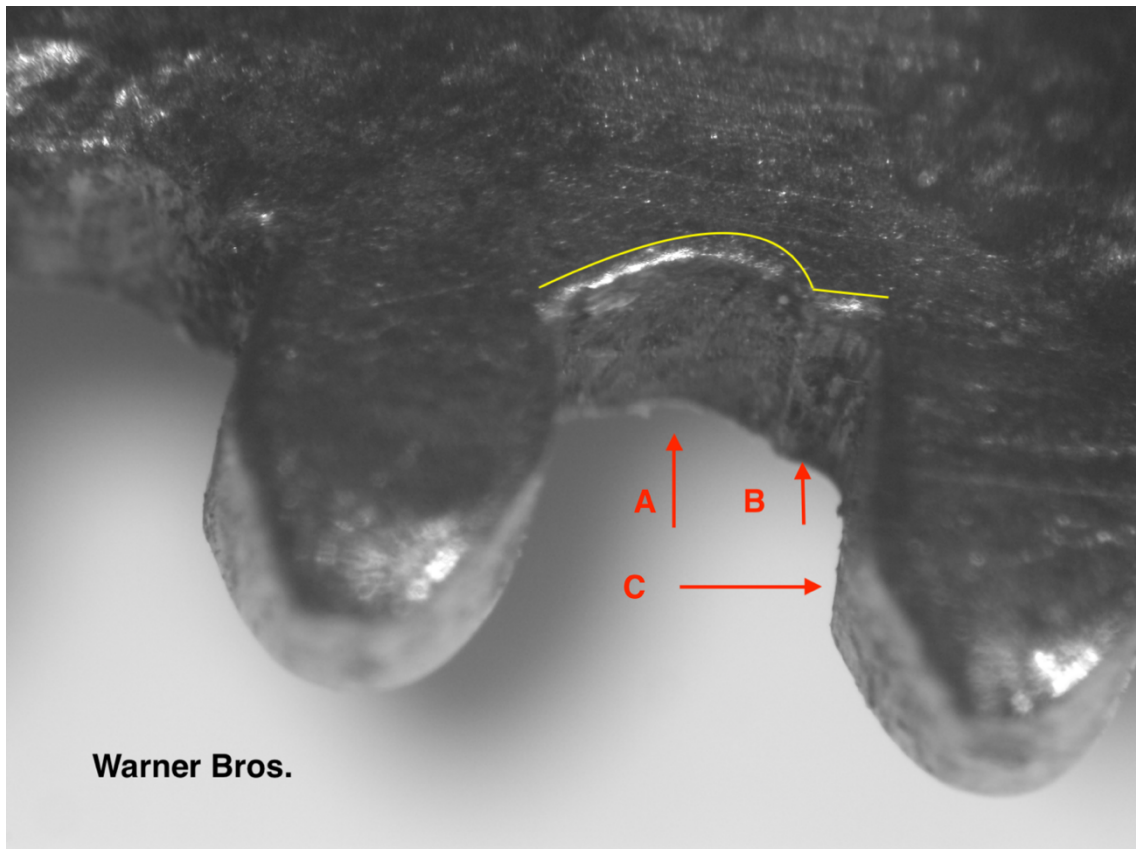
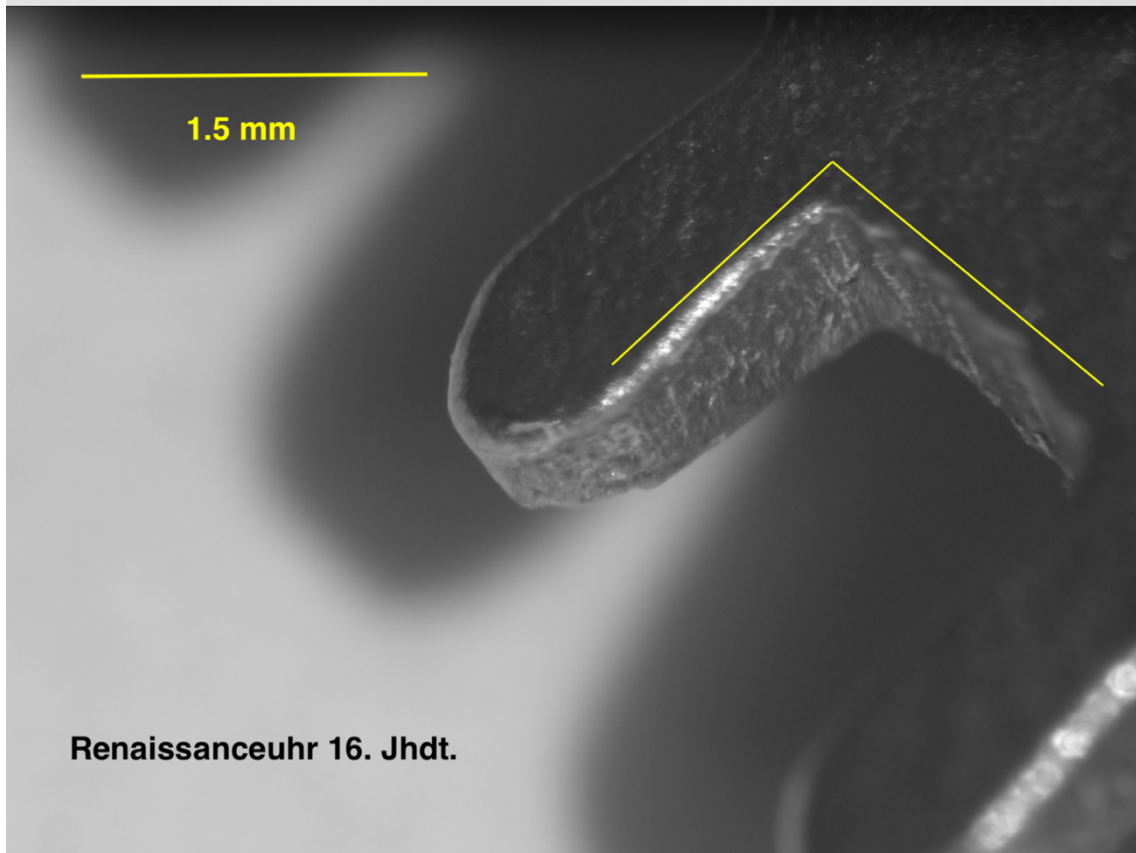
Mikroskopy 02

Explanation of Microscopy 01 to 03:

Points A to B mark the manufacturing characteristics of the newly made gear intended for driving the moon phase.

The material is made from old iron sheet with a thickness of approximately 1.24 mm. Both surfaces are heavily corroded with pitting. The division, or module, was cut using a machine milling cutter. This results in the straight tooth flanks, which show no manual filing traces, see C. The tooth flanks and cycloids were subsequently polished abrasively, resulting in a rounded, inhomogeneous surface, which is not typical for either non-operated or operated gears in practice.

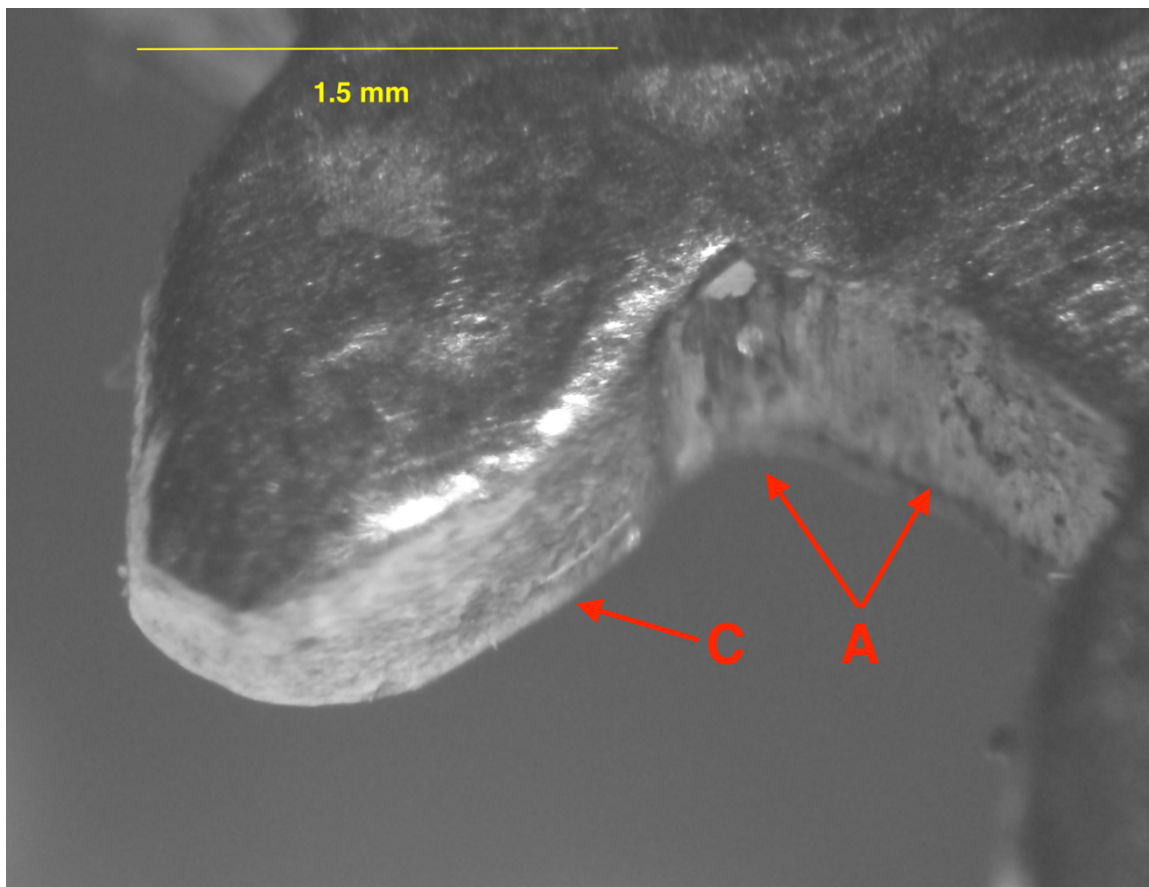
Mikroskopy 03

A clear indication of the incompatibility of the drive engagement can be seen in **Microscopy 03**. Here, the tooth engagement of the escapewheel is outside the simulated wear marks.

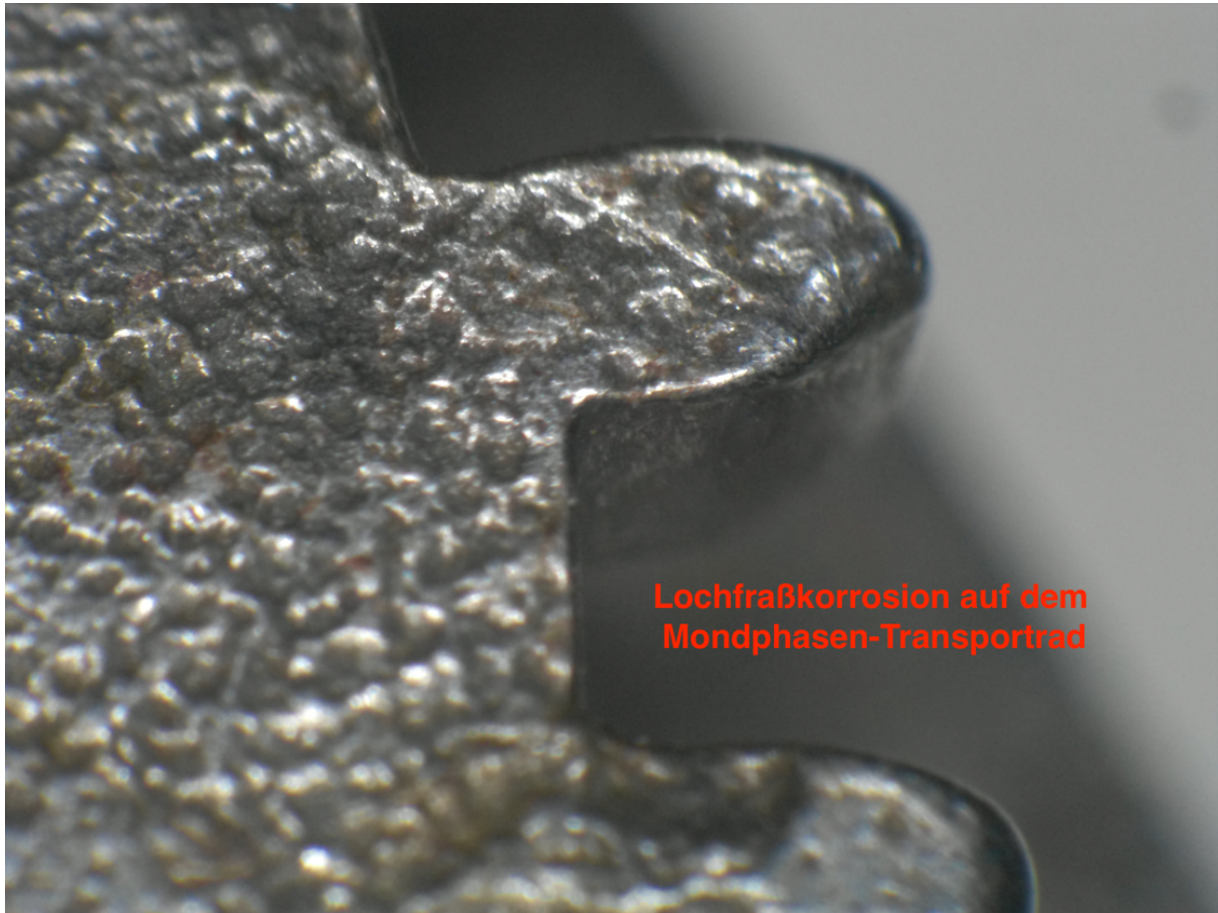
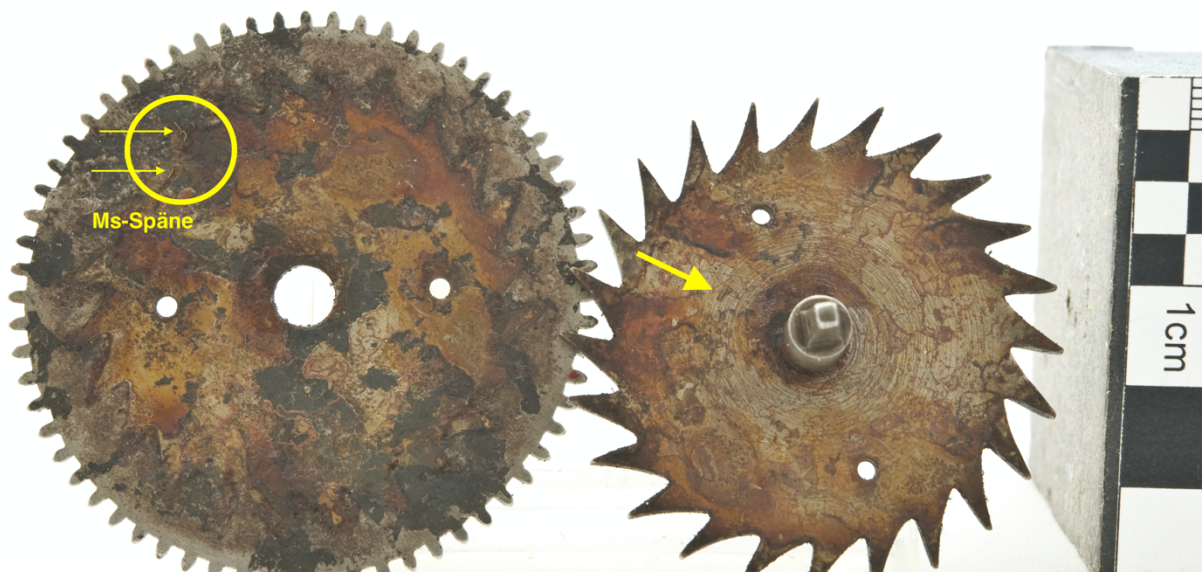
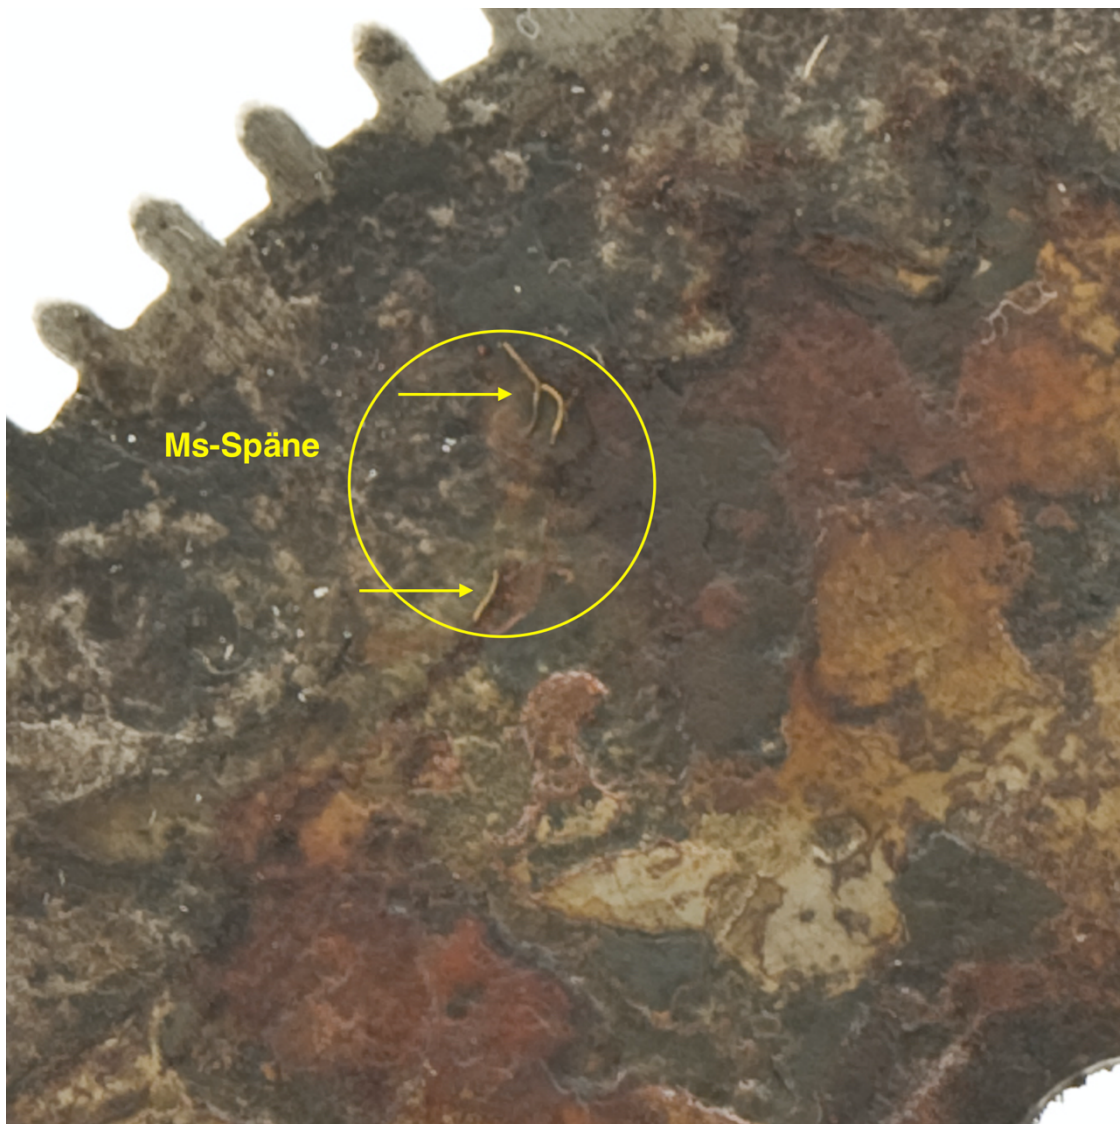
The transport wheel of the moon phase also shows an inhomogeneous pattern. Such severe pitting corrosion would have also significantly affected the tooth flanks, tooth cycloids, and the machine-milled tooth base.

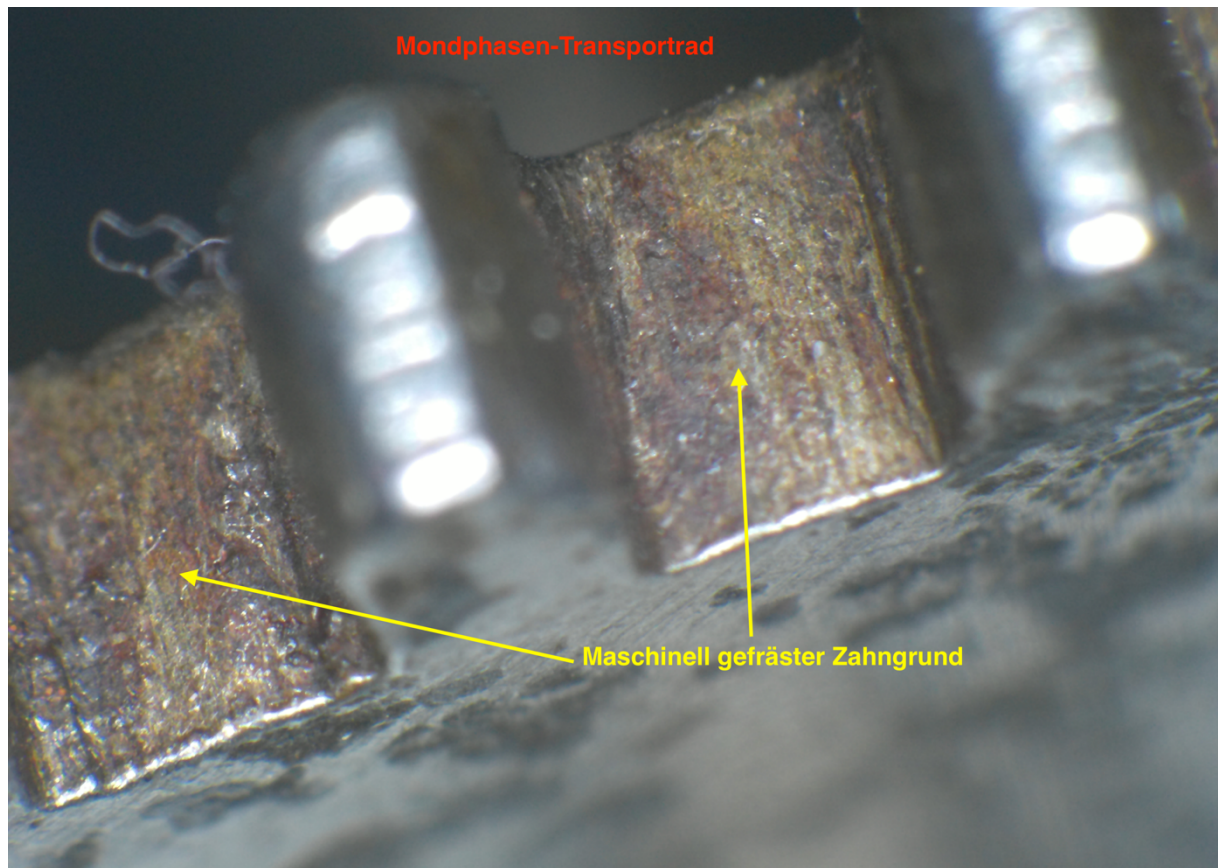
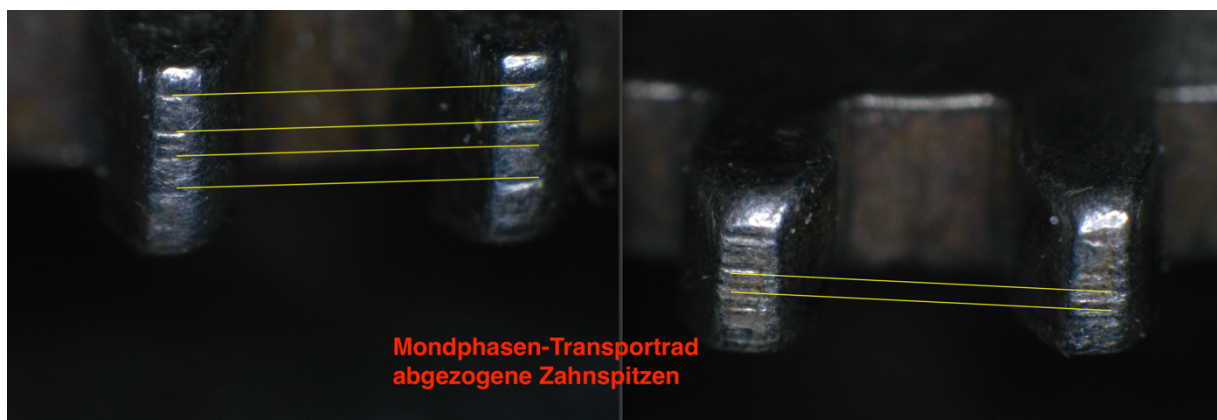
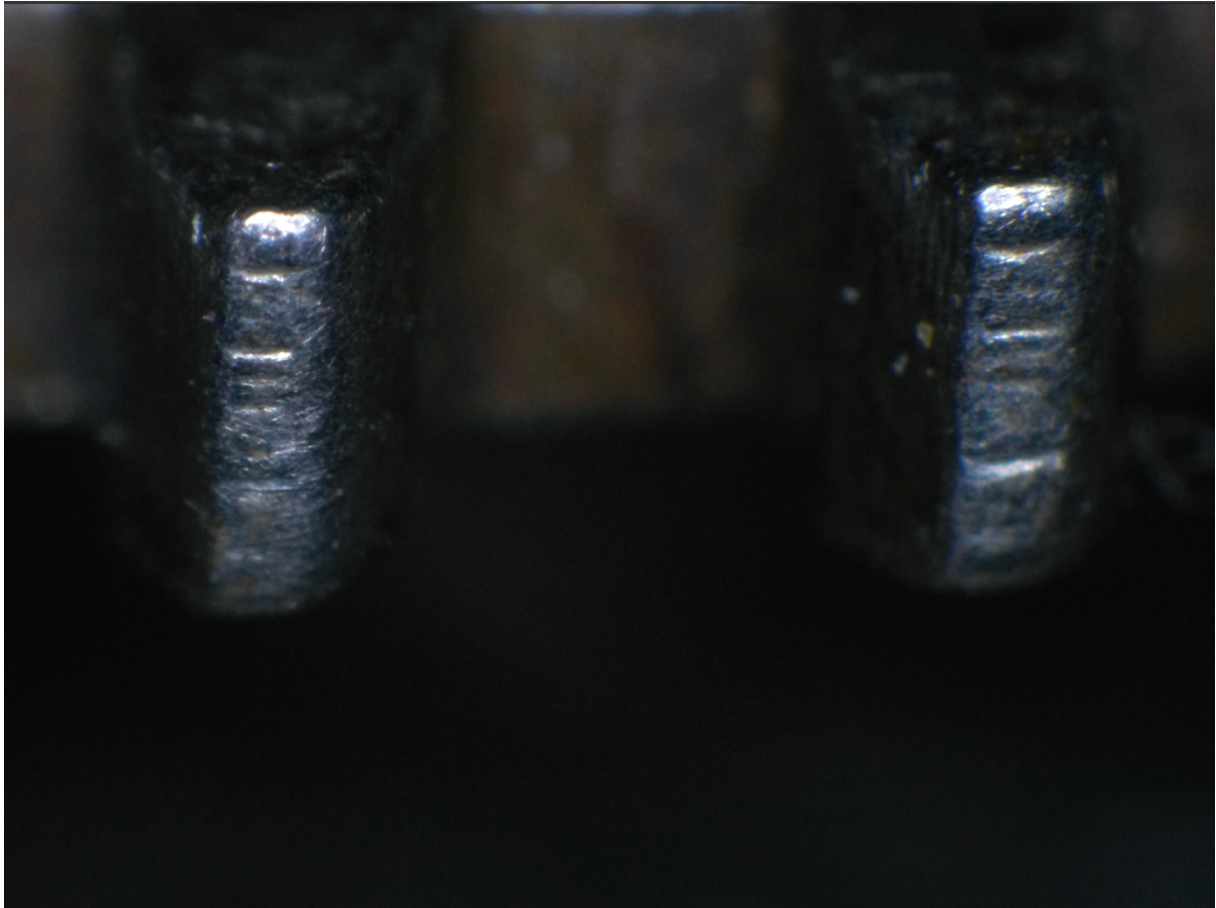
The tooth tips were filed down

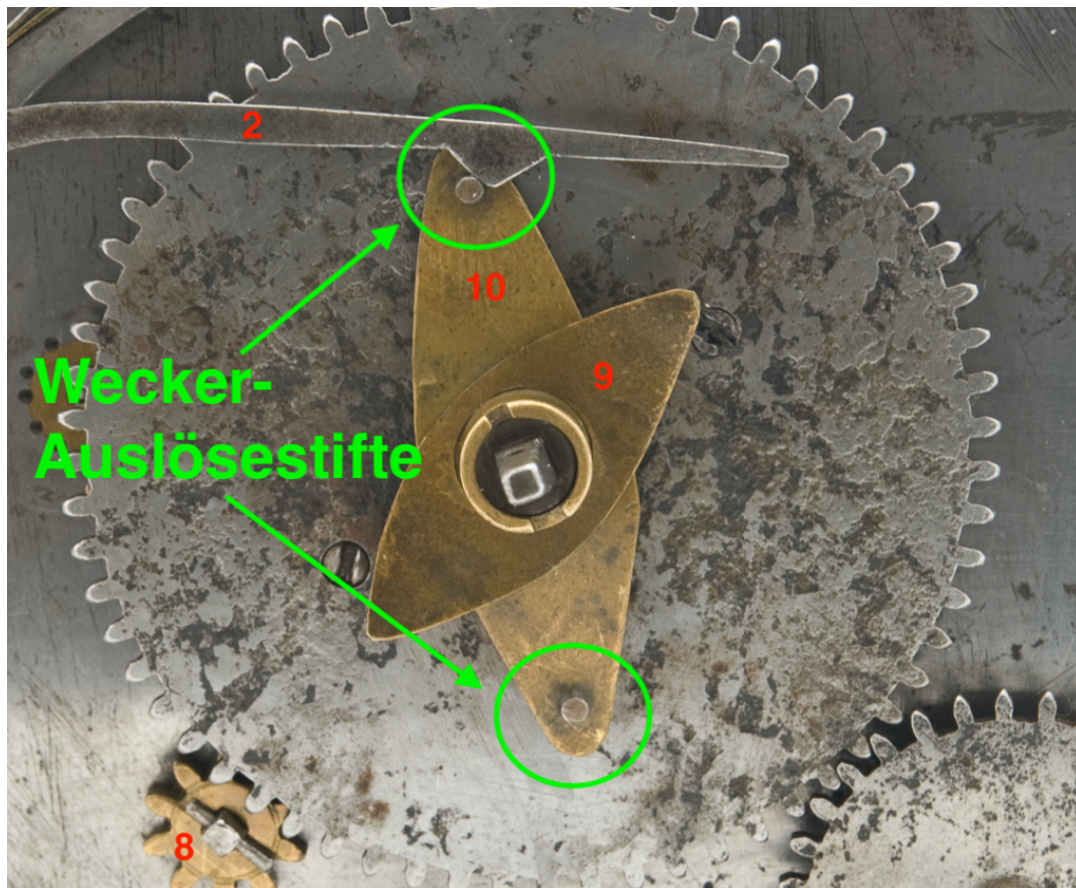
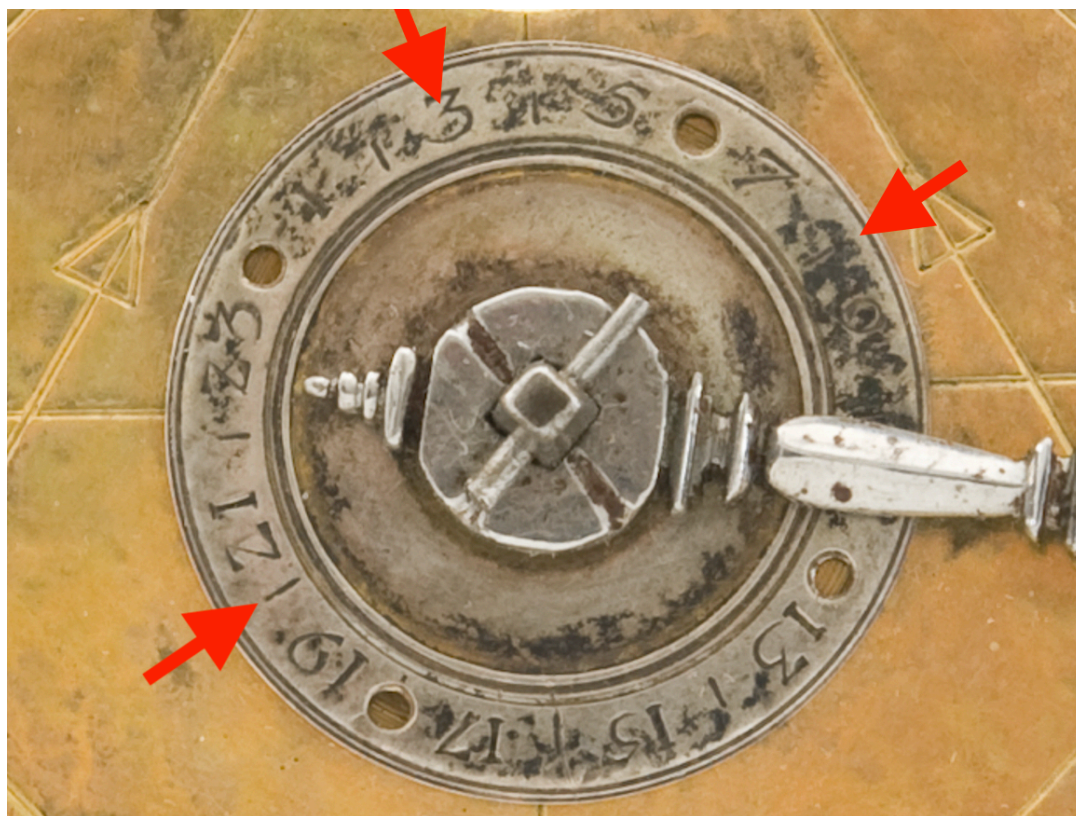
Assuming the brass pressure spring exerted enough pressure to transport with the wheel — which it does not — then the alarm would trigger twice in 24 hours. This means that if you set the alarm disc, for example, from 3 o'clock to 8 o'clock, the alarm would trigger at 8 o'clock, which is correct. However, if I wanted to set the alarm time to 18 o'clock, the alarm would also trigger at 8 o'clock. Therefore, in this configuration, a 24-hour alarm dial with a mechanism that triggers twice in 24 hours doesn't make sense to me.

The two release pins made of iron are new parts riveted into old brass.

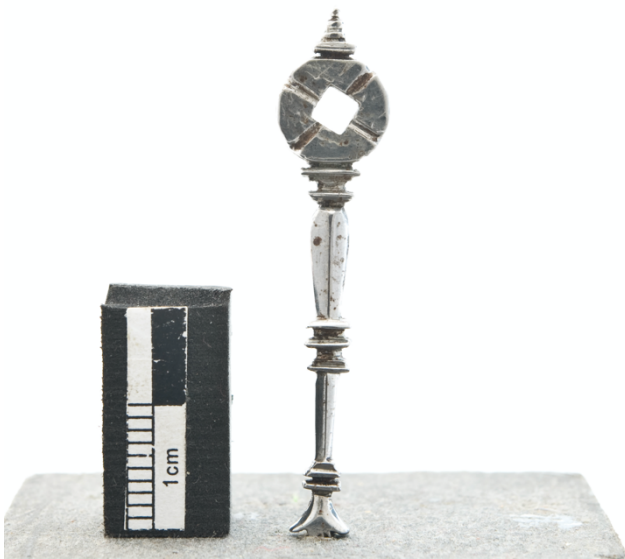
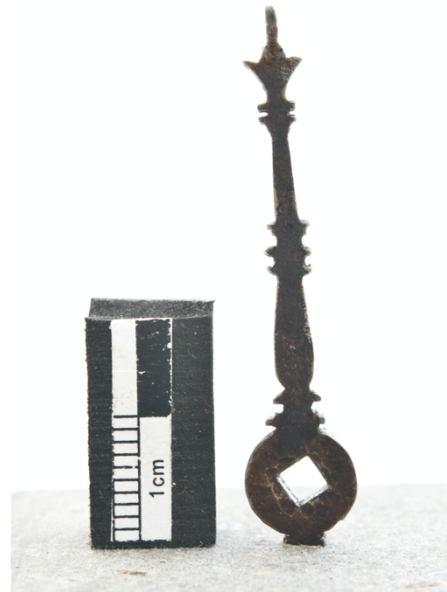
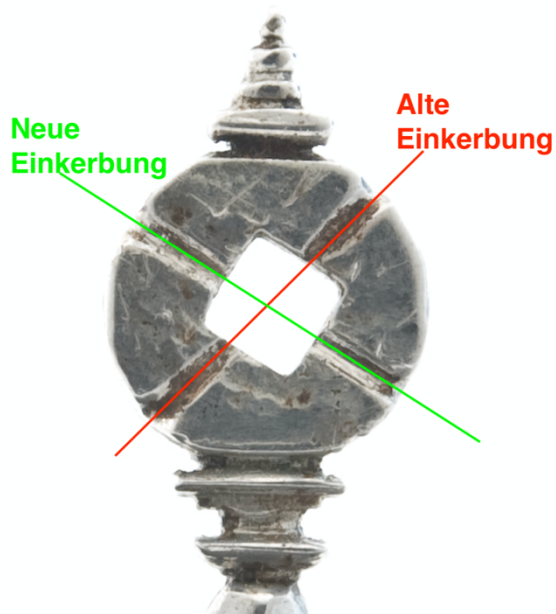
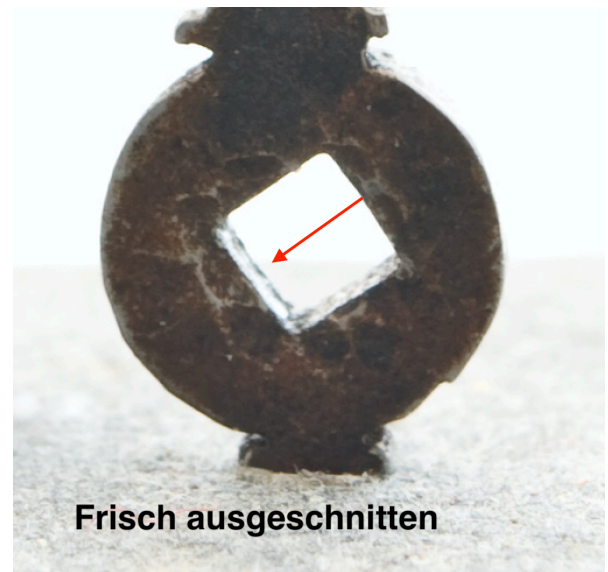
The hour hand could very well be an old hand that was adapted for this clock. The square hole was enlarged at least by filing. The notch for the placement of the retaining pin was adjusted by adding a new notch for the pin onto the square of the hour wheel.

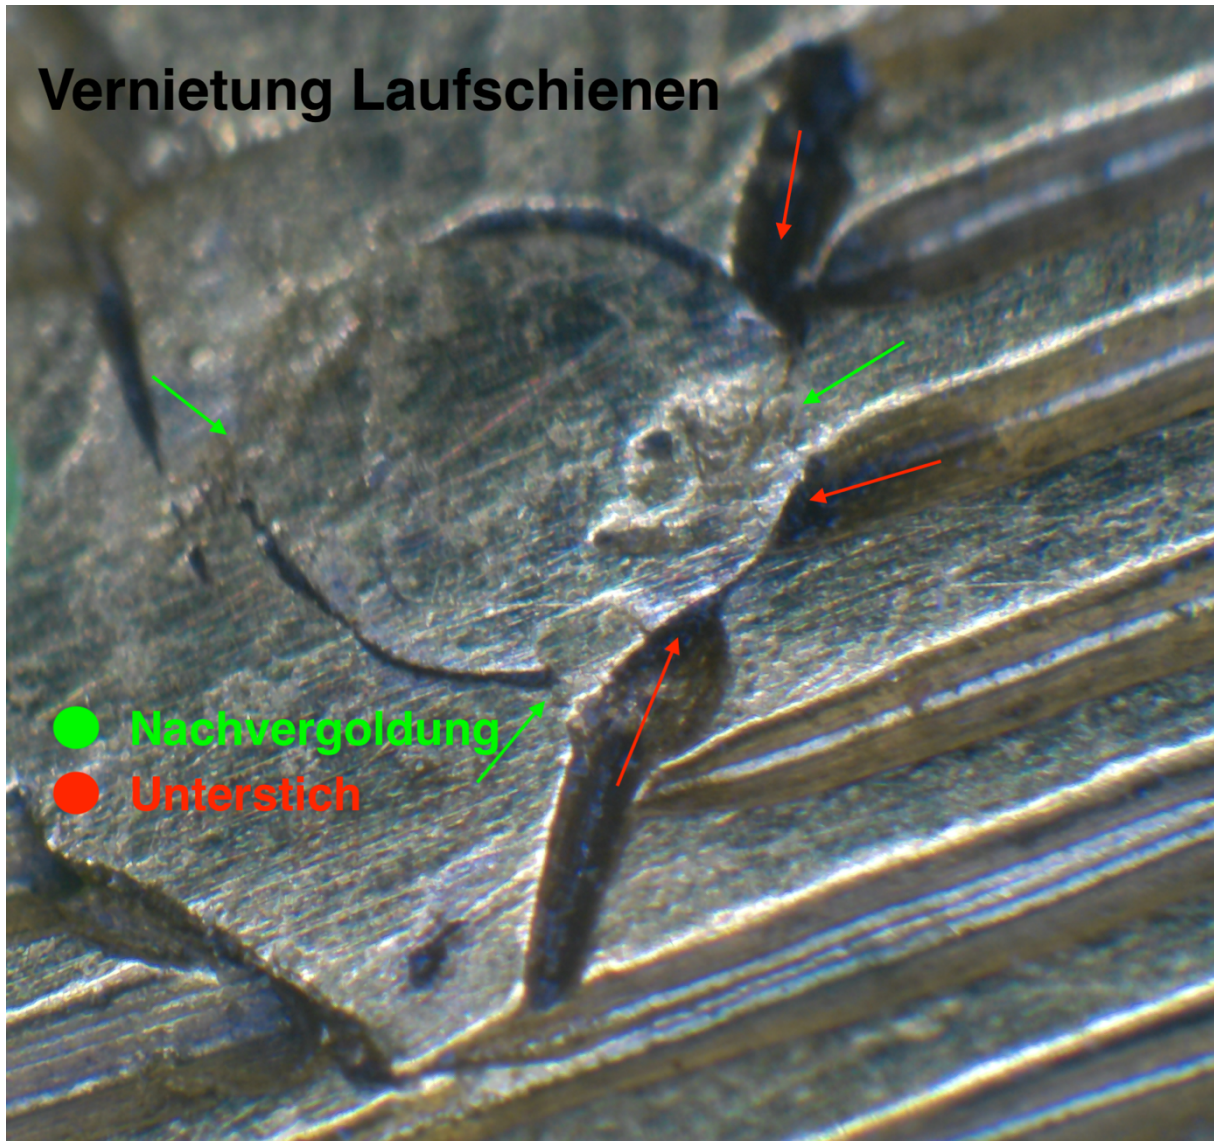
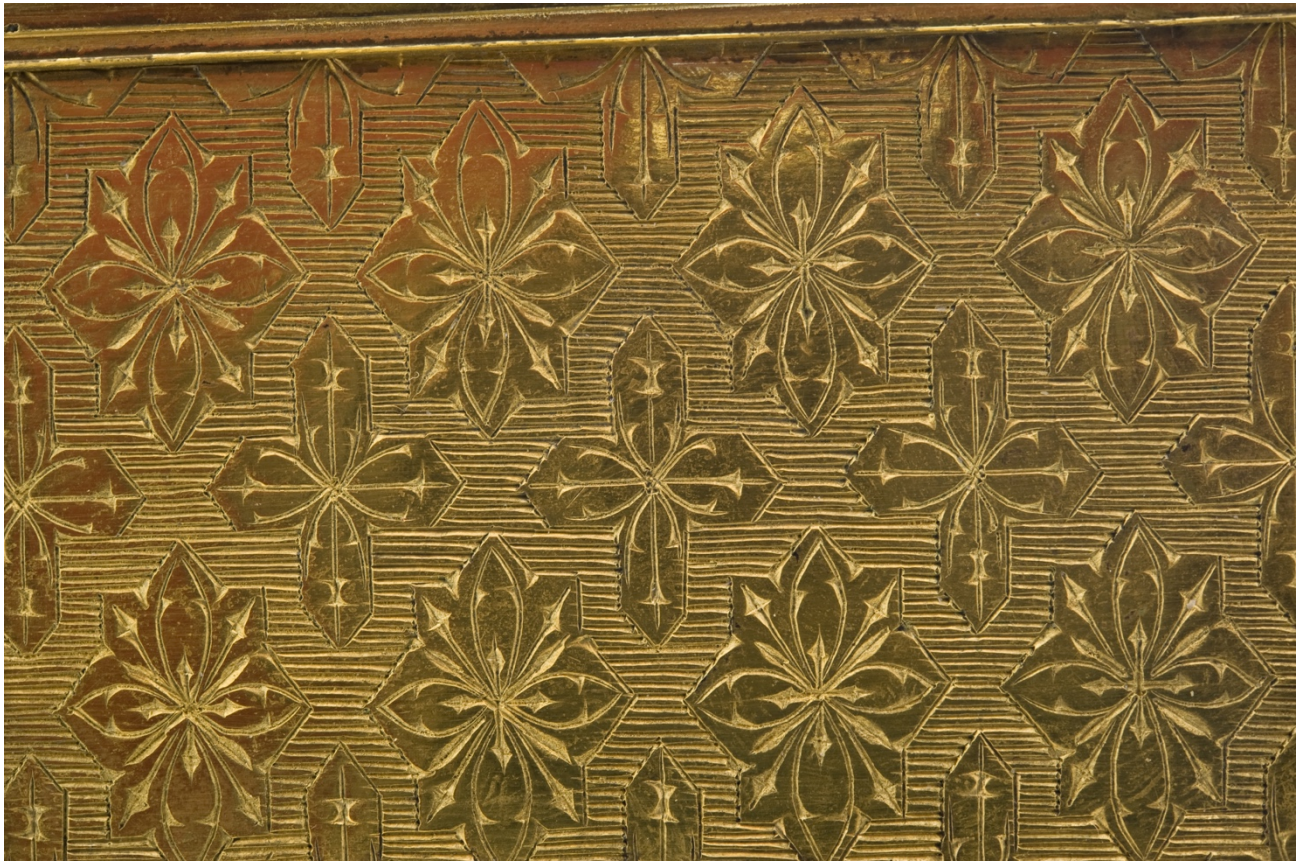
The running rails attached to the movement case are riveted through the case body and show clear signs of engraving on the outside, which must have occurred before the riveting.

To achieve such a flat rivet surface, the rivet head must be filed down to be level with the case surface and then smoothed out after riveting.

It is highly unlikely that such crude work would be performed during the creation of a new case in this sequence. This would require that the engraver and the gilder had already completed their work.

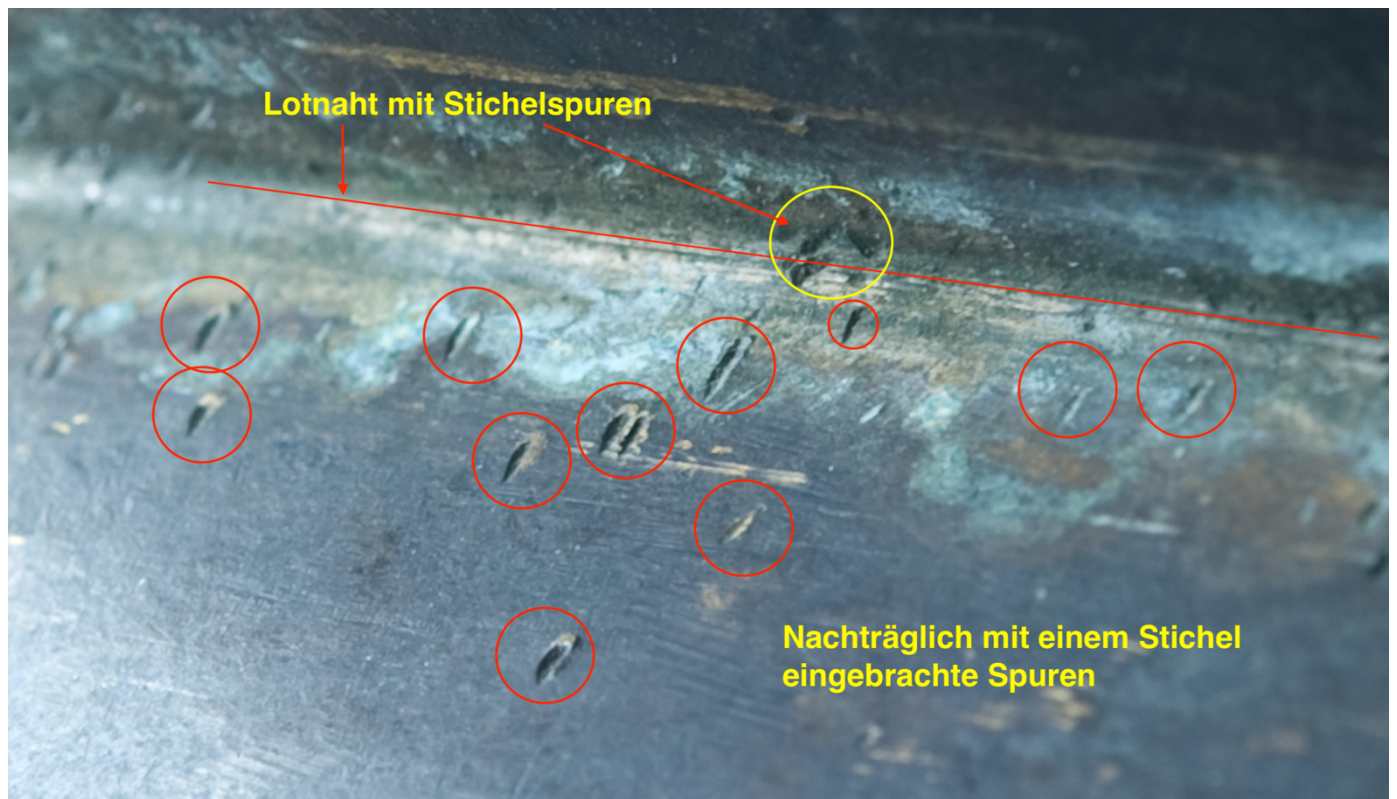
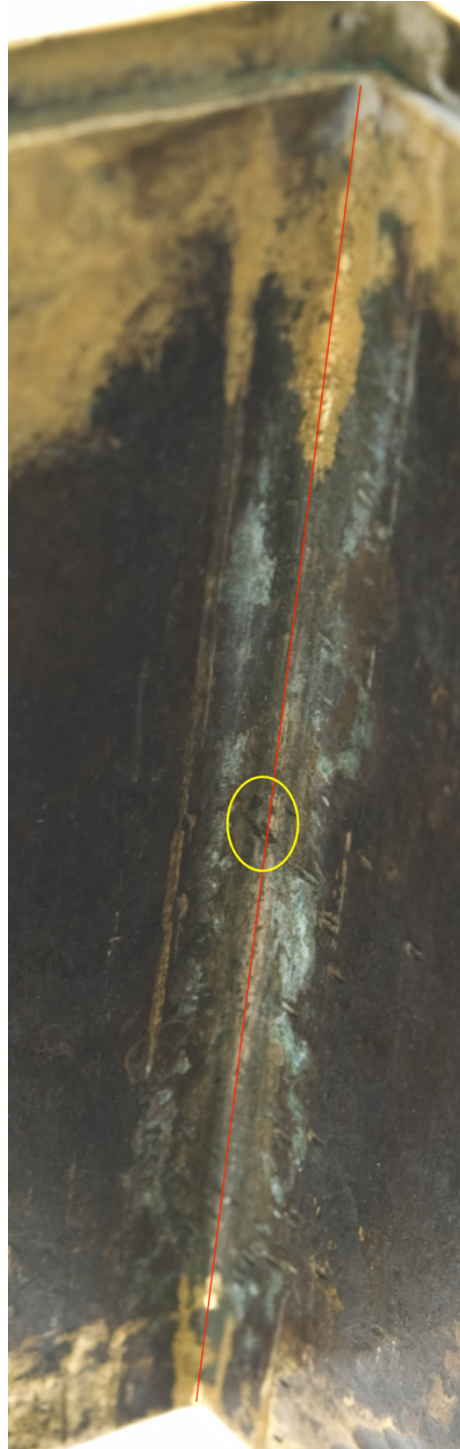
An interesting clue is the subsequent, faked material injury, made with a sharp stylus.

The bluing of the case's interior walls was done later, but it had no patinating effect on the silver solder of the joint. This proves that the artificial aging marks were made after the soldering and into the silver solder. These irregularities in the material could theoretically have been present before the plates were soldered, but their presence in the solder is evidence of a later, deliberate addition.
