Real or Fake?

Examination and Analysis of a Clock Presenting Itself as a "Horizontal Table Clock from the 16th Century" with Astronomical Display

from Jürgen Ehrt

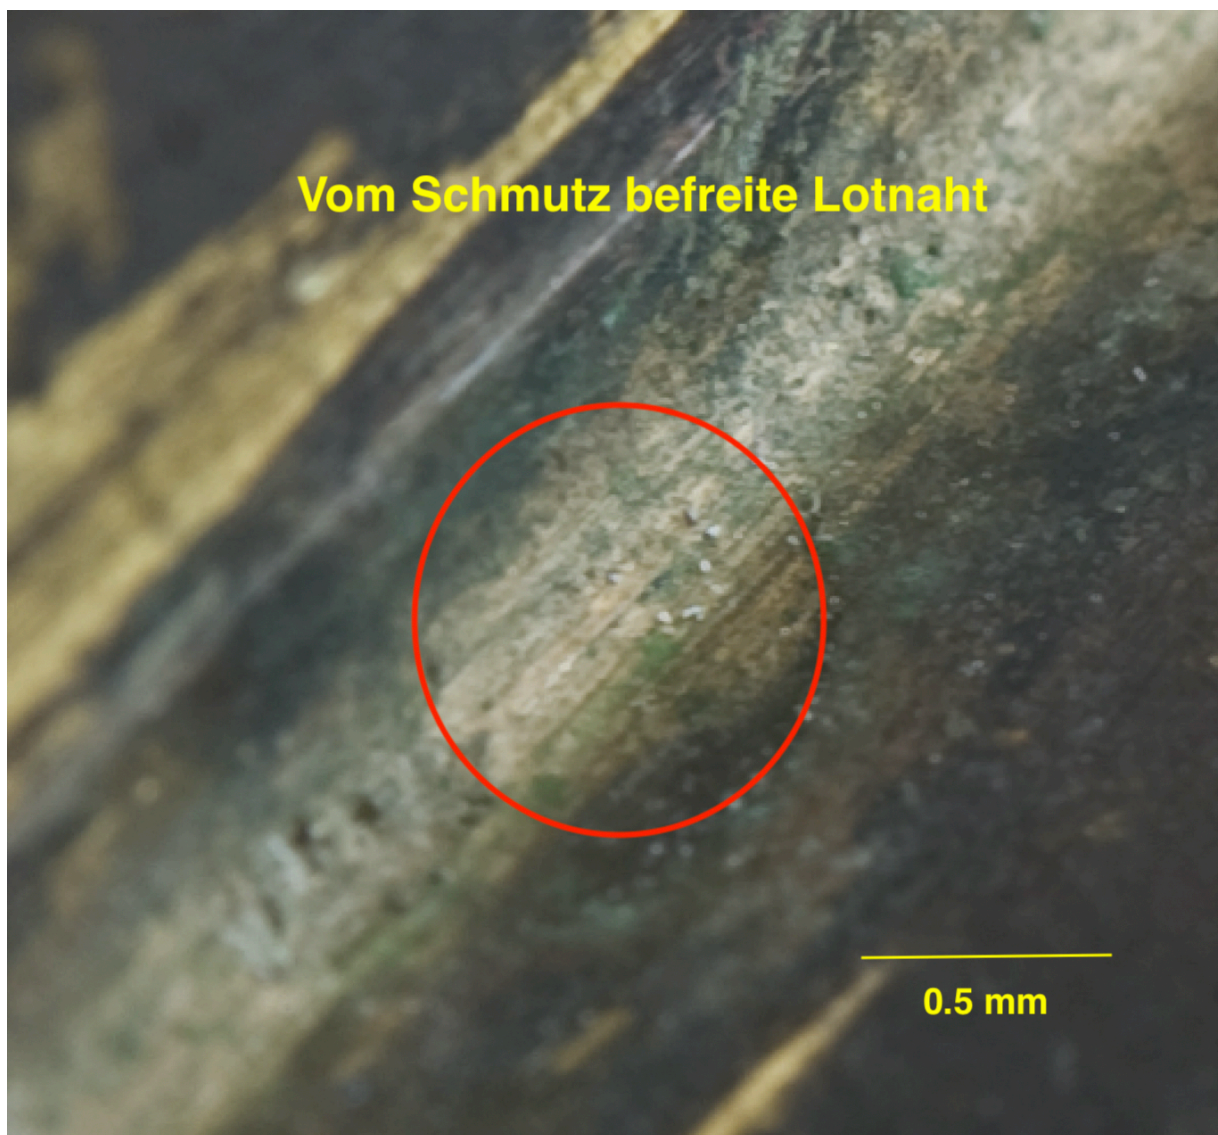
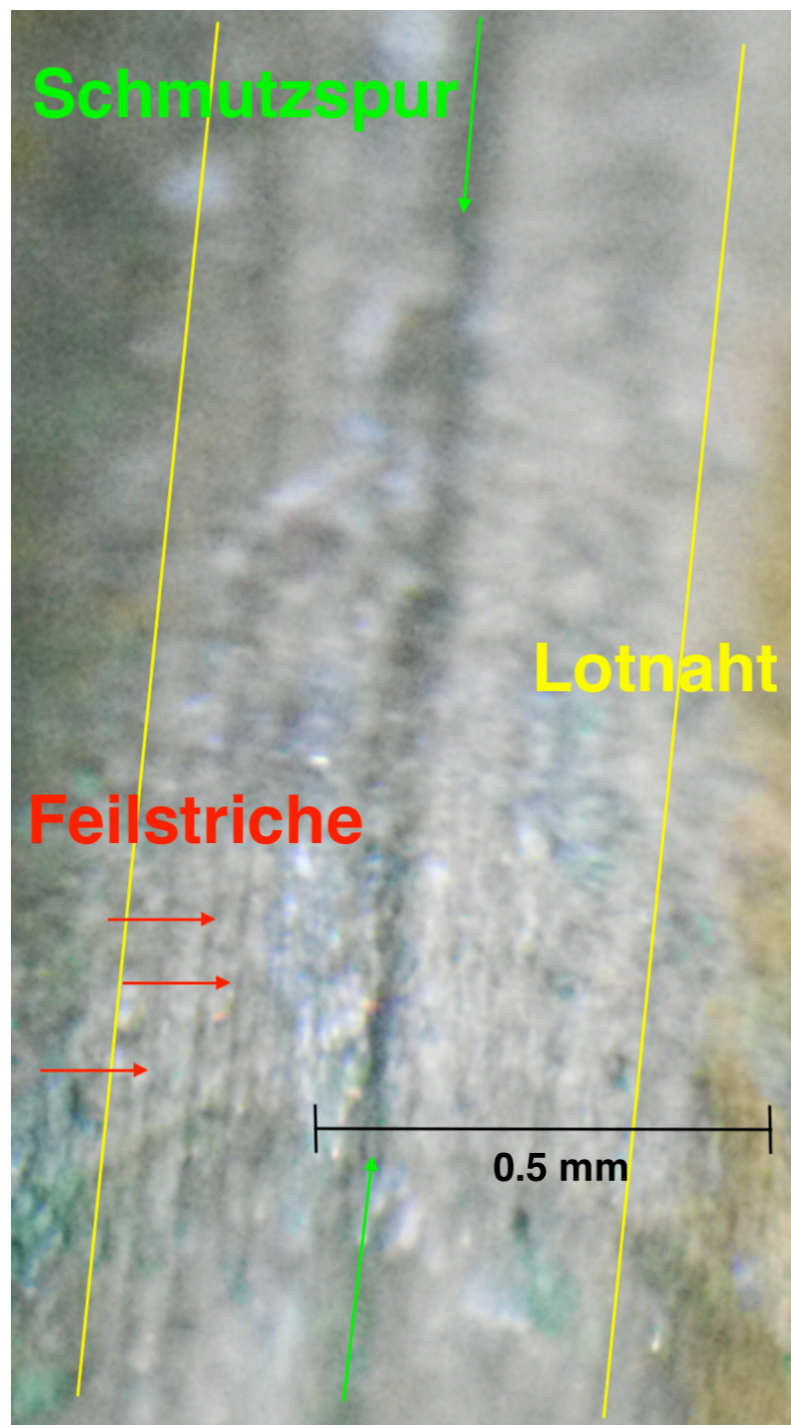
If the protective layer applied on the solder joint is removed using a cleaning medium based on gentle, residue-free surfactants, such as SurTec 104 in this case, the surface dirt is dissolved.

The surface dirt mentioned here is applied as a replacement for patina on the copper solder joint. After removing the surface dirt, even the finest file marks, which were created during the smoothing of the solder joint, become visible. Comparing the resolution of the microscope image at 0.5 mm with the spacing of the file marks makes it clear that this cannot be the work of a tool from the 16th century.
